# **The Massachusetts Propane Investigation**

# **The Cause/Origin Investigation**

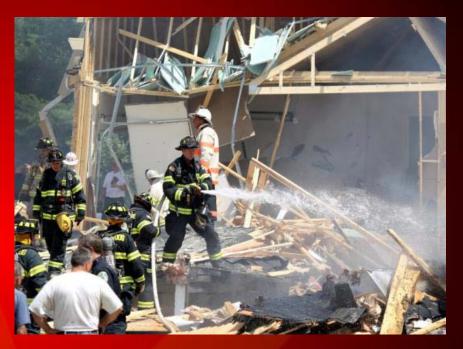
- July 30, 2010 at 1220 hrs.
- Multiple calls for a reported explosion
- Resulted in 7 injuries and 1 fatality.
- 5 alarm rescue/fire mission; took over an hour to extricate victims.
- 21 communities in MA responded along with DFS Support Units

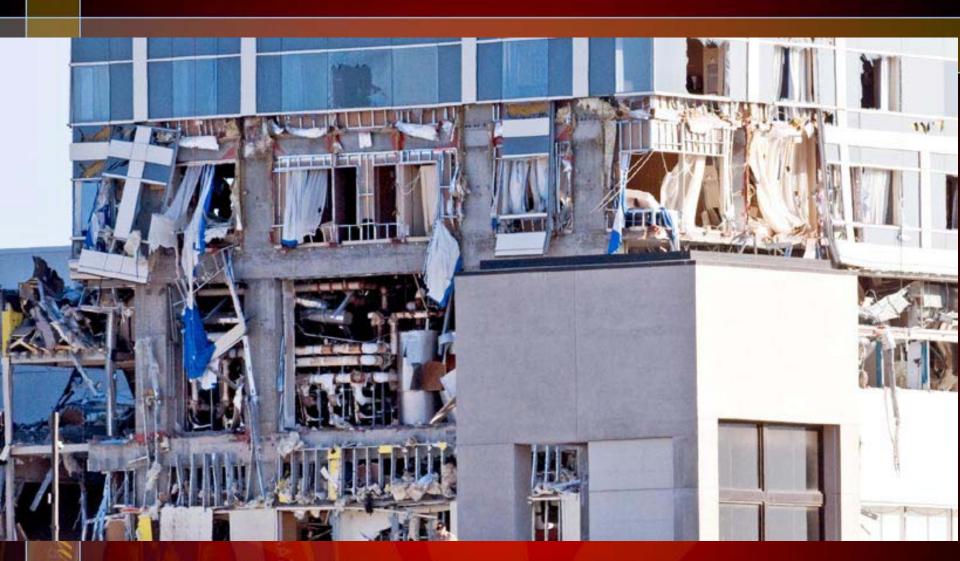
Explosion seriously damages three floors of a Hilton Hotel under construction in San Diego in May 2008, injuring 14. 15
