SUBJECT: Report of Investigation of August 10, 2015 Electric Fatality
Benton, New Hampshire

Safety Division Findings of the August 10, 2015
Electrical Contact and Fatality with a New England Power/
National Grid 230 kV Transmission Line in Benton, NH

Safety Division Staff Final Report

May 12, 2017

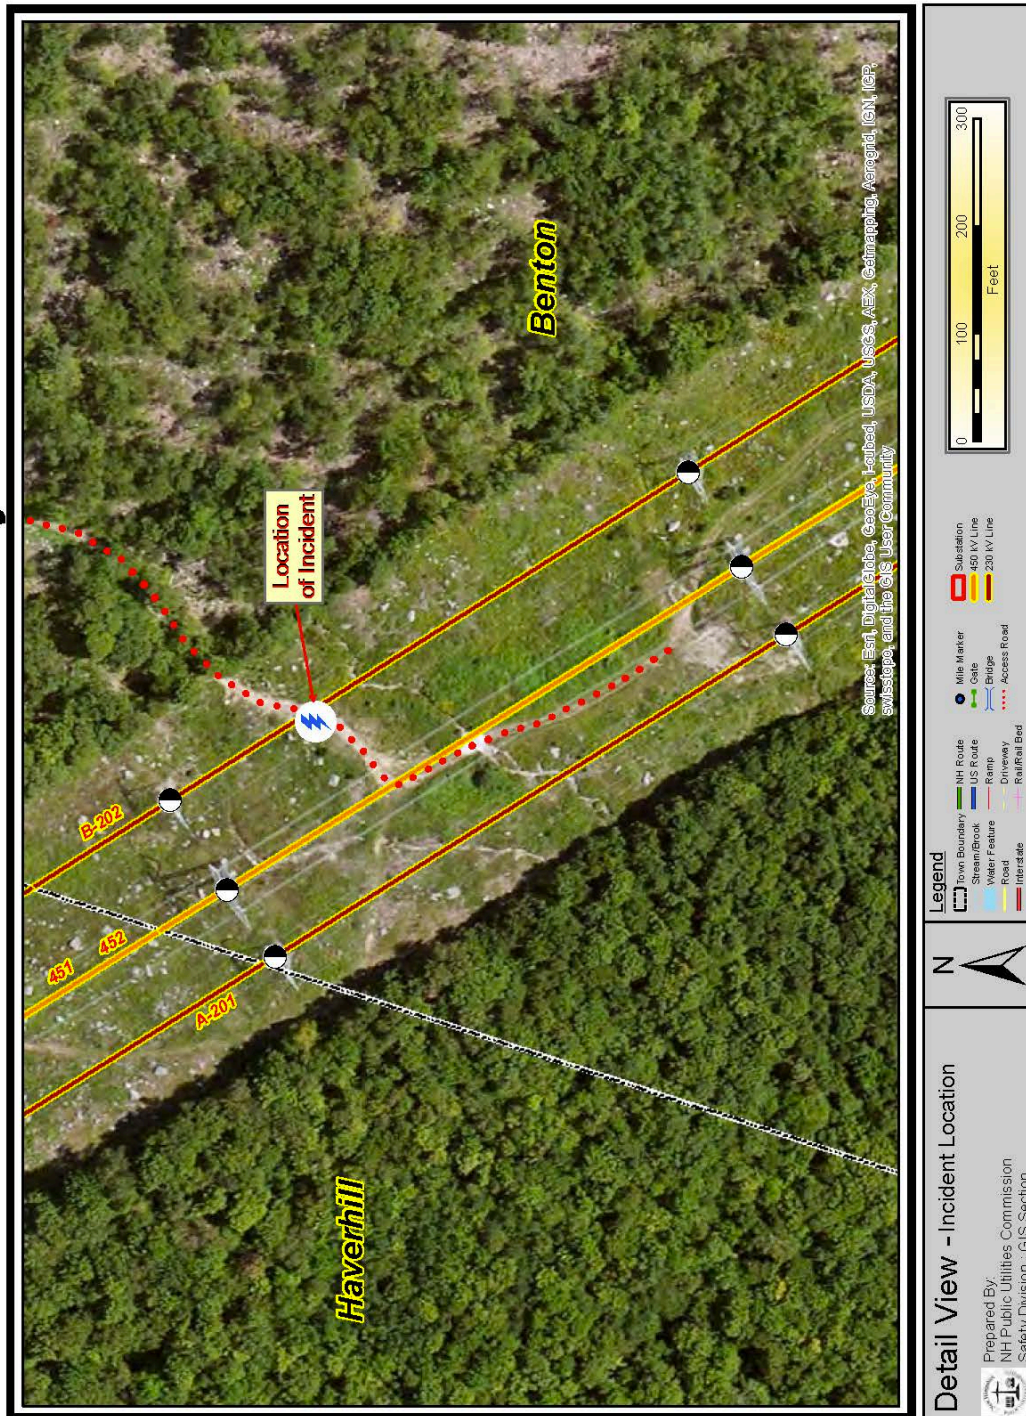
event, did not receive shocks and tried to provide assistance to their fallen colleague. No utility personnel from NGRID were present. (See Detail View Attachment 4 of this report for incident location depictions.)
