Threats to Distribution Pipelines

NEPSR Seminar, Portsmouth, NH September 21, 2014

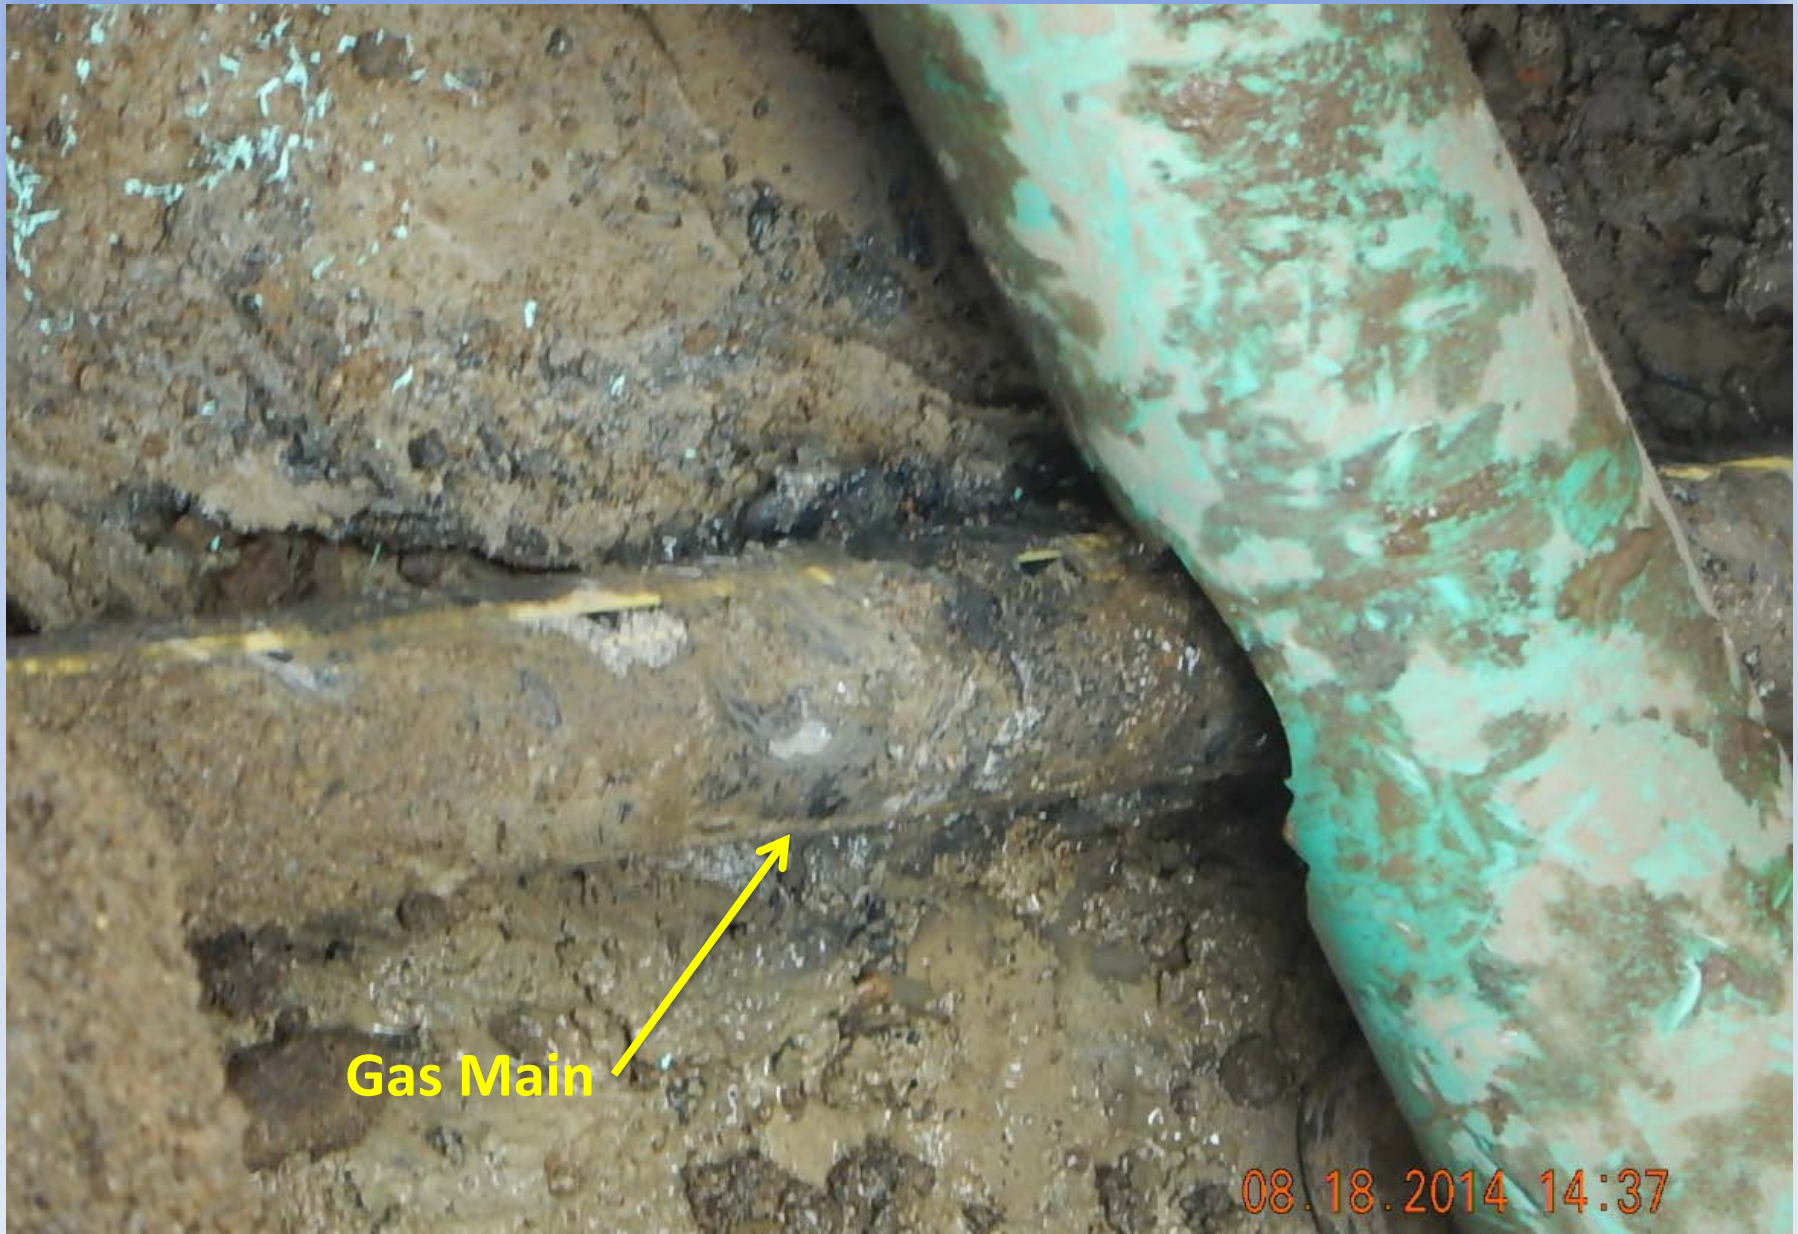
Sewer Lateral Cross Bore

Gas Main

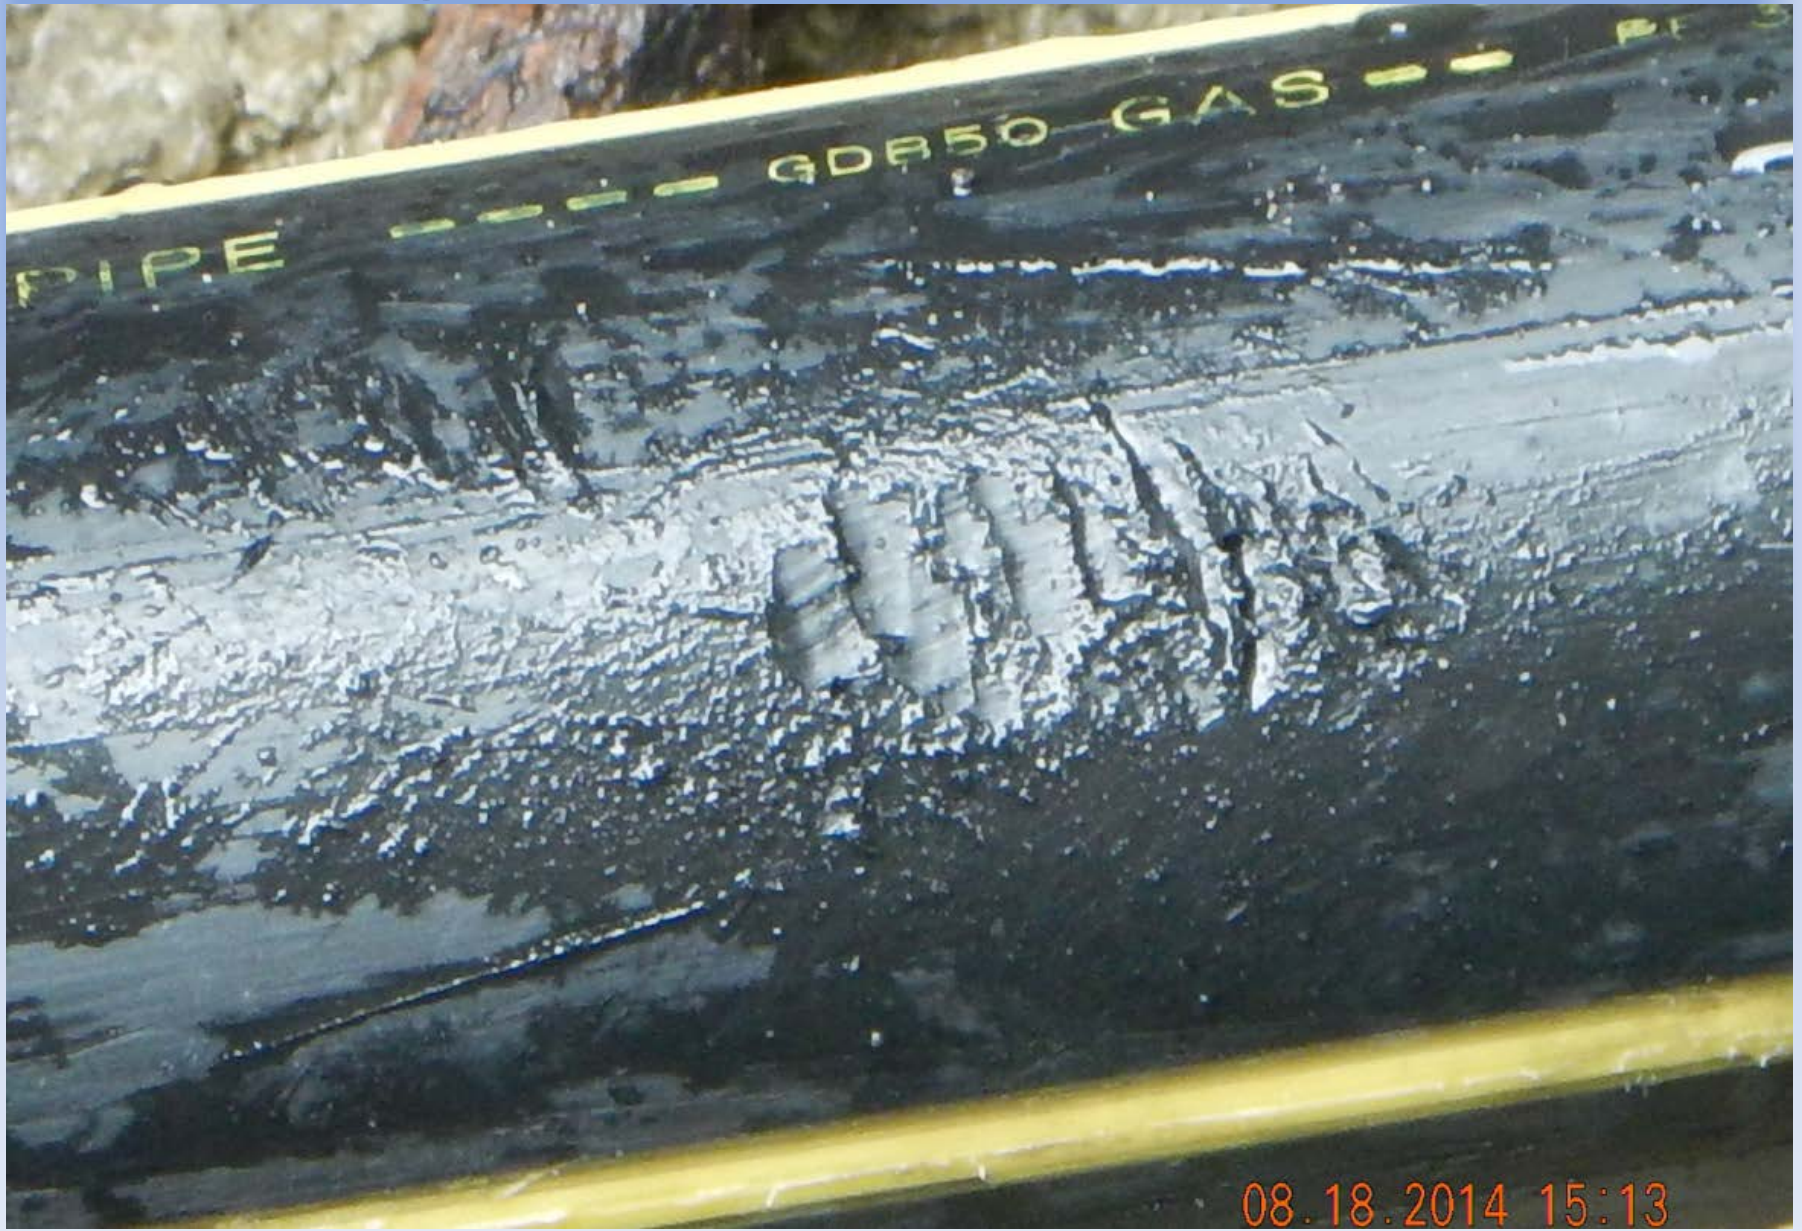
Damage from Mechanical Snake

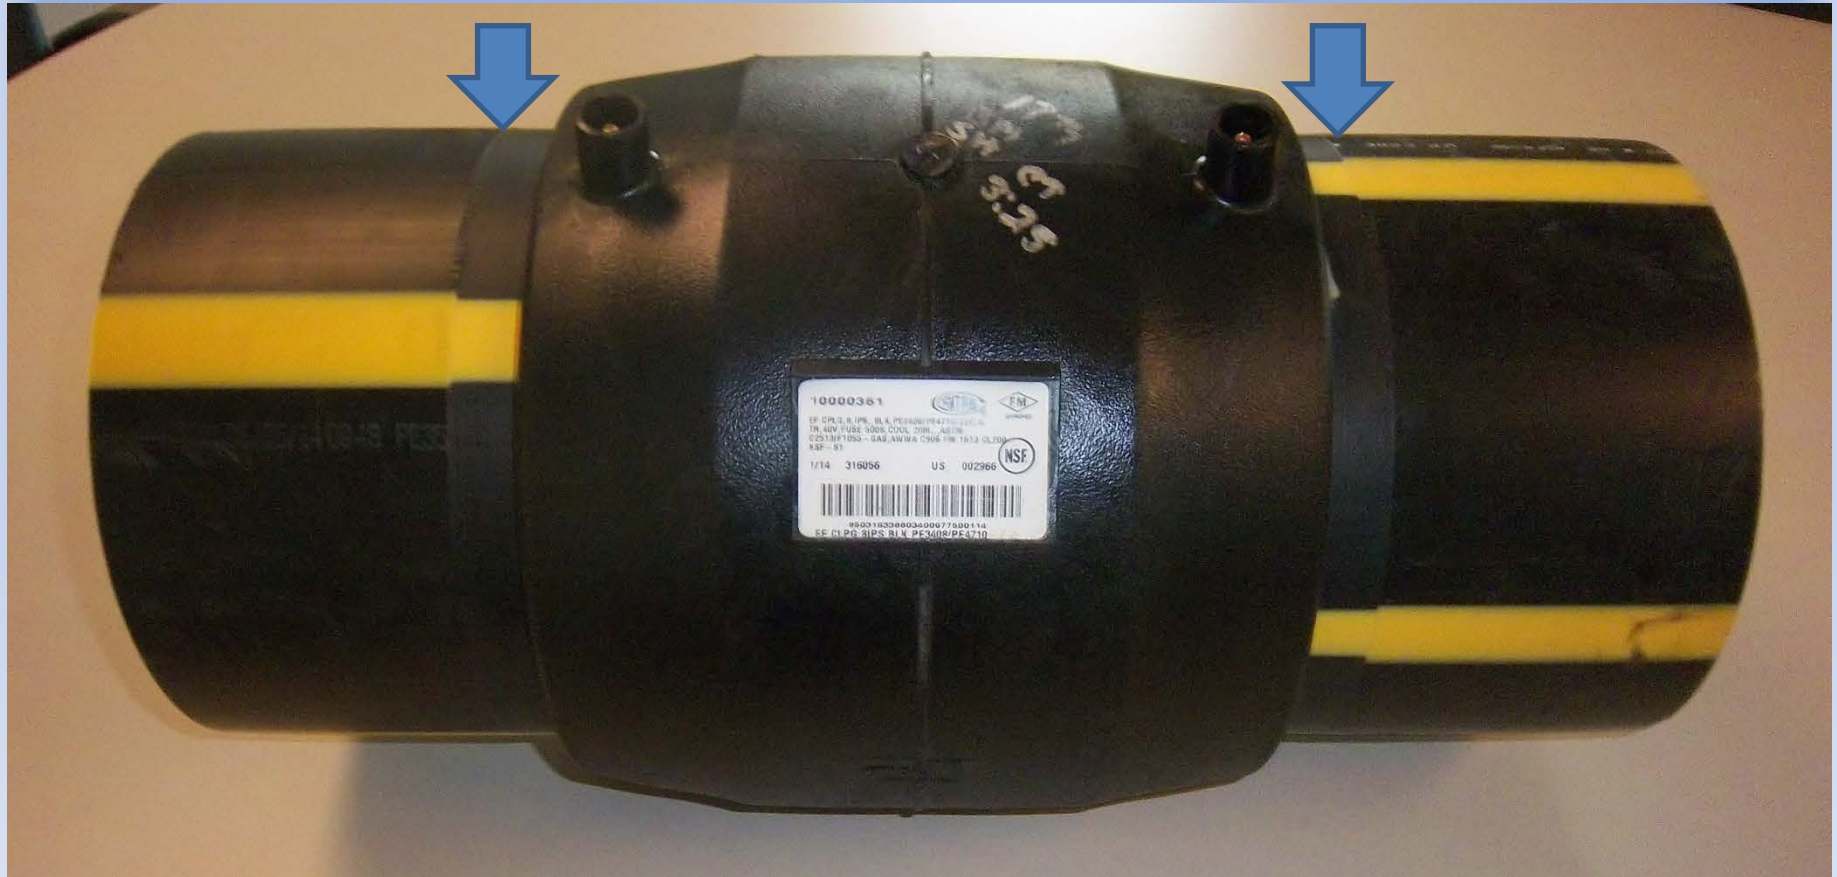
Is the pipe adequately prepared for this coupling?

- Not if it's used for a tie-in; where the coupling is slid completely over one pipe end, then back onto the second pipe.
- Central Plastics' procedure requires that the first pipe is prepared over the entire length of the coupling to avoid contaminants.

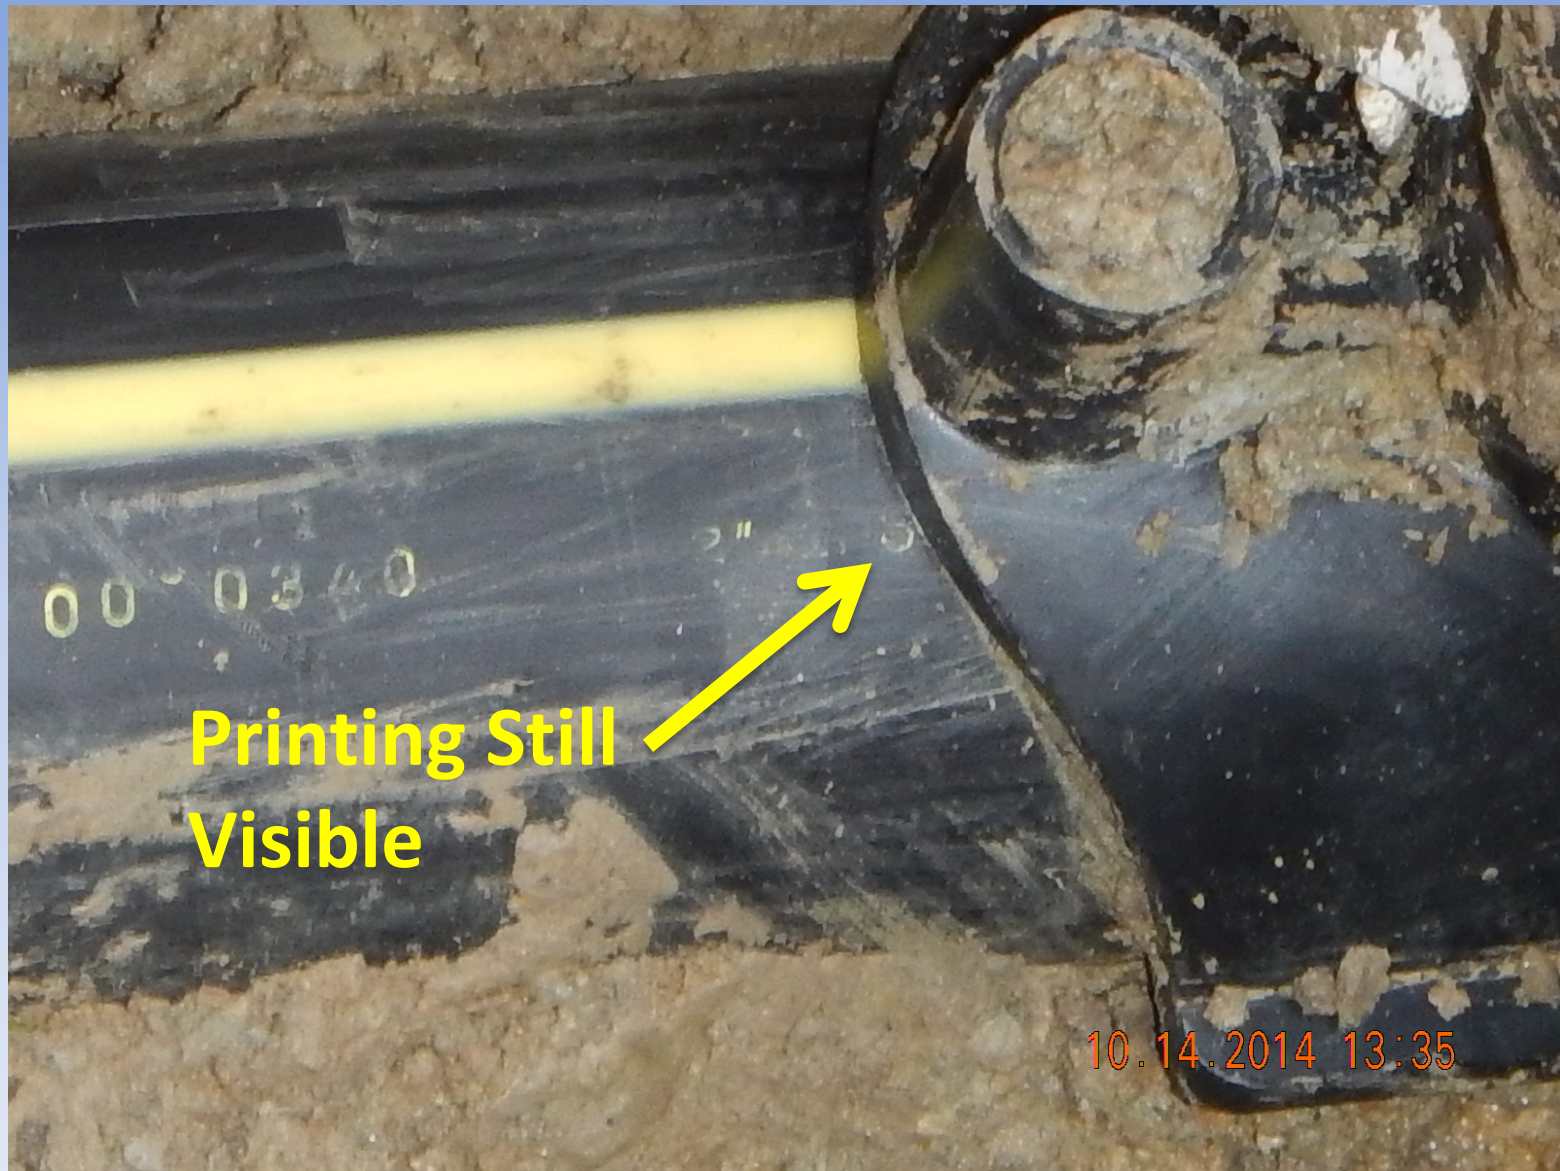
- A failure during pressure testing, and a subsequent failure of a tee in service have led to investigations of other tees;
- The investigation is looking for adequate surface preparation extending beyond the saddle
- At this time, the problem appears to be rooted with the use of non-serrated, paint style, scrapers (approved by the manufacturer's)

Electrofusion Tee - Installation

**Printing Still
Visible**

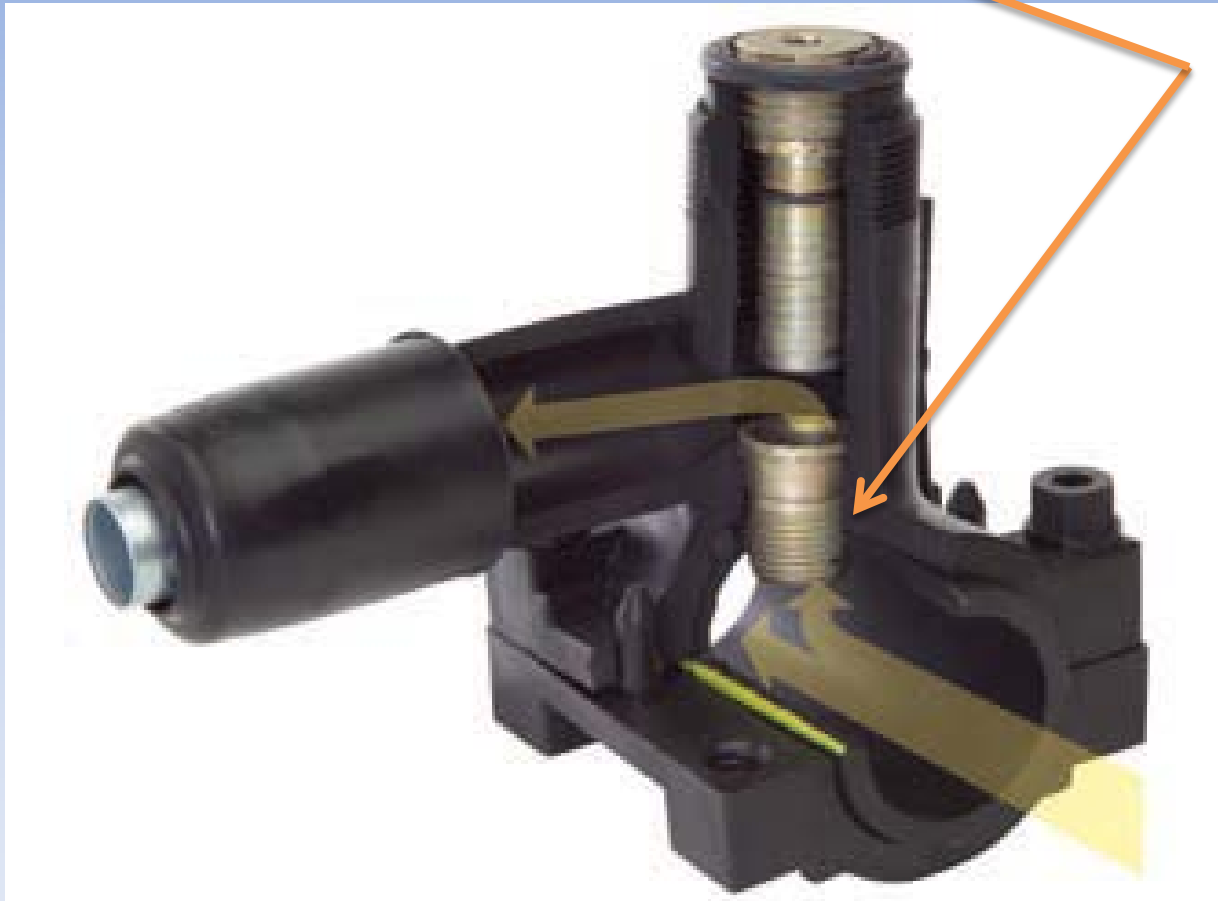
- A leak survey showed indications of gas at the approximate location of a service tee
- When excavated, the tee blew off the main
- The cutter sleeve was found to not be properly seated and the plastic bolts were broken
- Subsequently, similar tee installations have been found

Bolt On Tees - Installation

- Depend on the threads of the cutter's sleeve to hold them on the main

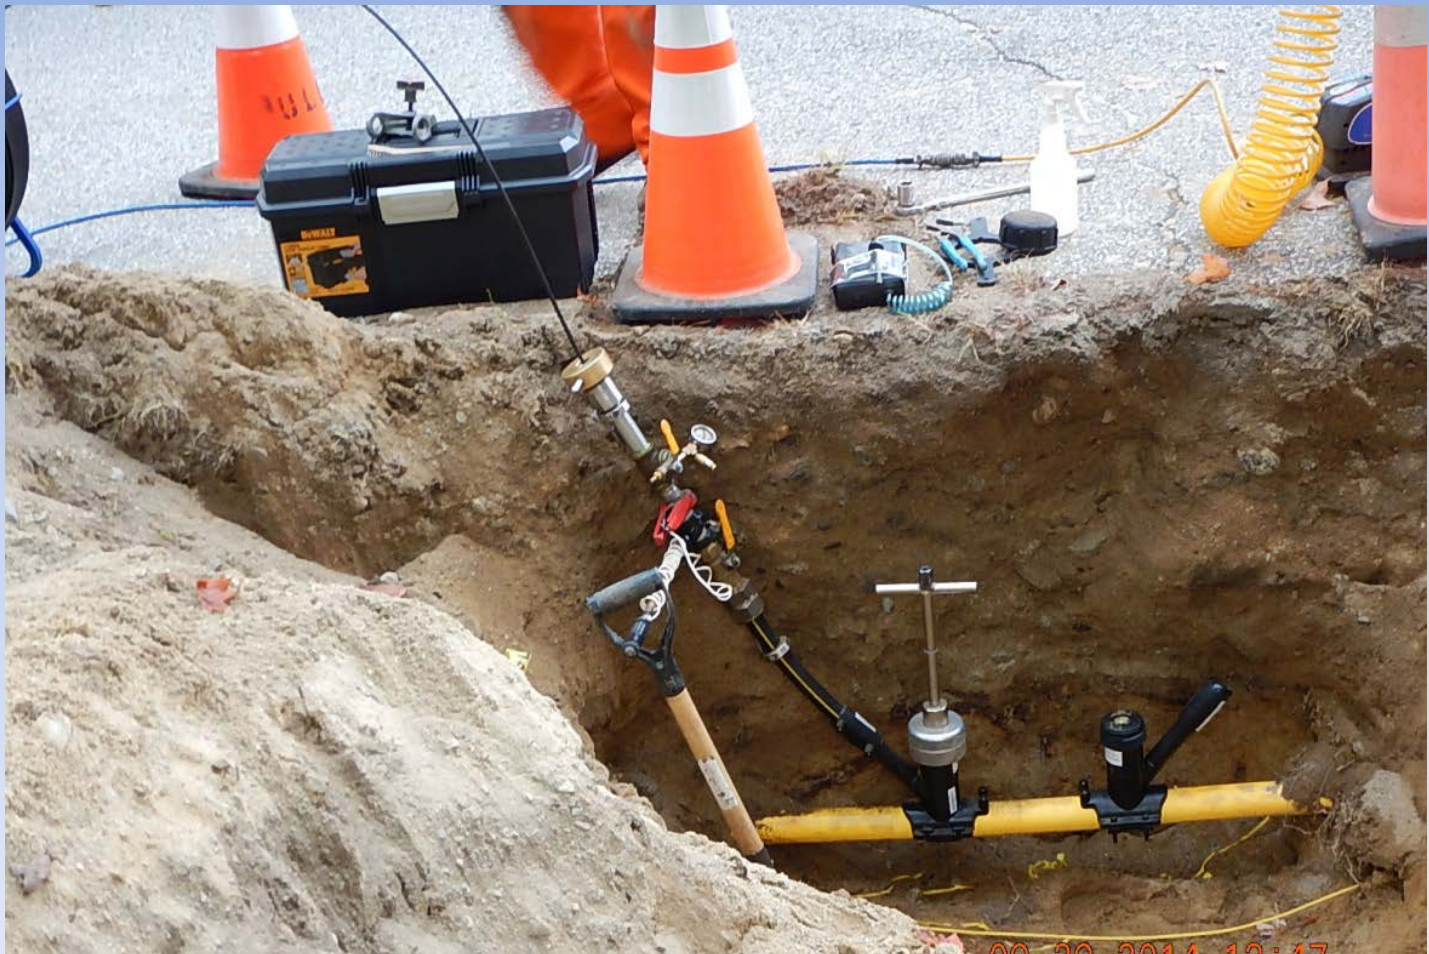
Bolt On Tees – The Investigation

- Initiated by the operator, utilizing in-line camera, looking for adequate sleeve penetration

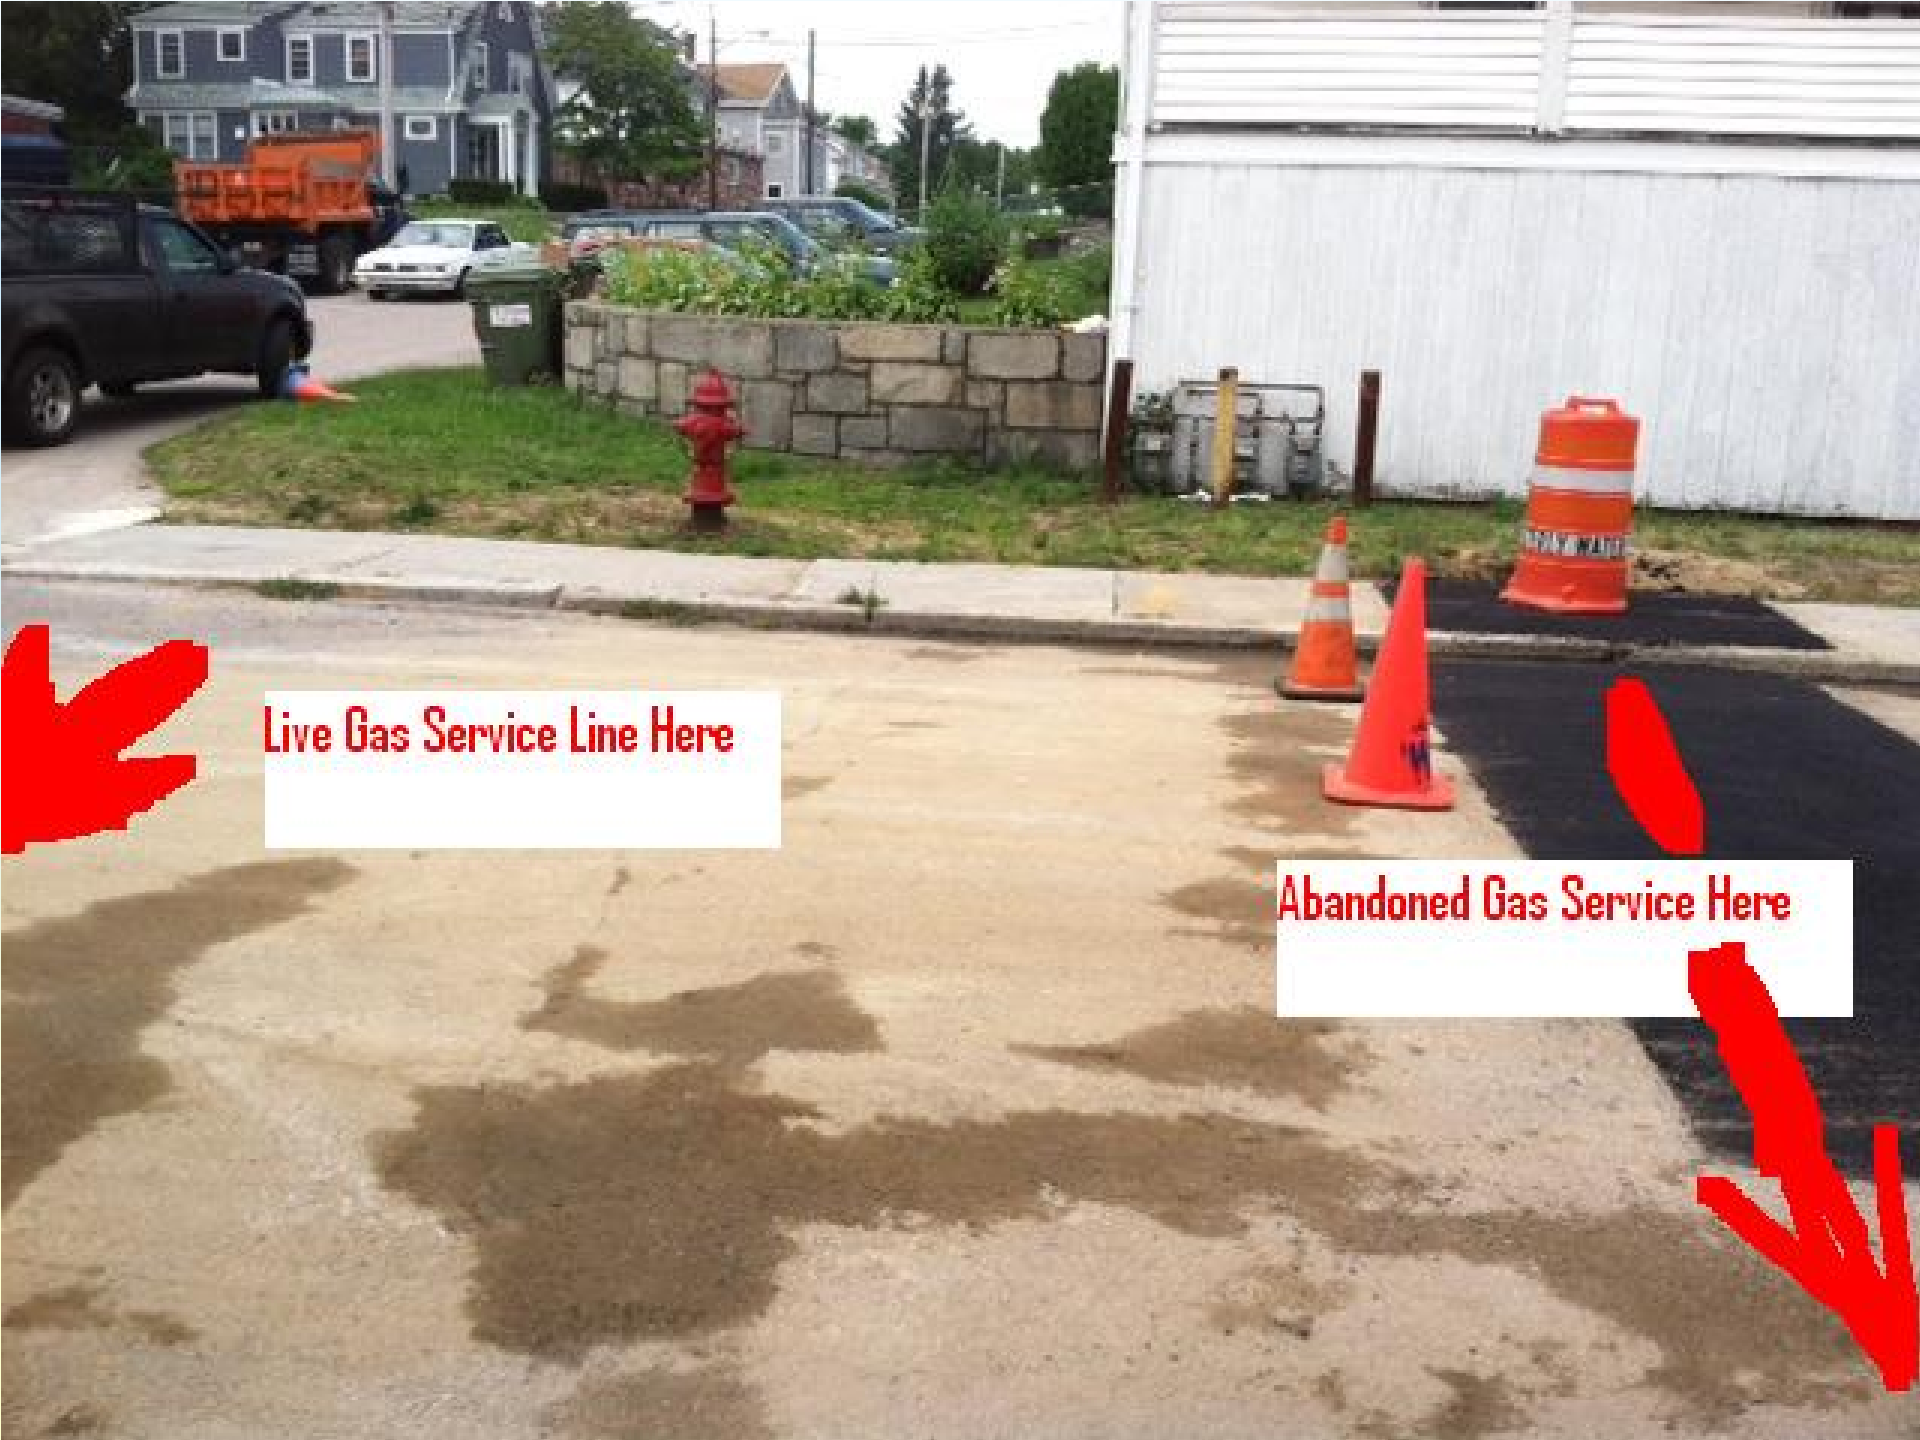
Live Gas Service Line Here

Abandoned Gas Service Here

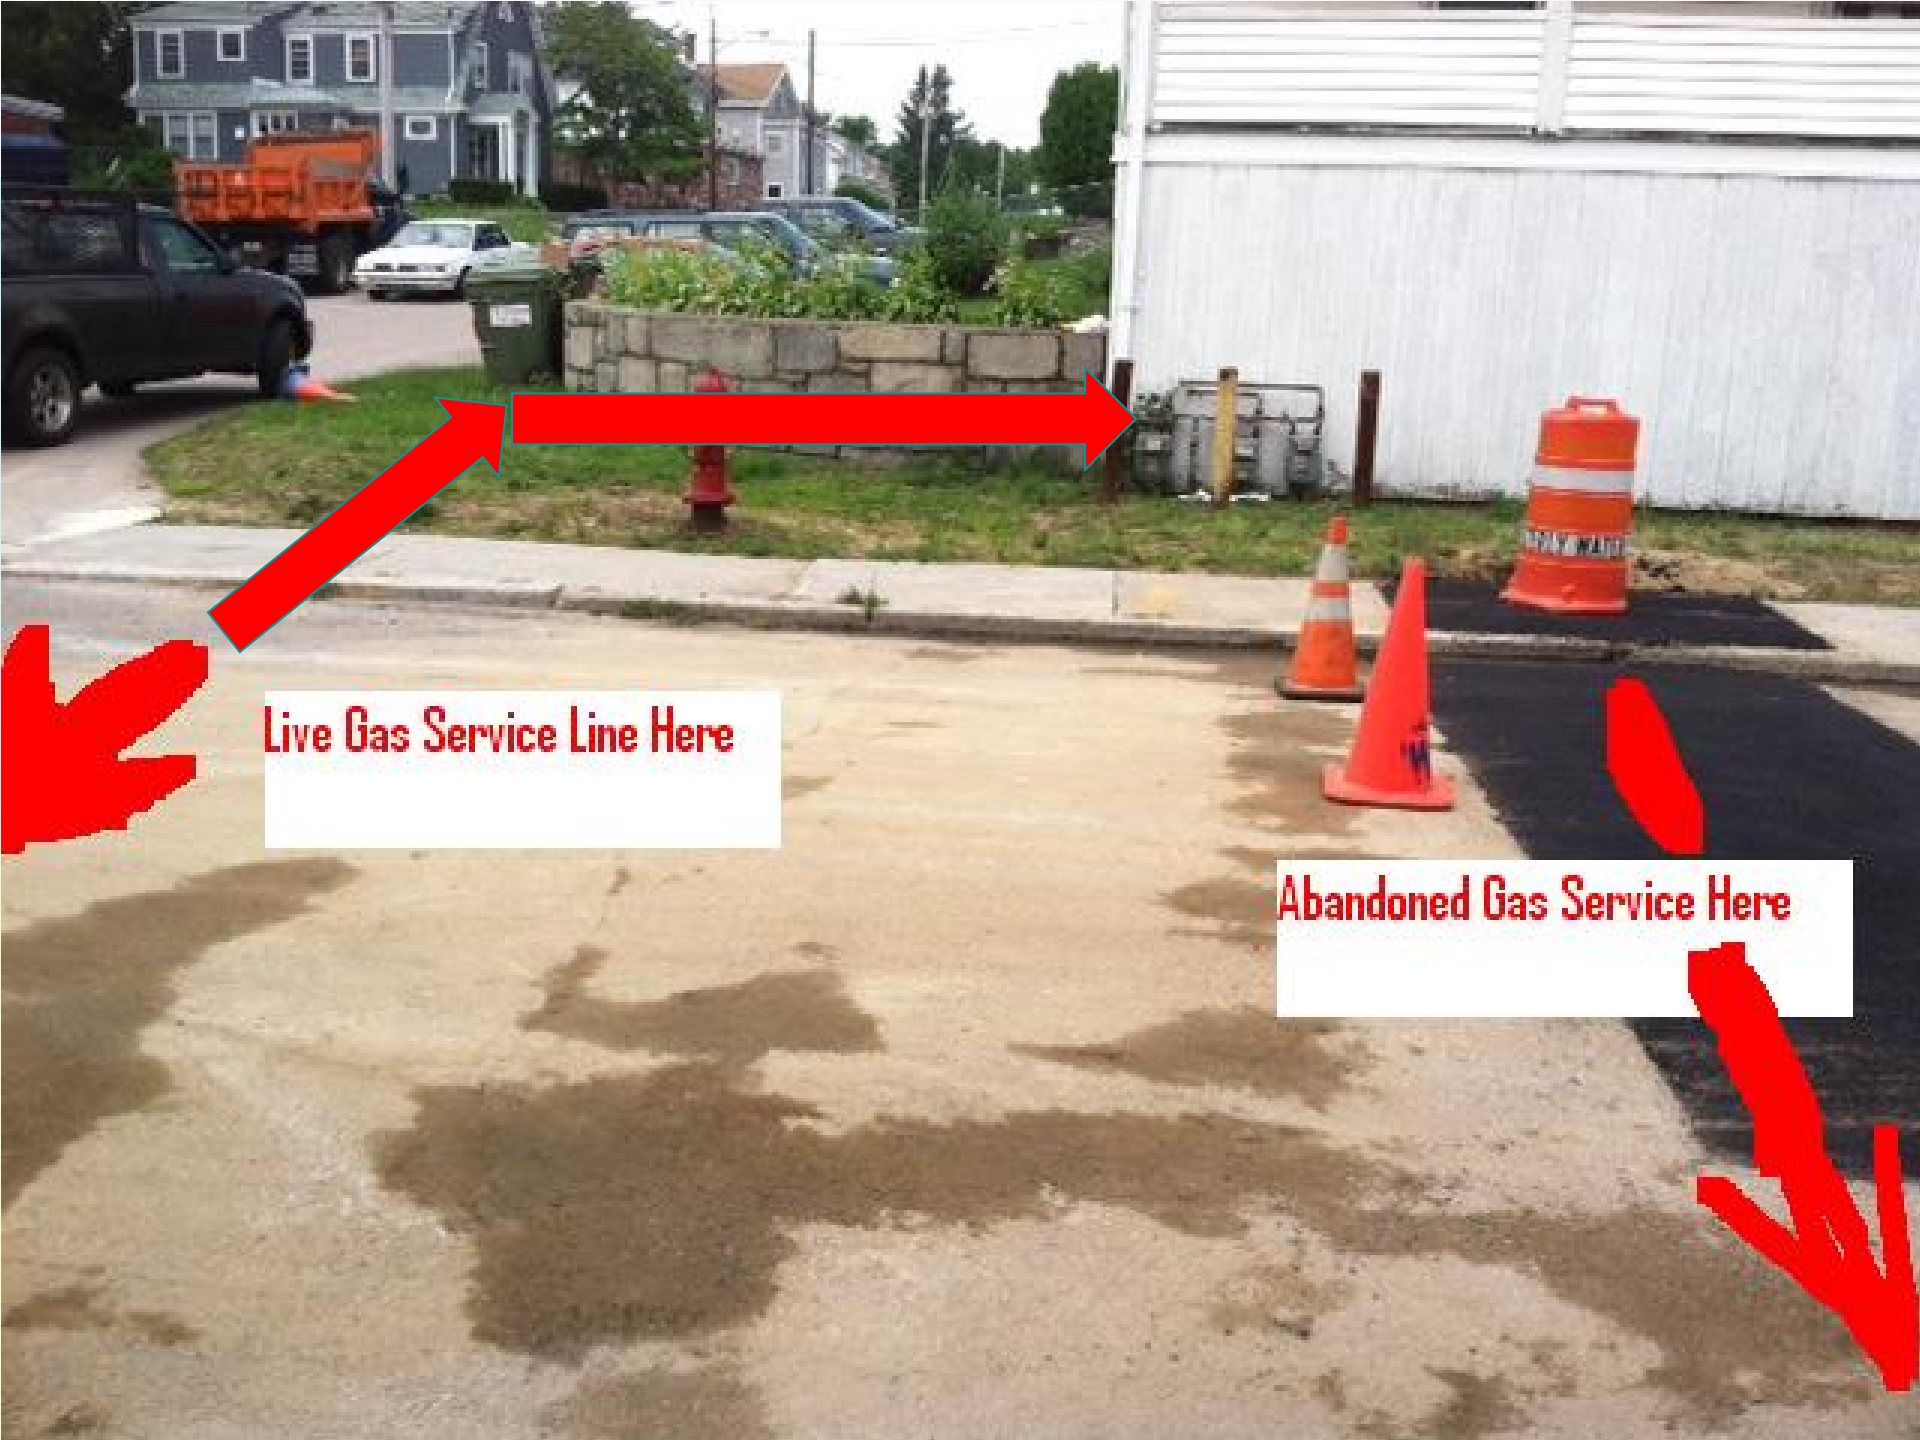
Live Gas Service Line Here

Abandoned Gas Service Here

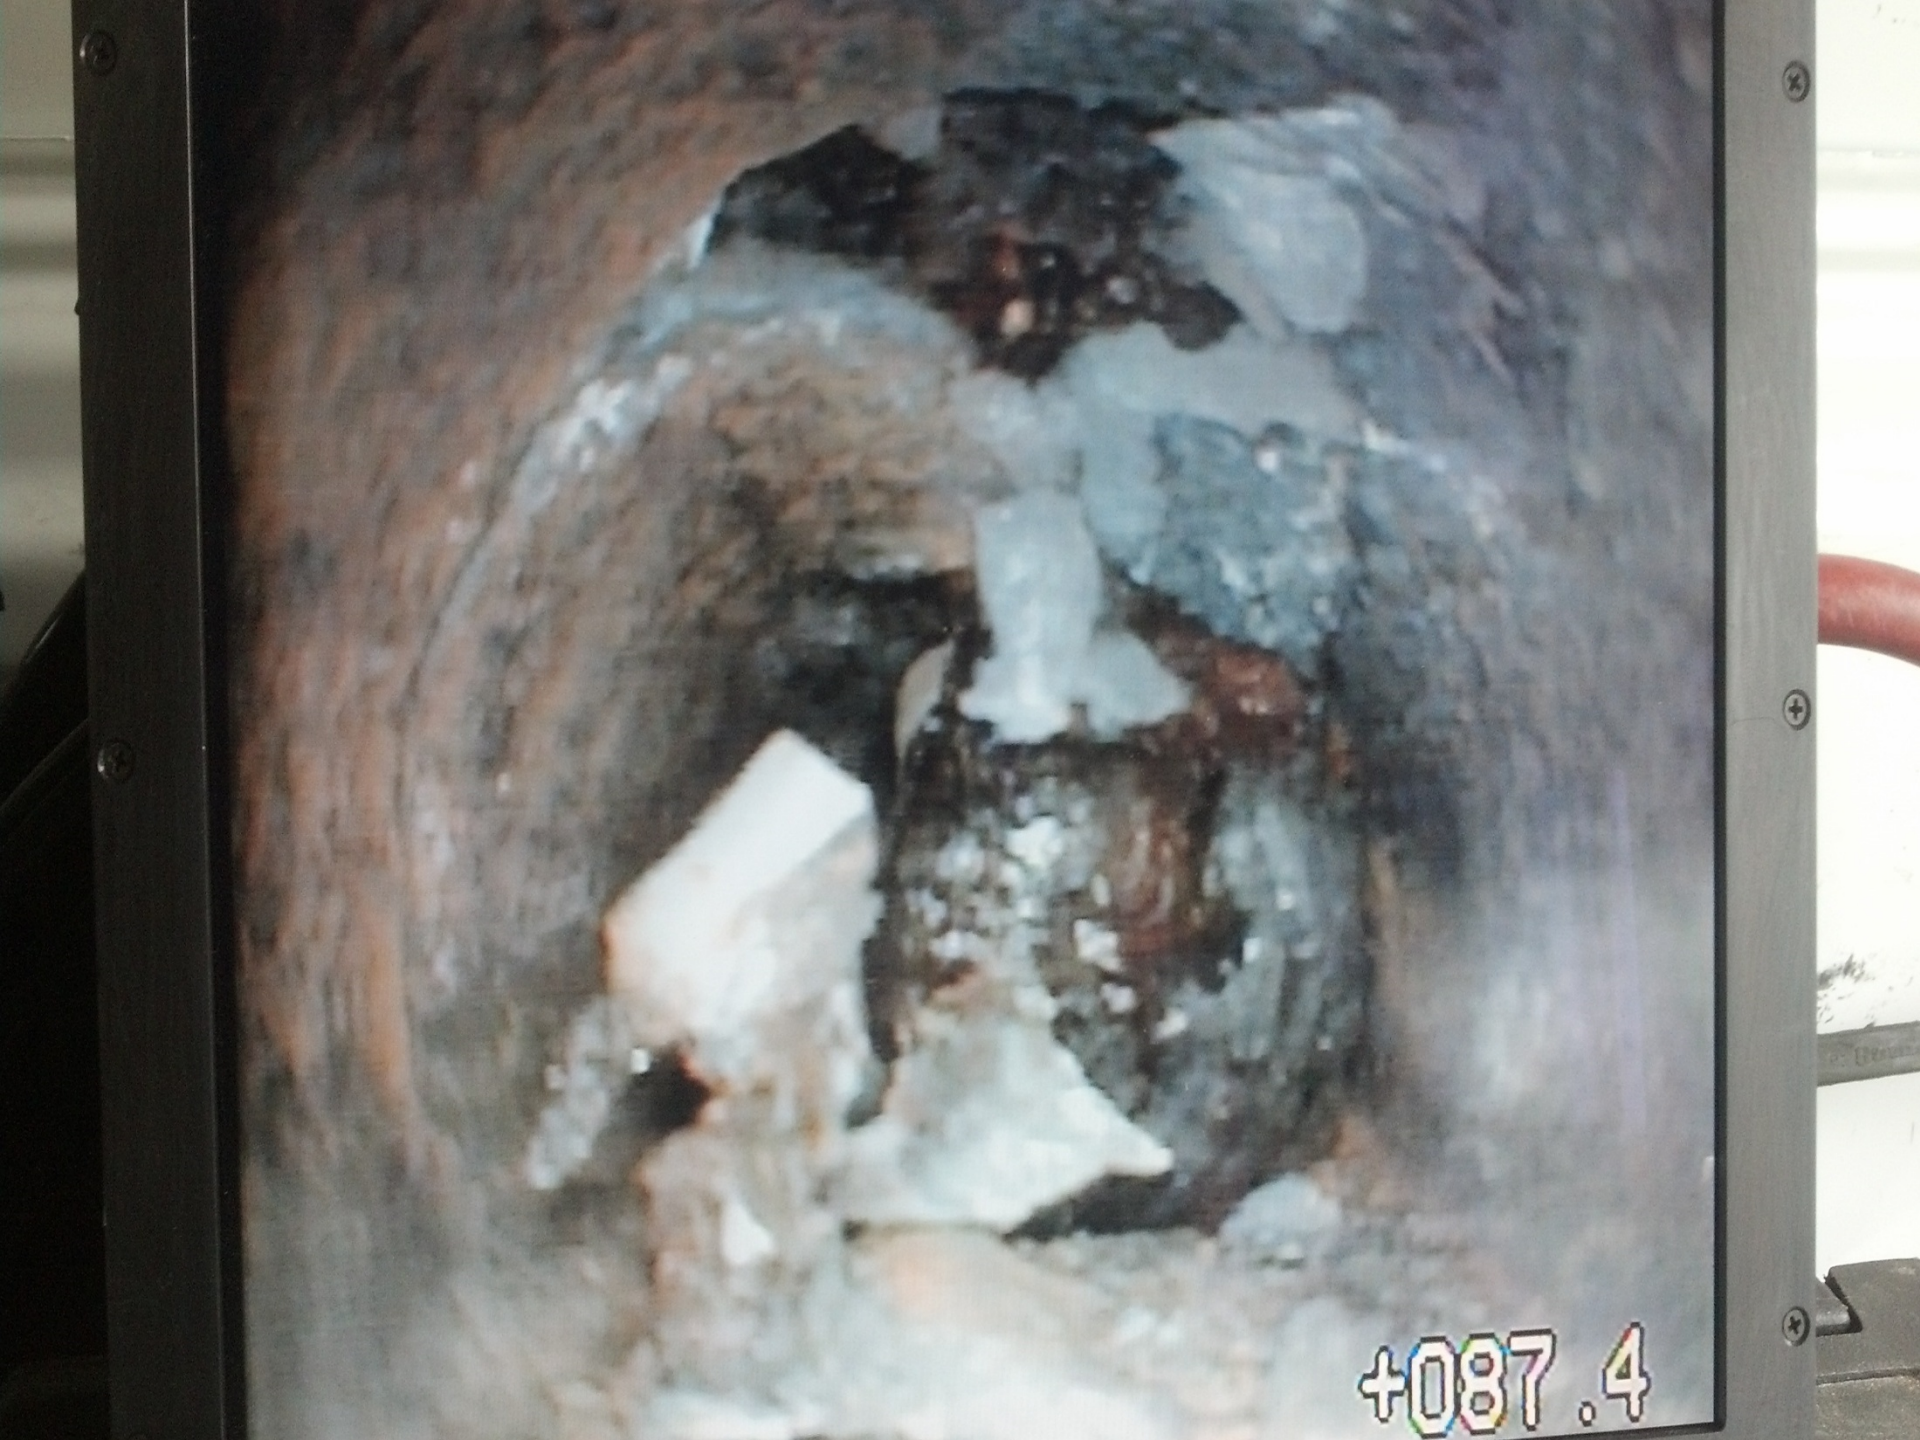
Some sort of rag used
to pack the joint
