Regulatory Next Steps in Addressing Pipeline Seam Weld Challenges

**Pipeline and
Hazardous Materials
Safety Administration**

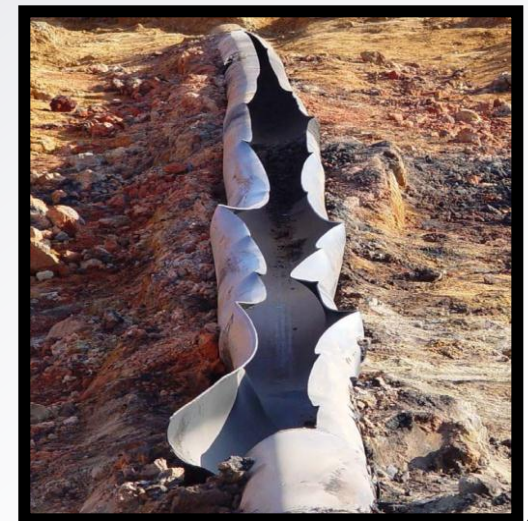
**Incident #1 -
Carmichael, MS**

- **U.S. PHMSA - Advisory Bulletins on ERW Seam Failures**
 - **Alert Notice – ALN-88-01 and ALN-89-01**
 - Advised operators and the public on factors contributing to operational failures of pipelines constructed prior to 1970 with Electric Resistance Weld (ERW) seams
- **Liquid Propane Pipeline Rupture – Carmichael, MS**
 - November 1, 2007
 - Fracture along LF-ERW seam
 - 2 fatalities and 7 injuries

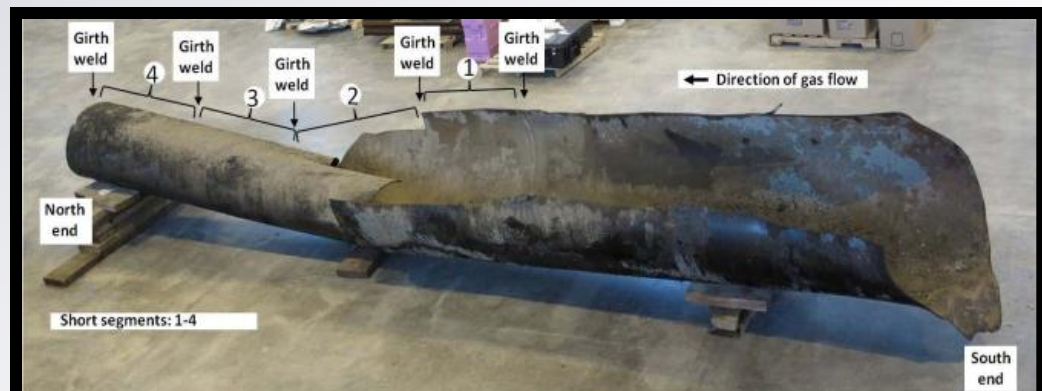
Incident #2 San Bruno, CA

- **Natural Gas Transmission Rupture – San Bruno, CA**
 - September 9, 2010
 - Failure of 30-inch diameter weld seams
 - Fracture along partial welded seam – 6 short pipe joints
 - 5 pups fabricated in 1956, did not meet pipe quality standards
 - 8 fatalities, many injured, 38 homes destroyed, 70 homes damaged

Photograph of the 28-foot-long ruptured section of pipeline
