NEPSR 2016 Pipeline Safety Seminar

Don Ledversis,
Rhode Island Division of Public Utilities
and Carriers

Rhode Island Gas Statistics

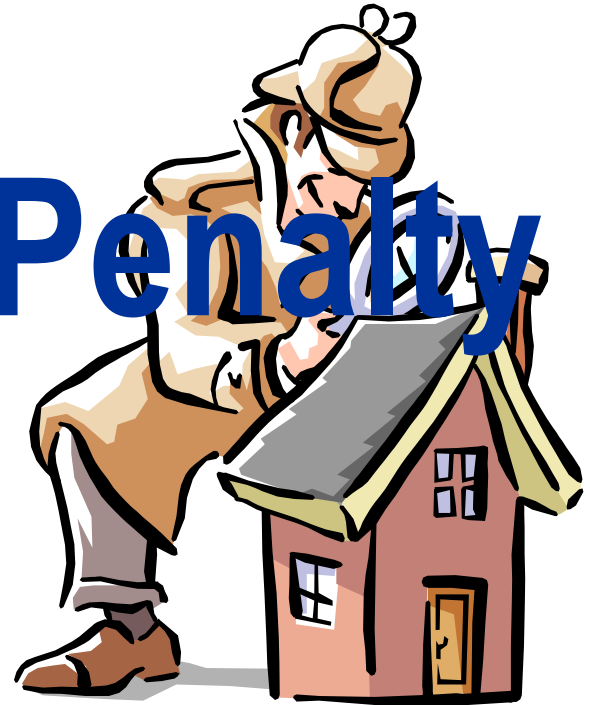
Failure to inspect a gas main under a bridge from 1999-2016

§192.481(a) Atmospheric Corrosion

\$10,000 Civil Penalty

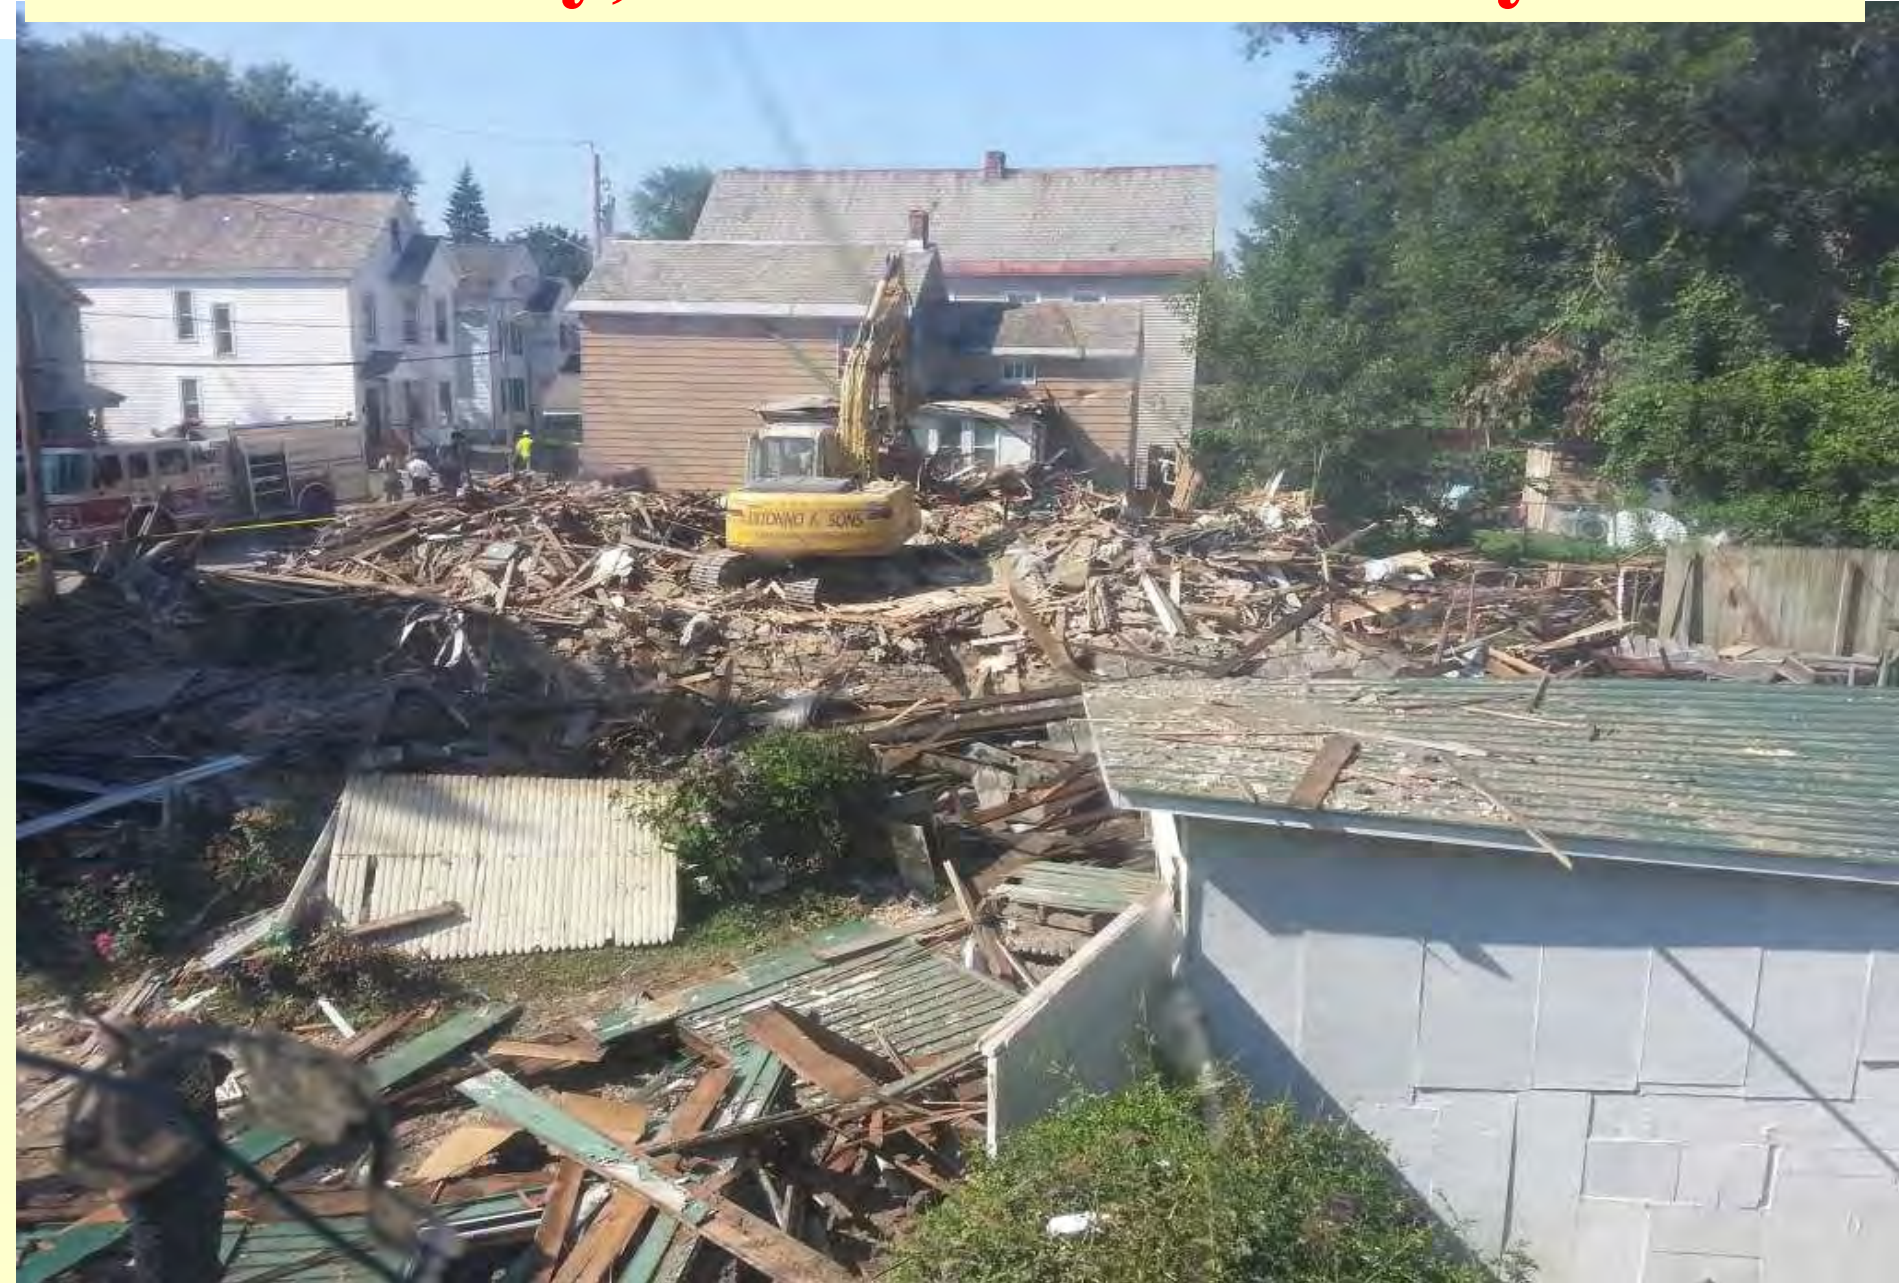
Schenectady, NY – Service on 6 years

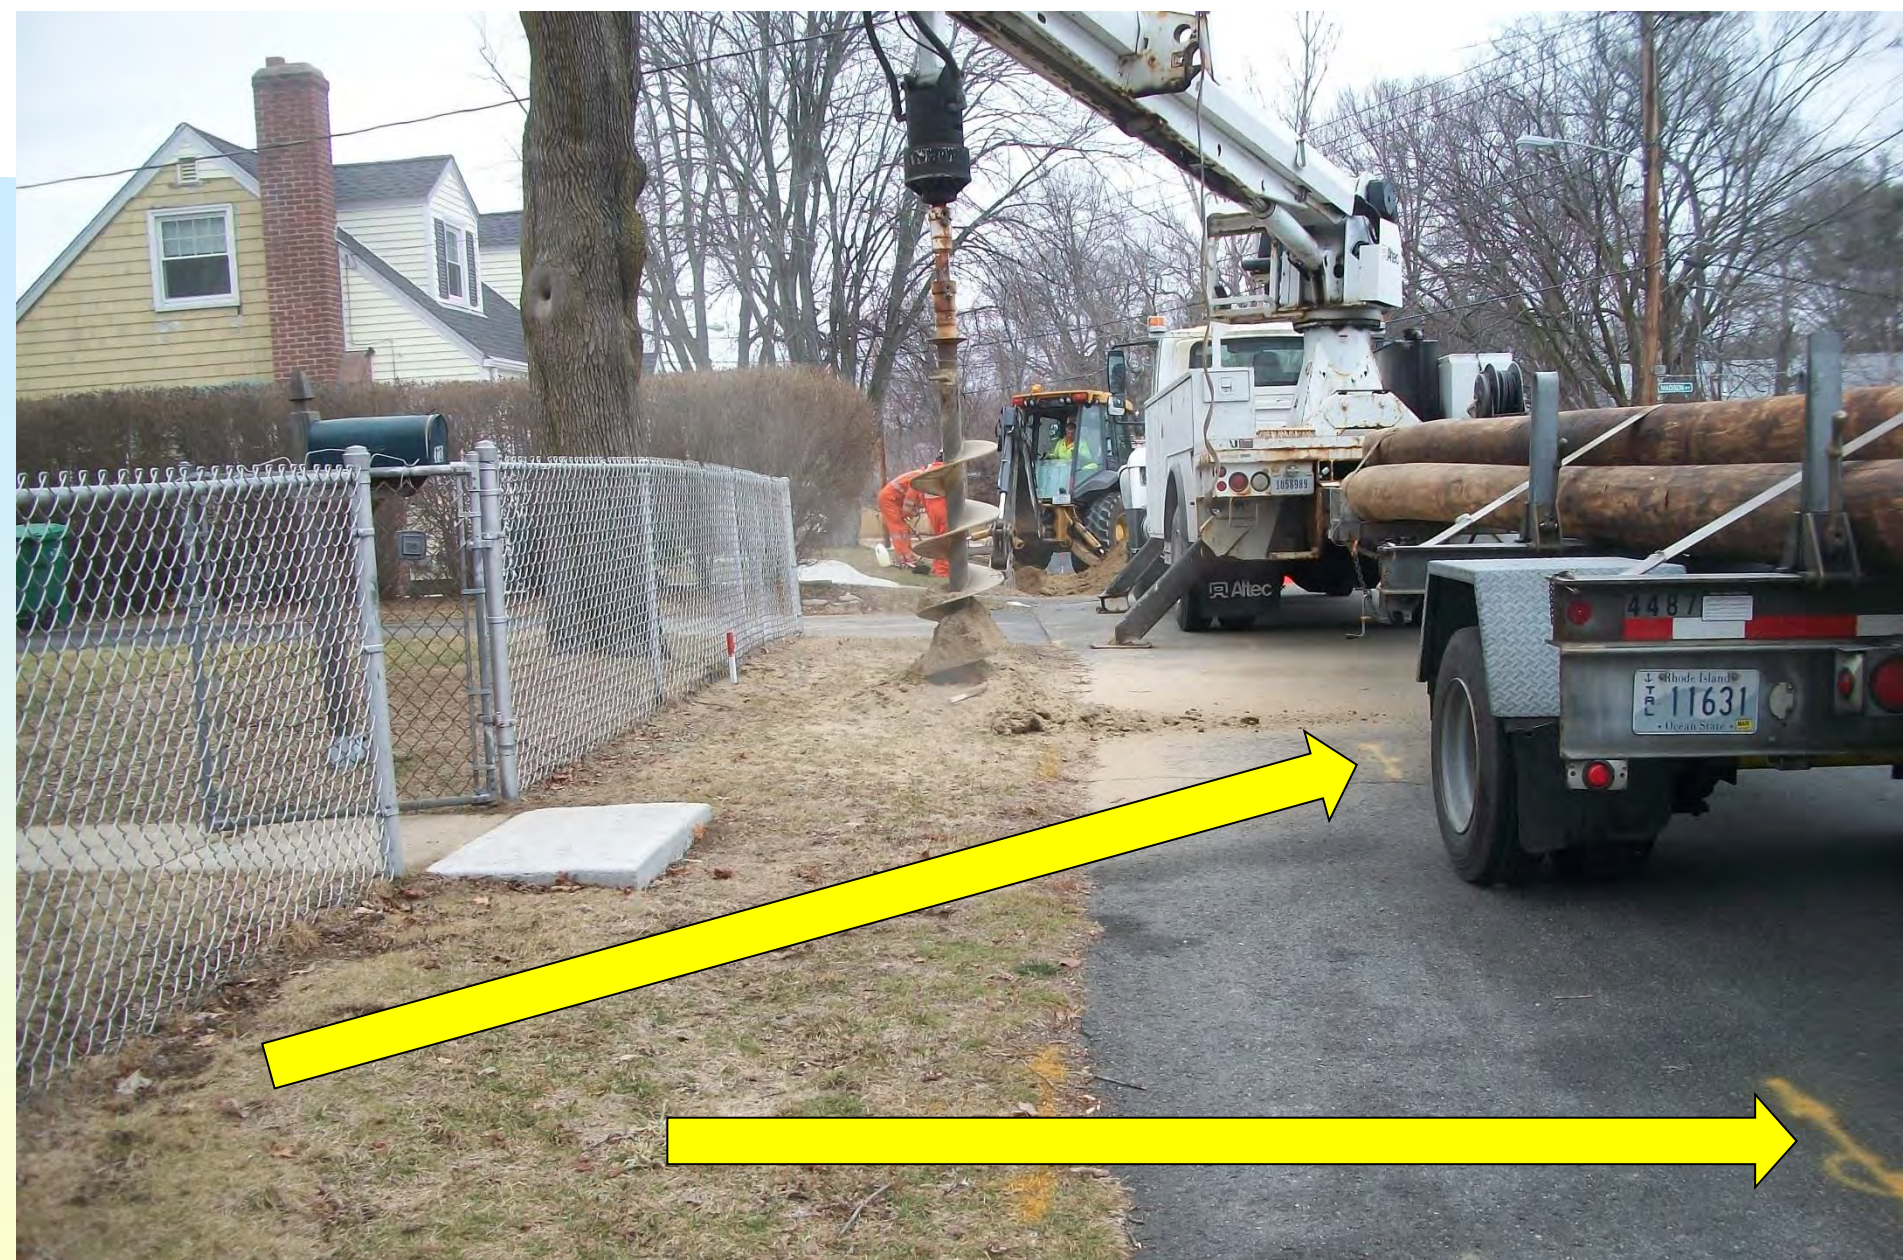
Gas main marked in sidewalk

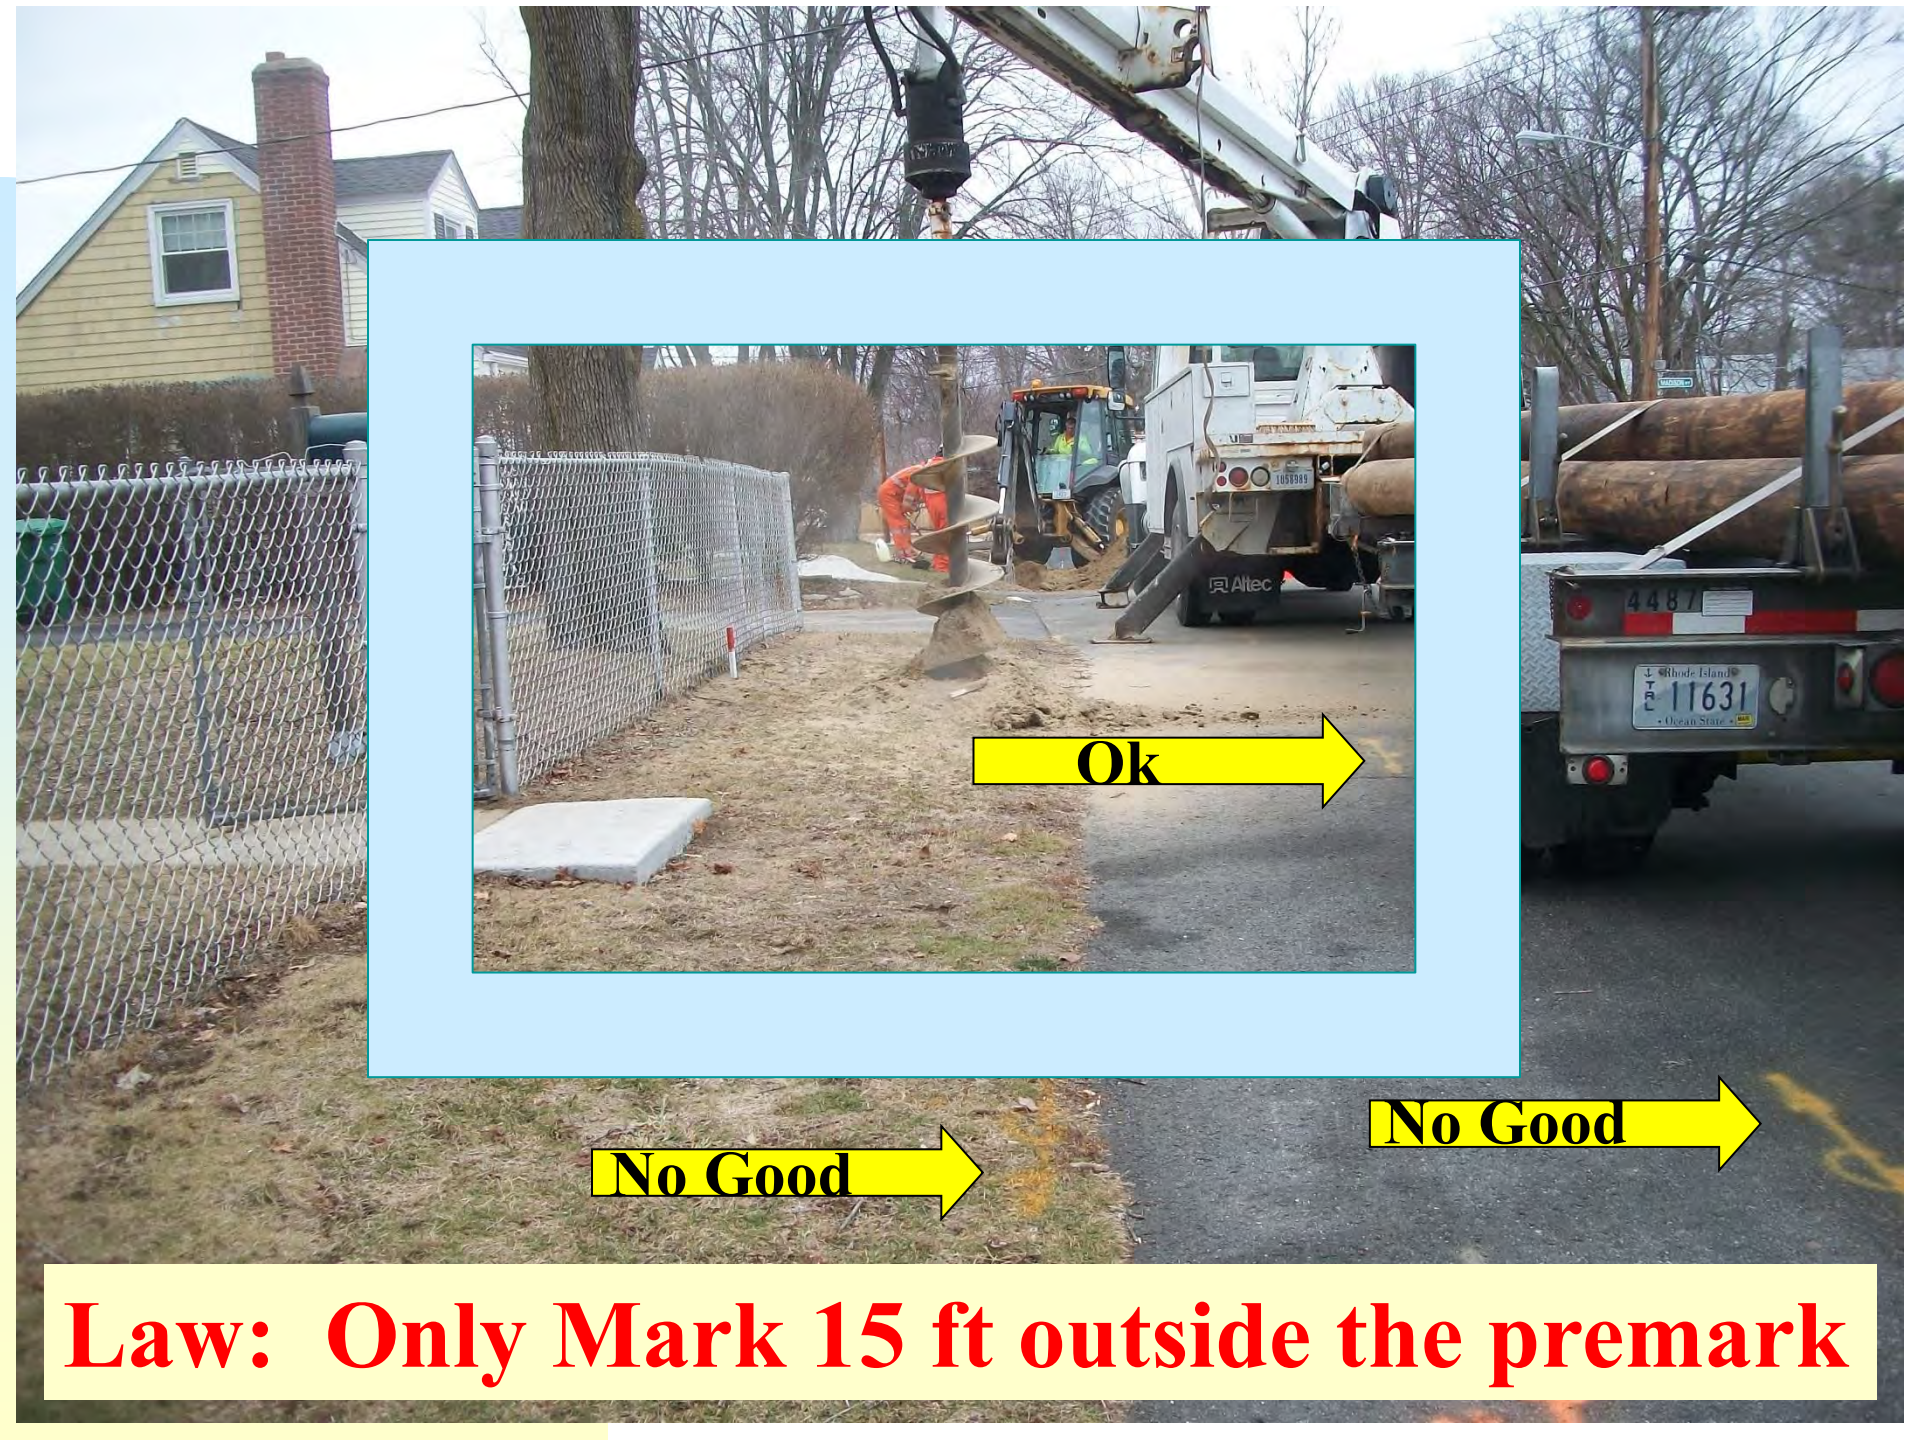
Problem: Gas main marked in street

No Good →

Law: Only Mark 15 ft outside the premark

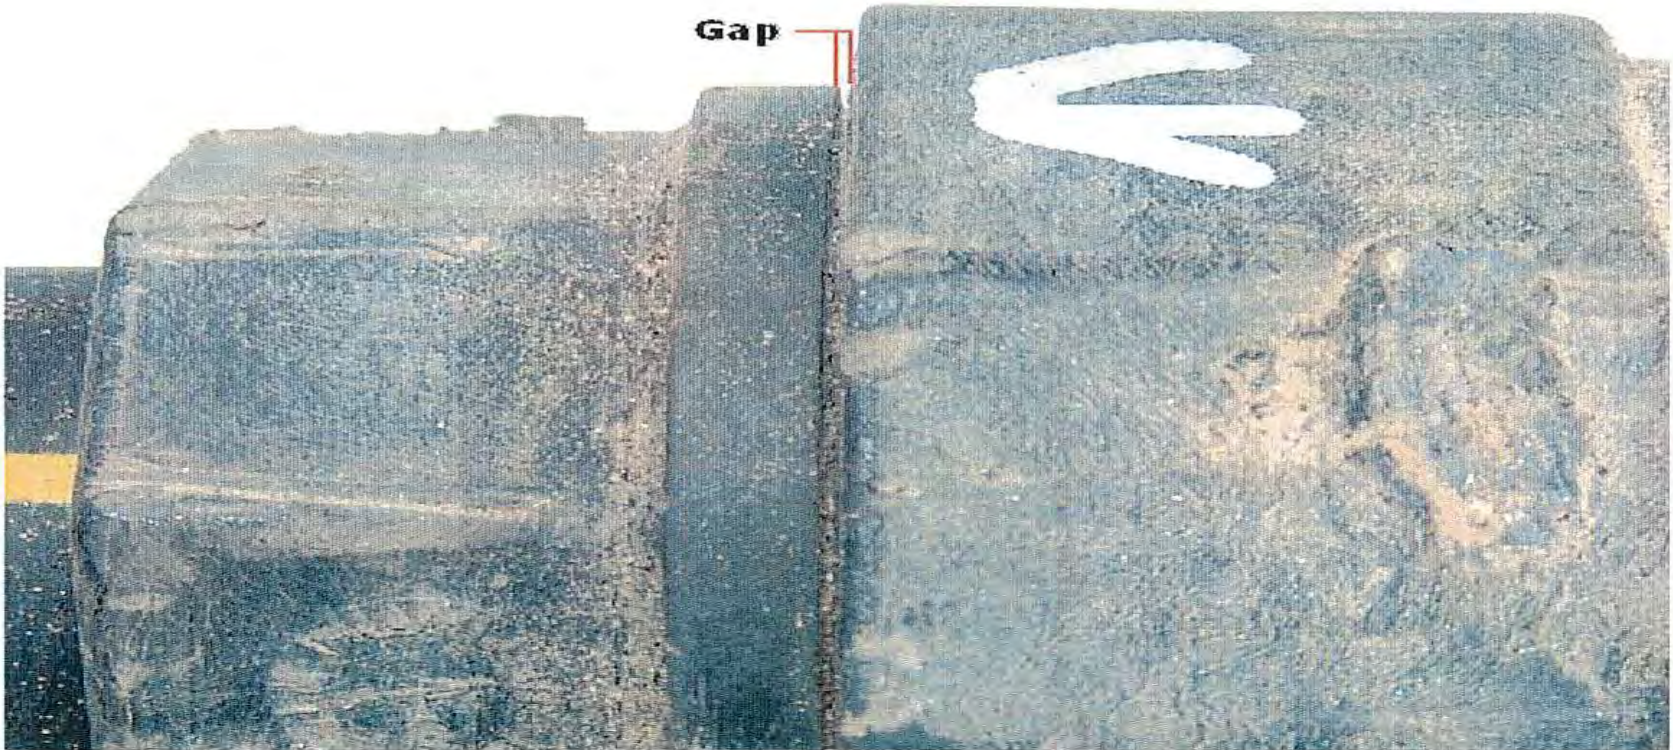
Dresser Style 399
Nut not tightened

Dresser 3-way tee Peeble imbedded in gasket

There is a slight gap on one of the compression nuts.

Gap

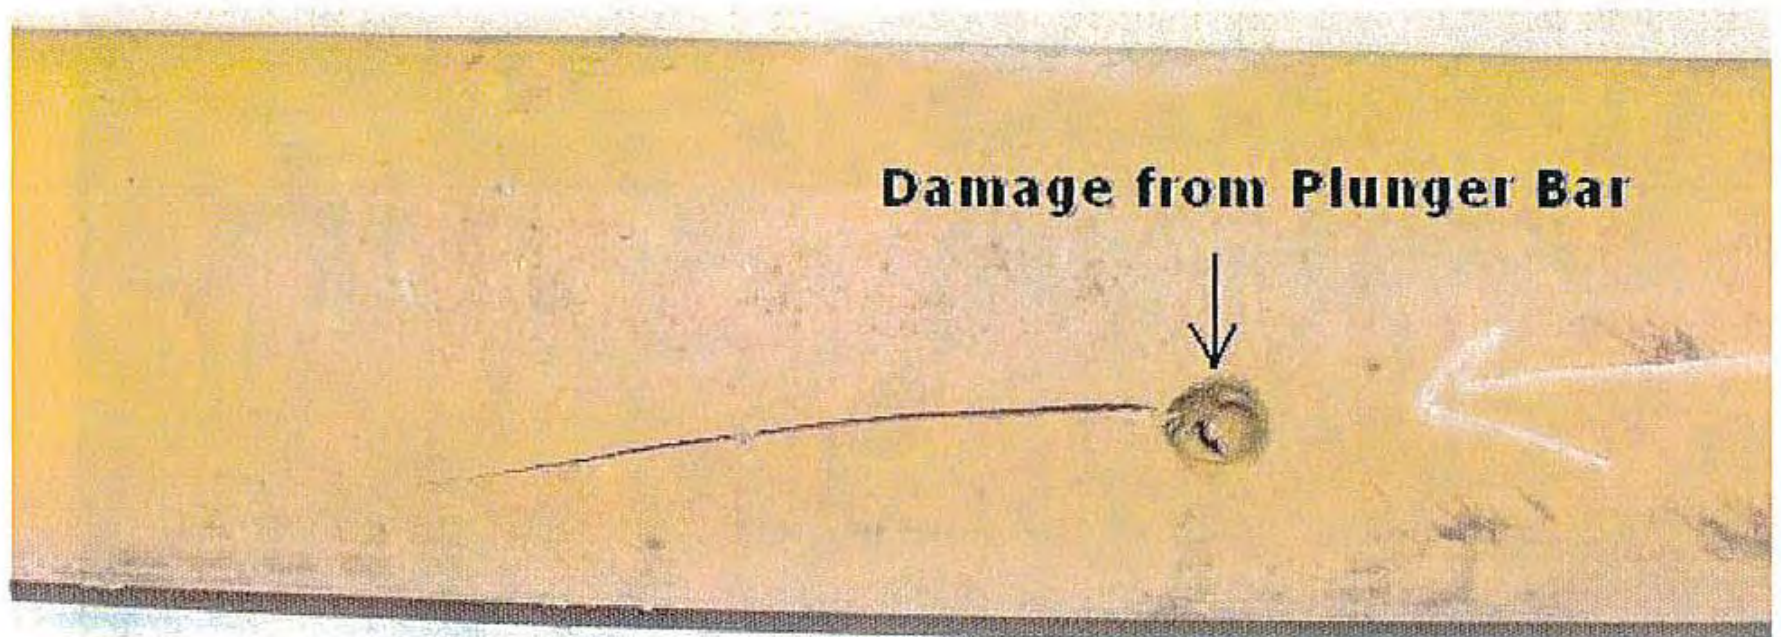
2" Polybutylene SDR 9 (1976)
Crack from rock impingement
Plunger hole day of investigation

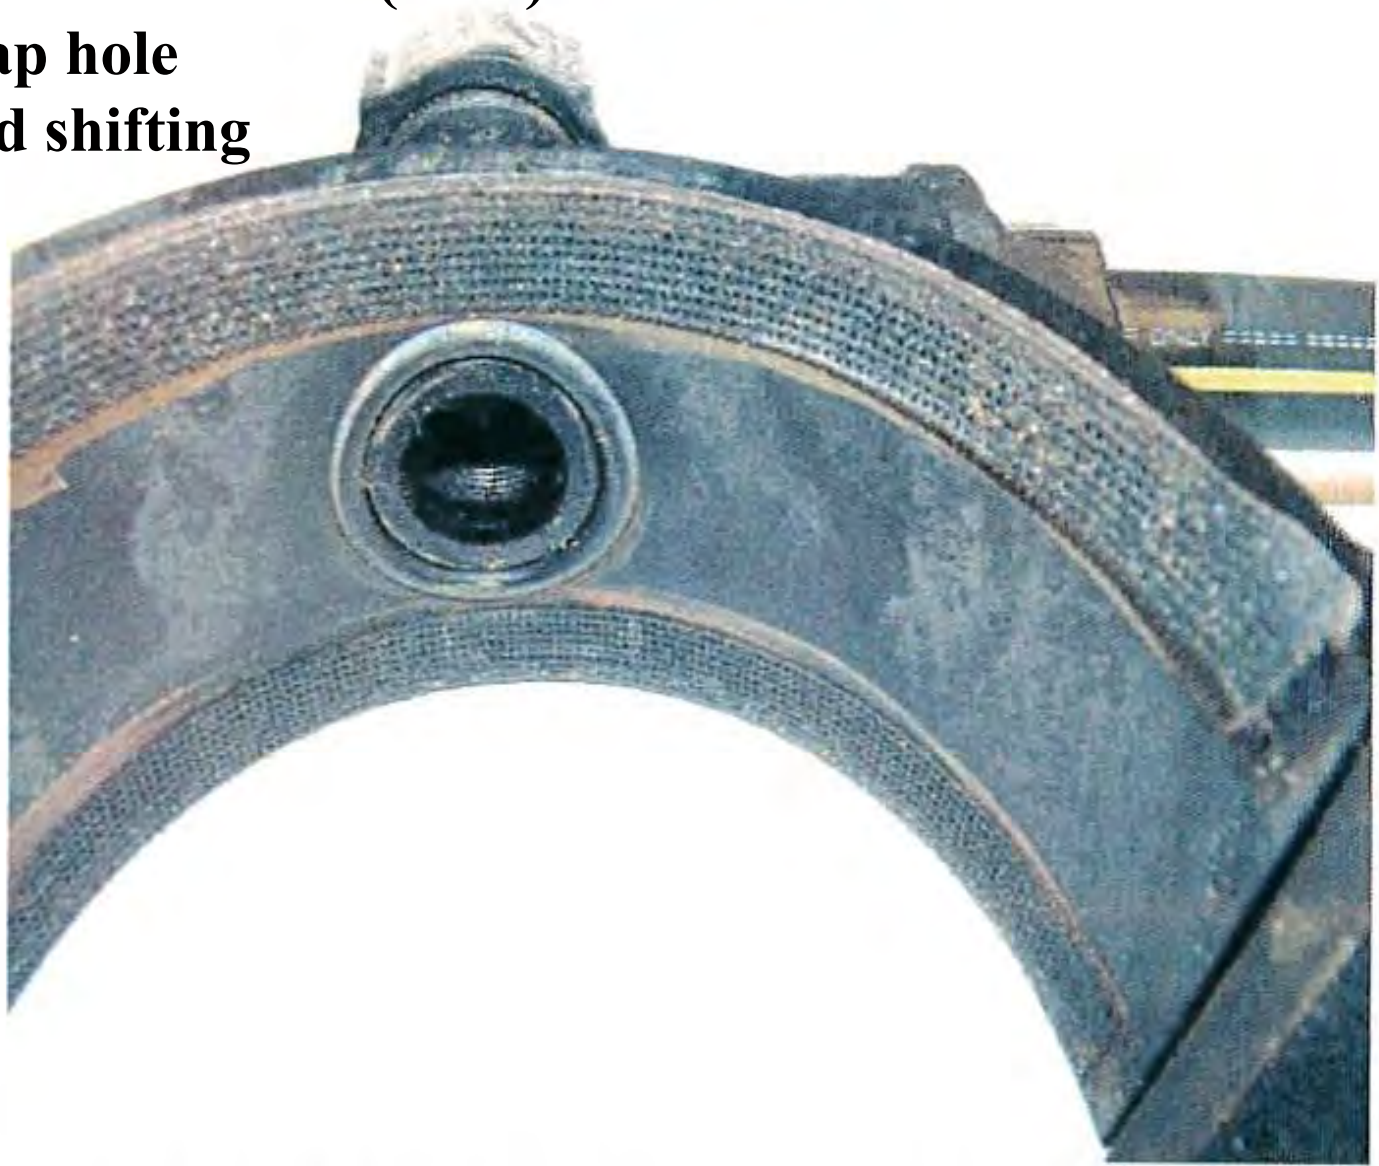
Dresser Mech. Service Tee (1998)

**Slid off the tap hole
due to ground shifting**

The failure is due to an unreliable design.

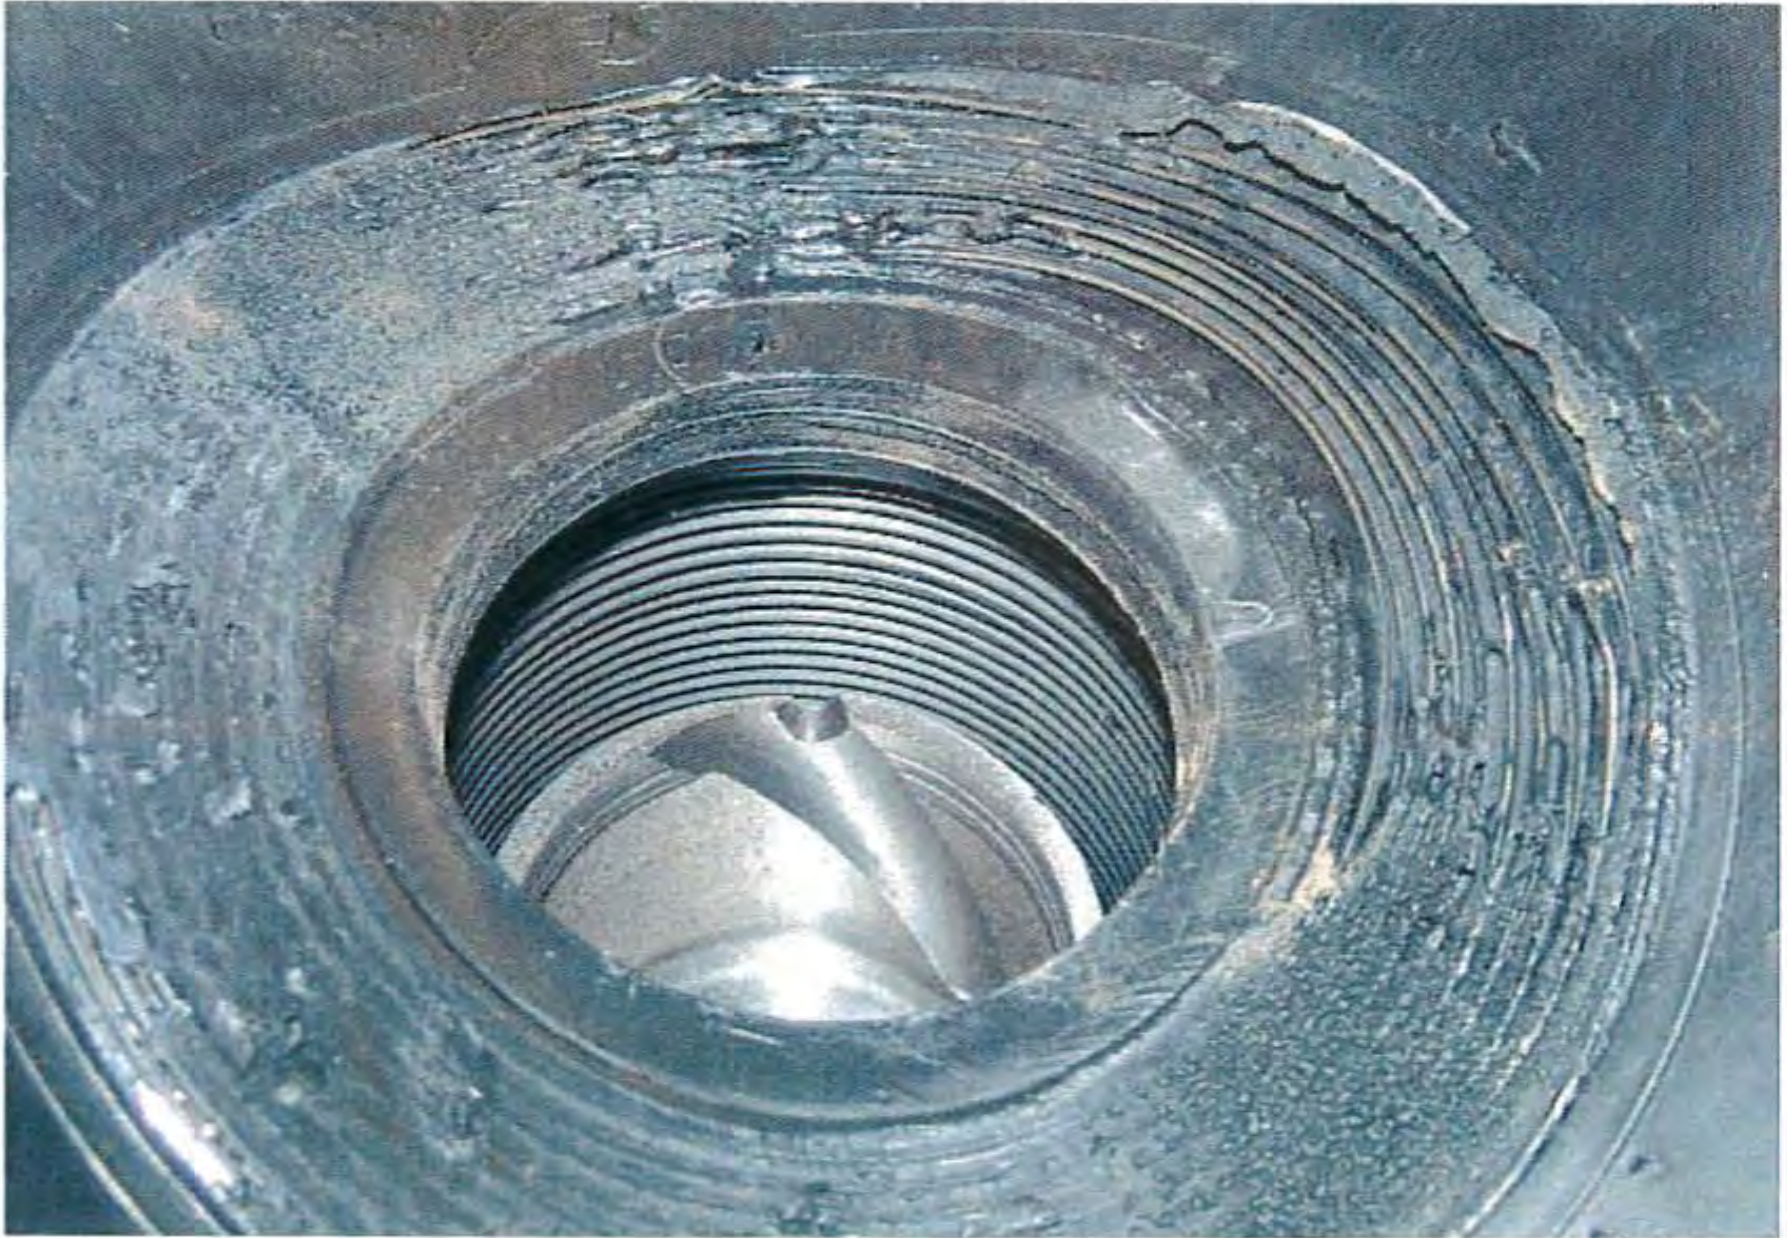
Electrofusion Tee: Improper manual setting input into machine

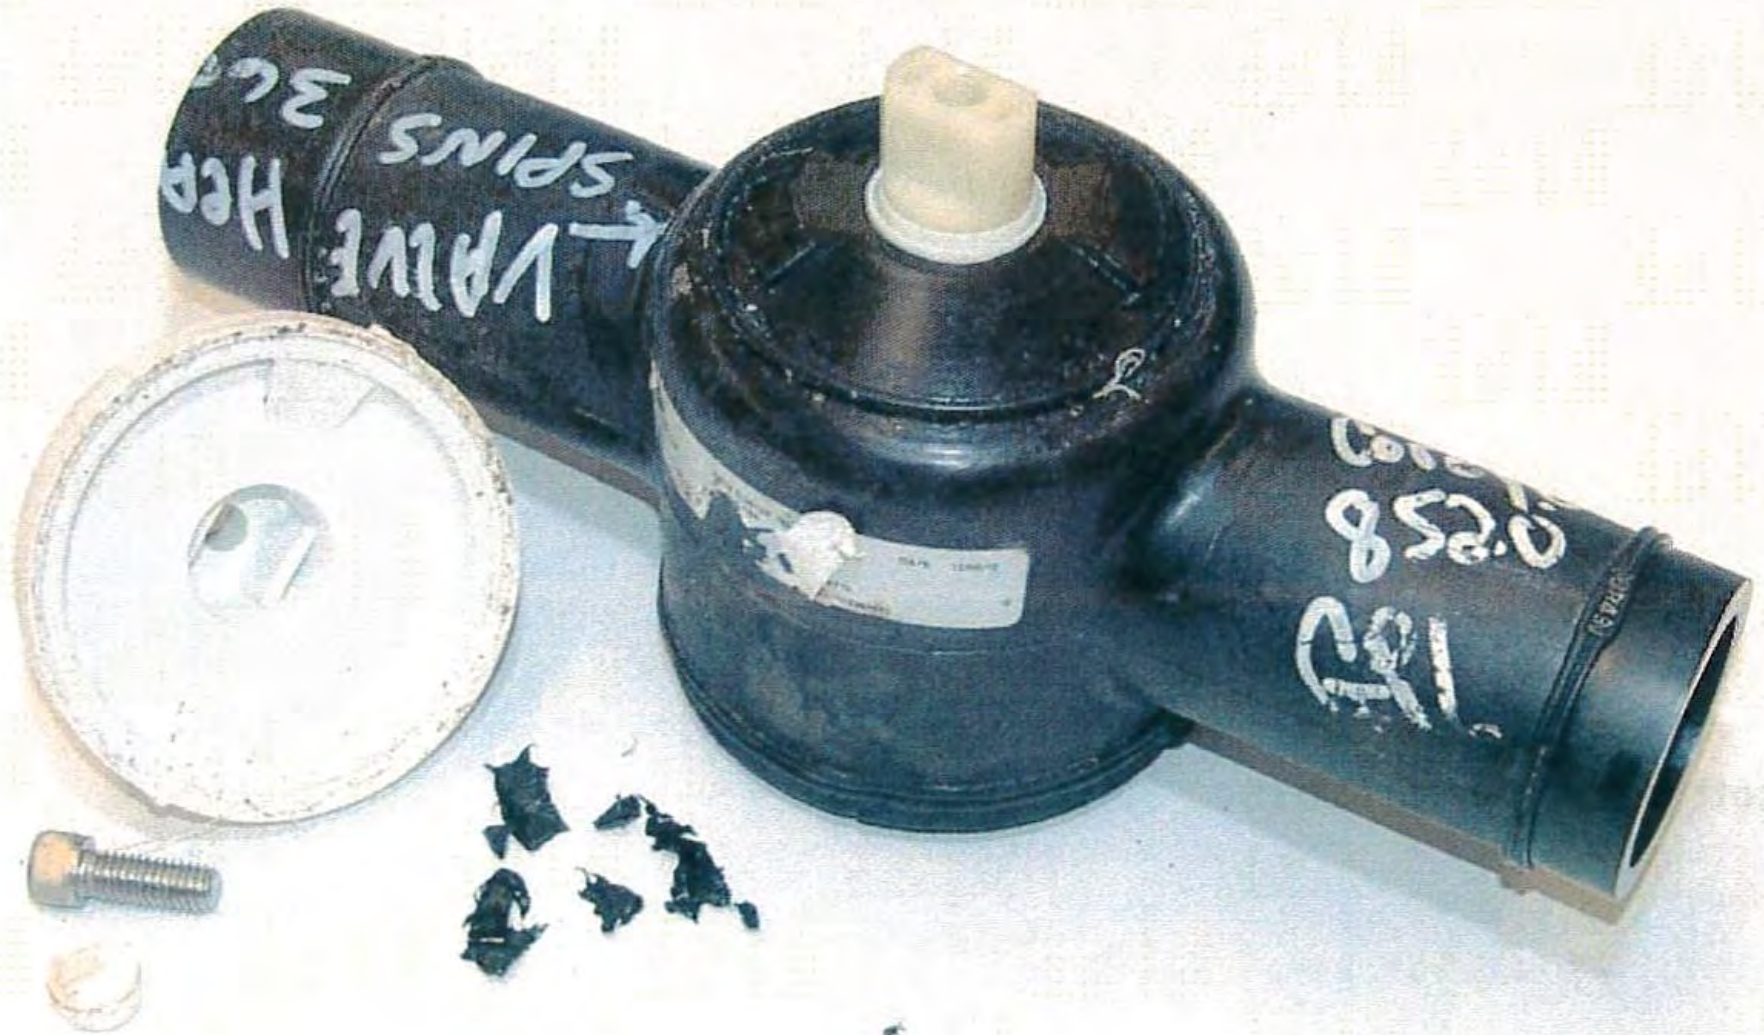
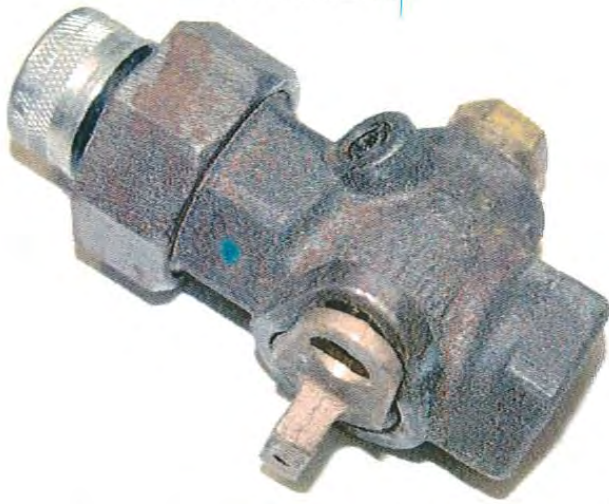
Perfection Permasert Valve: Over turned breaking the valve stops

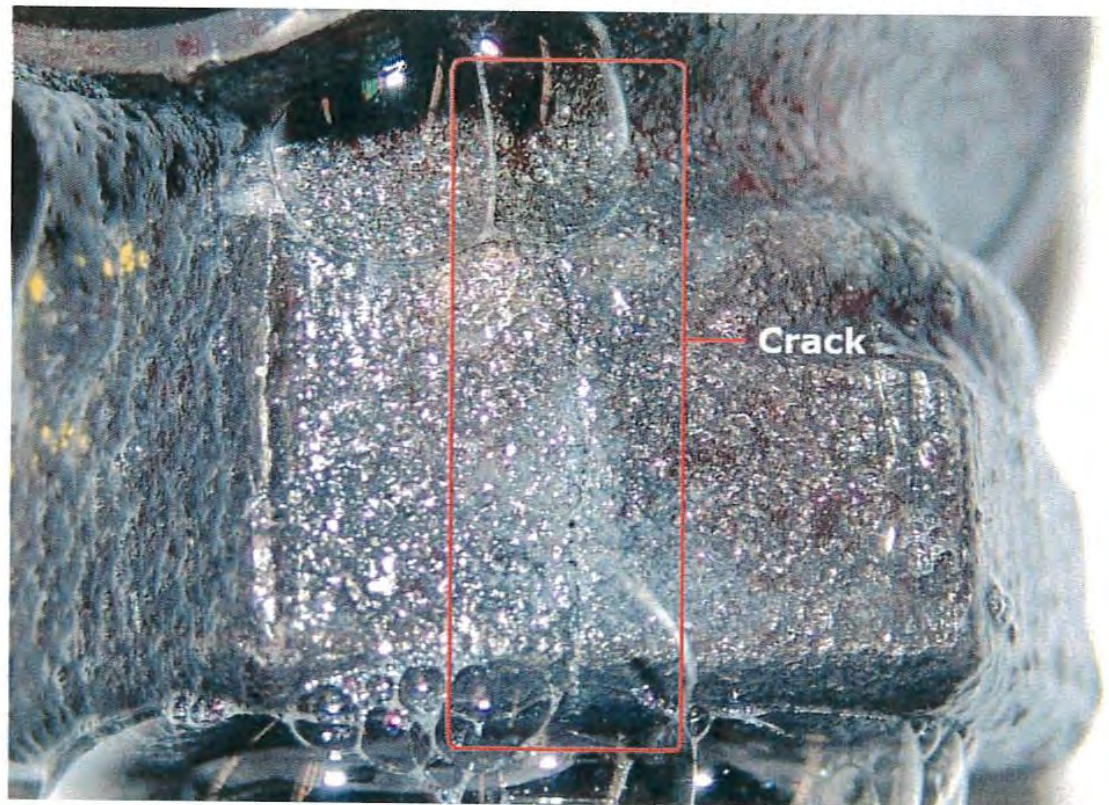
Mueller Insulating Riser Valve:
Not caused by over tightening,
manufacturers defect.

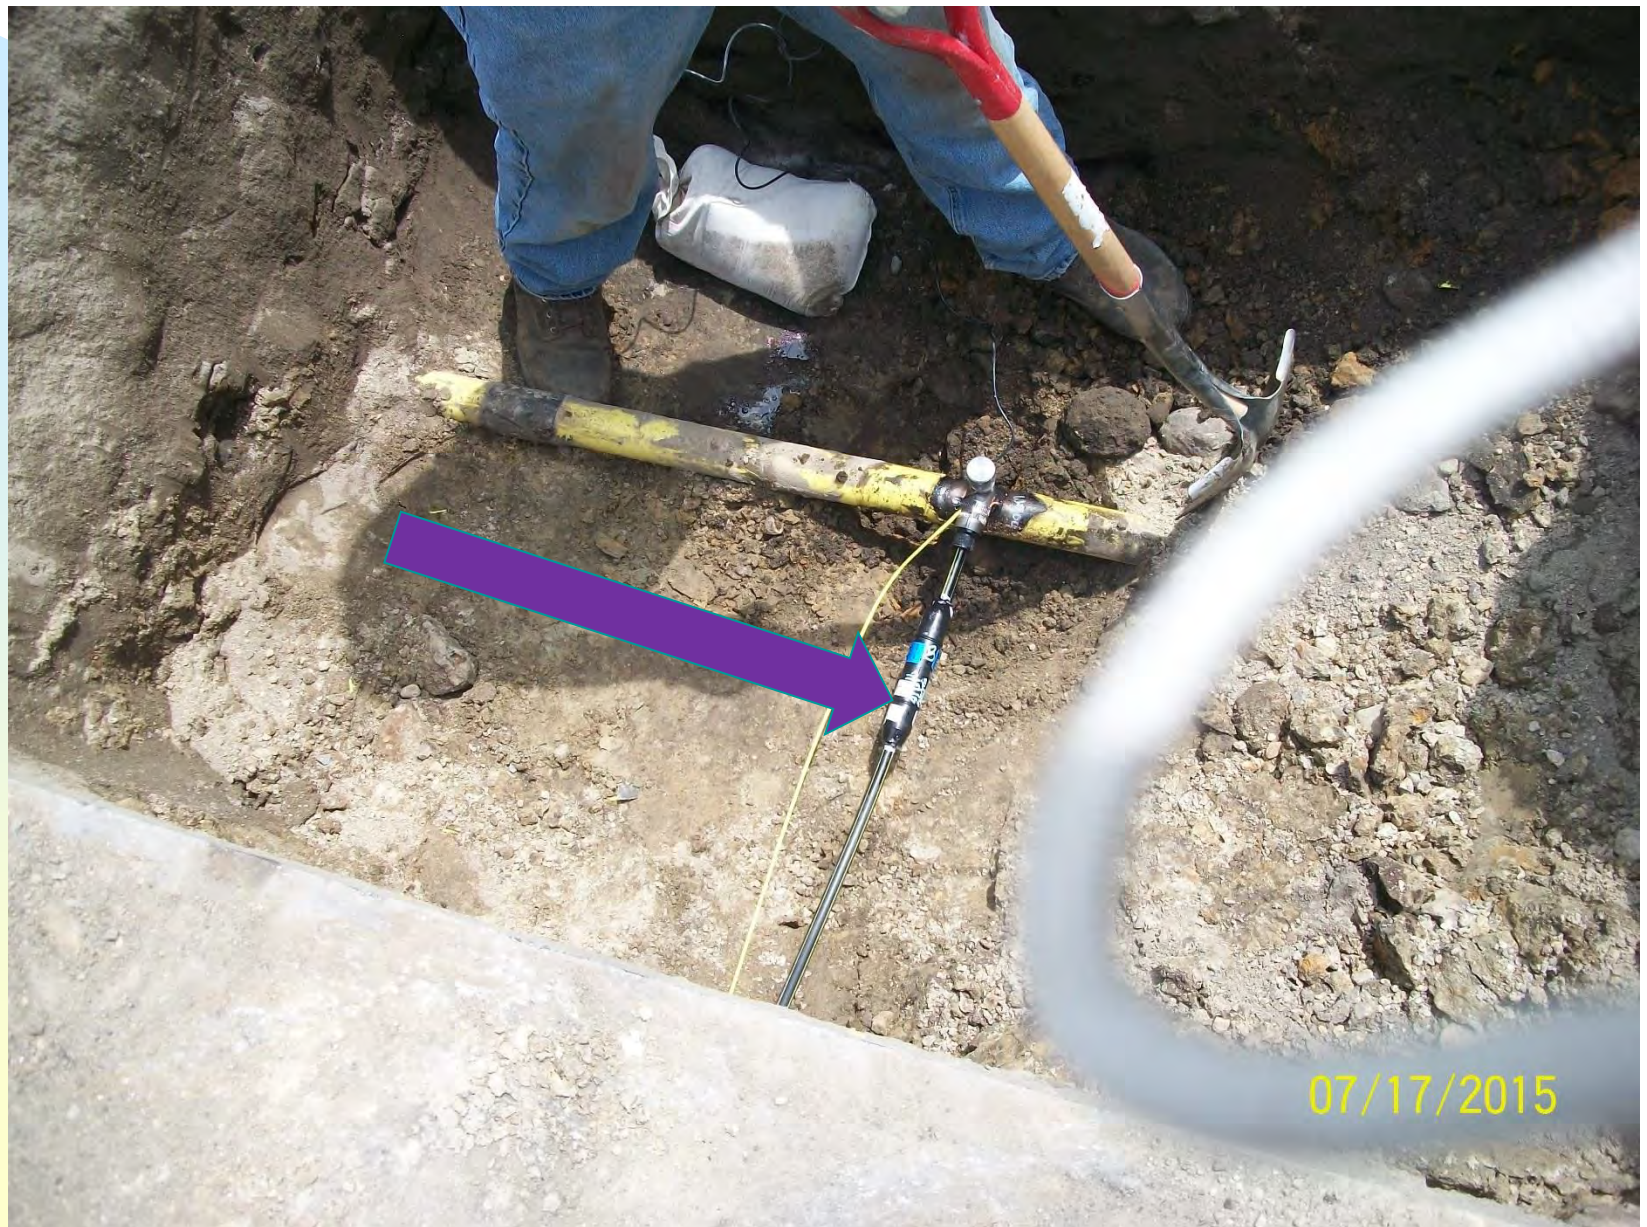
Excess Flow Valves

§192.381(d) Service Lines: Excess flow valve performance standards requires,

(d) An operator shall locate an excess flow valve as near as practical to the fitting connecting the service line to its source of gas supply.

i.e. at the main
