NEPSR 2016 Pipeline Safety Seminar

Don Ledversis,
Rhode Island Division of Public Utilities
and Carriers

Rhode Island Gas Statistics

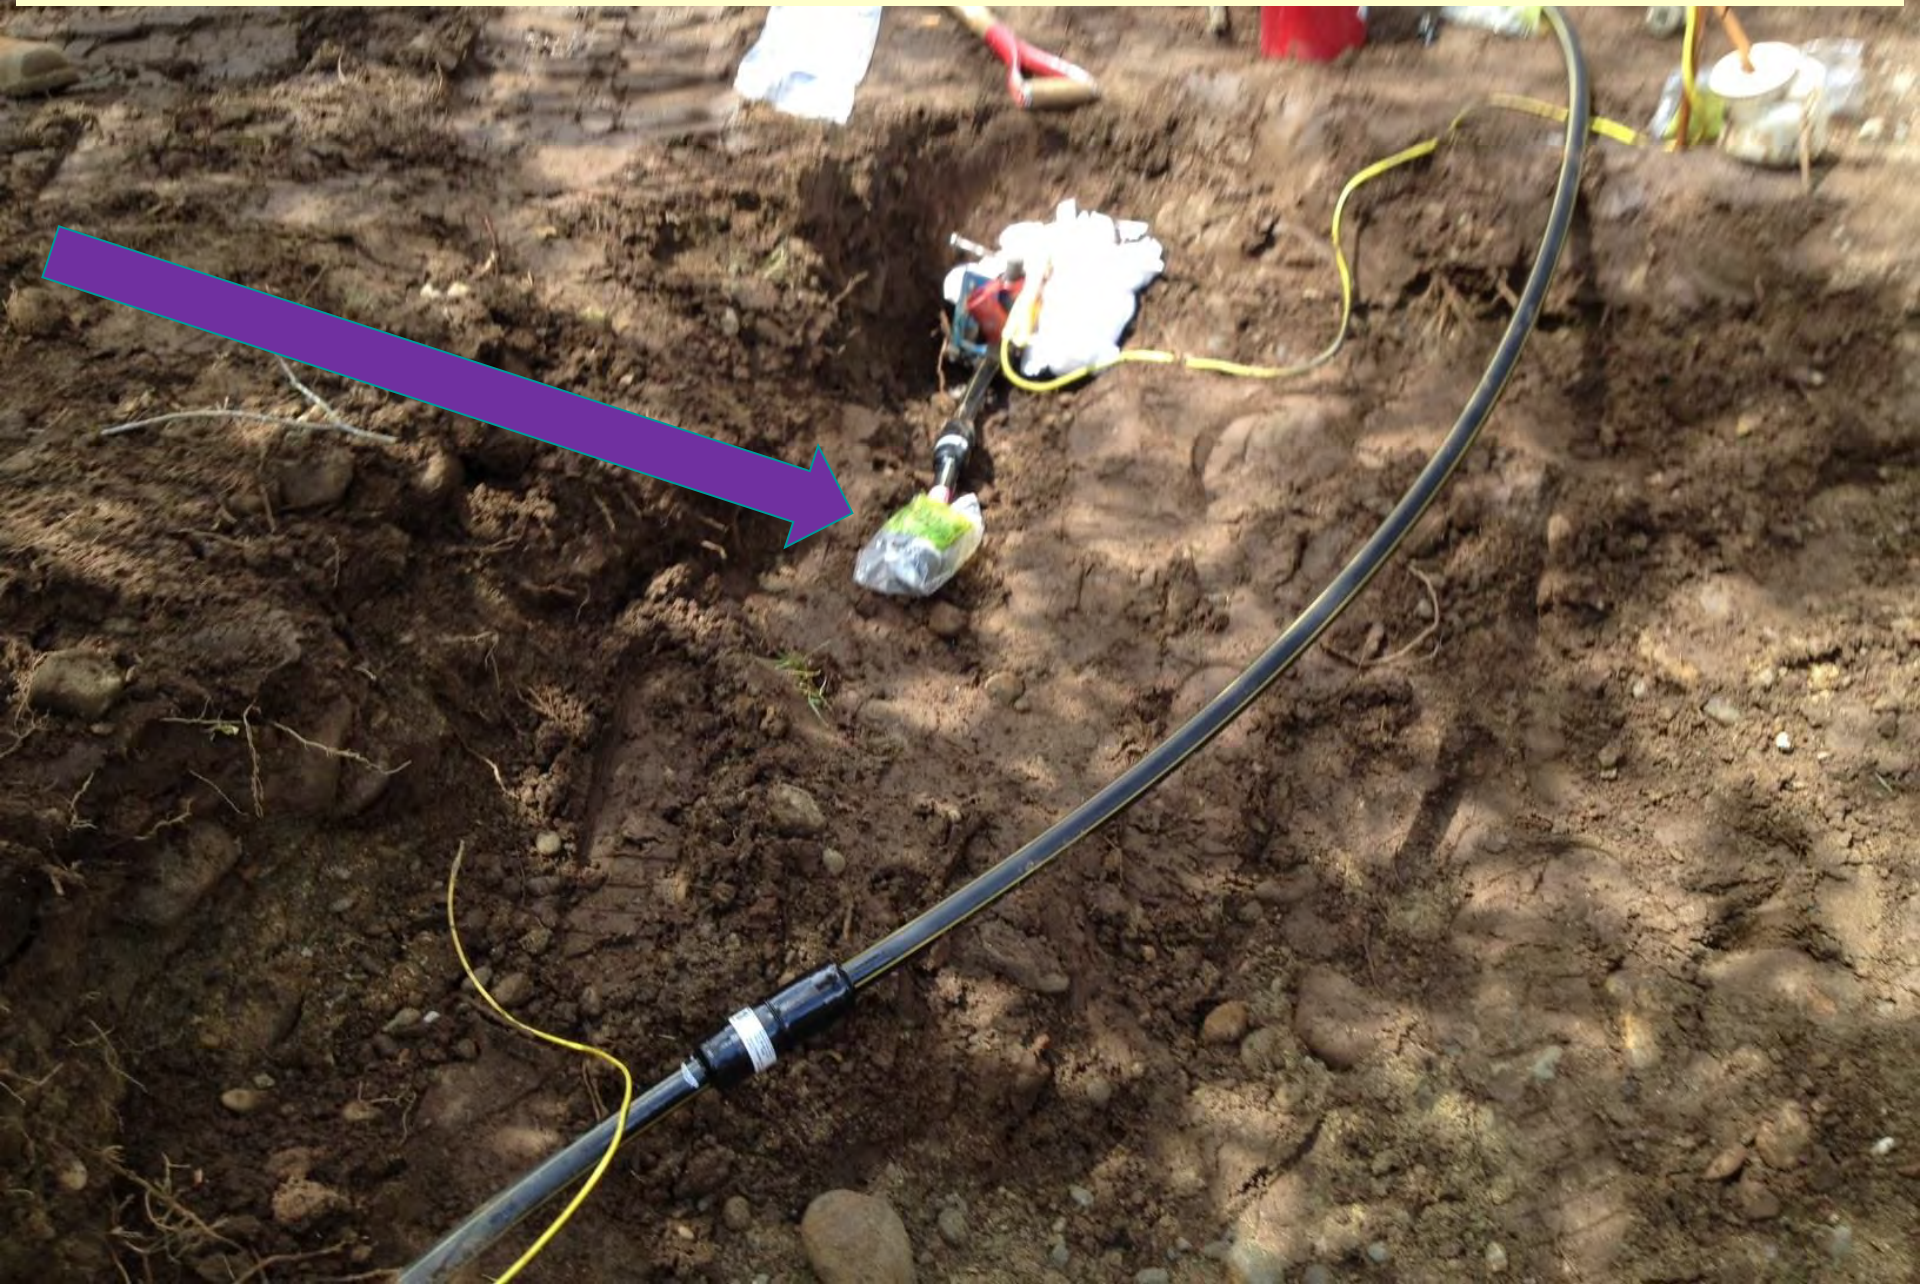
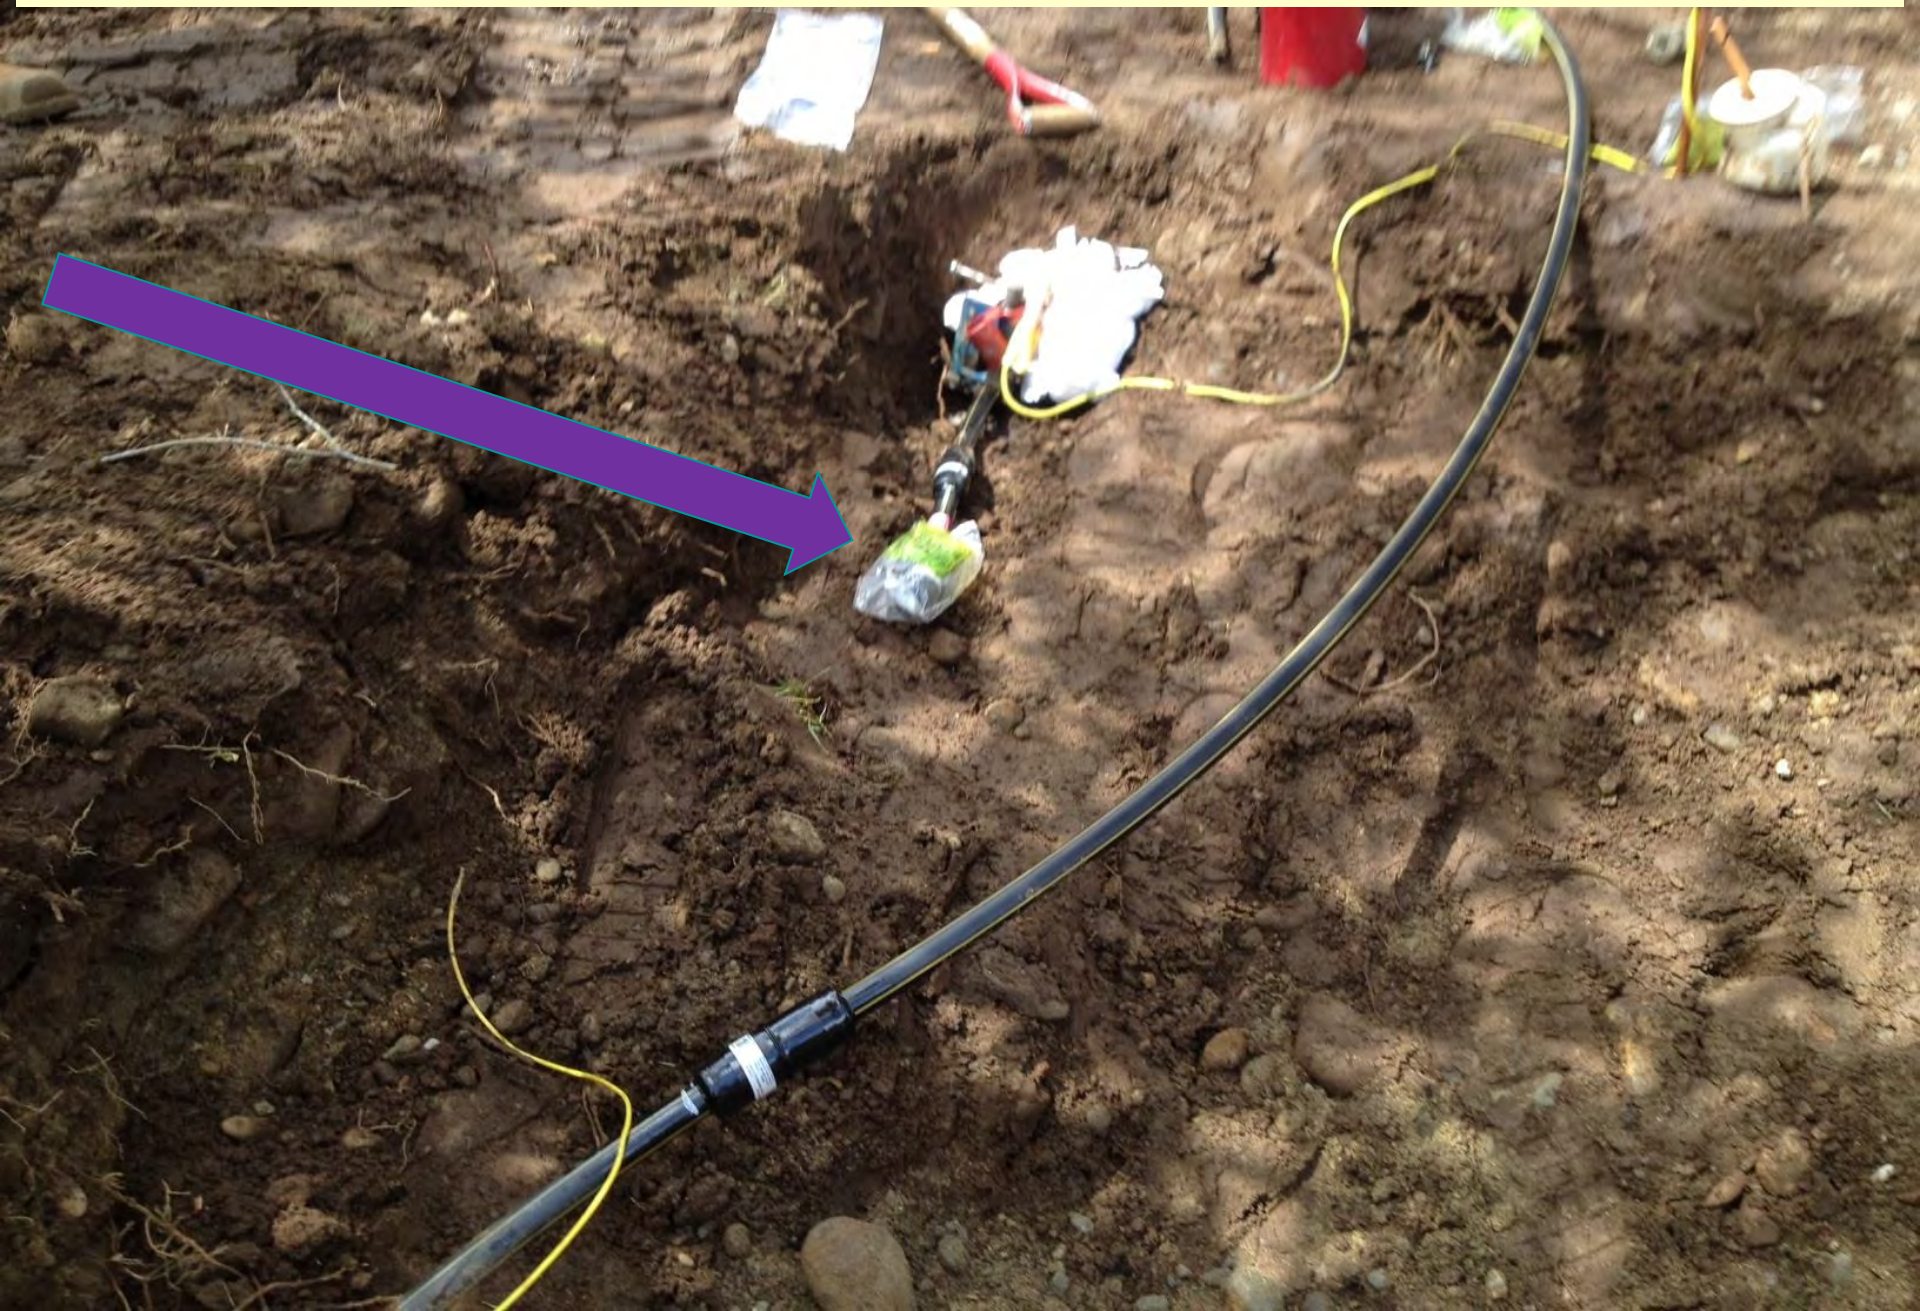
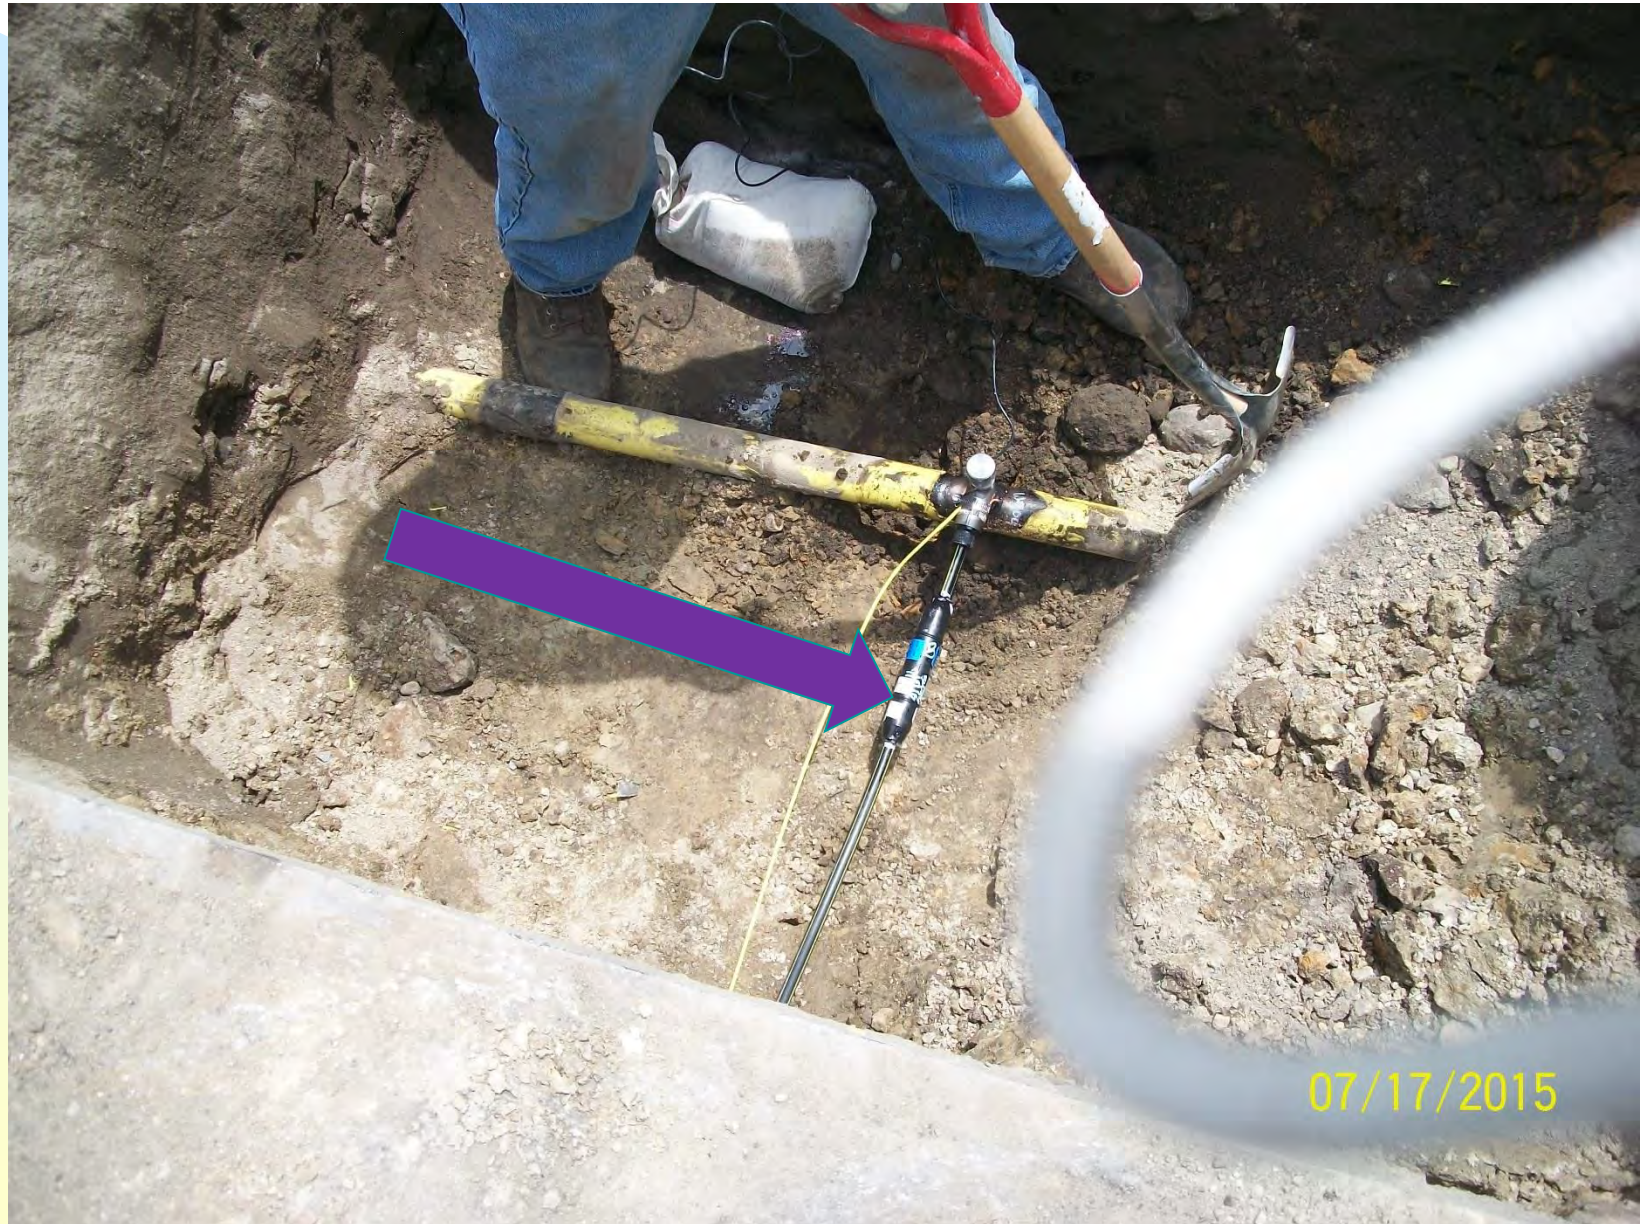
Where do you install the flow Limiter?

At the location of where the damage occurred?

...or back at the main?

“We agree with your understanding that if an excess flow valve is installed, it should be placed as near to the source of gas supply as practical to ensure the excess flow valve protects the maximum length of service line. An excess flow valve is required if the service line from the main to the customer's house, or a segment of service line near the fitting connecting the main to the service line (where an excess flow valve is usually located), is replaced. However, an excess flow valve is not required for replacement of short segments of service line far away from the main or source of supply because excess flow valves in those locations may not provide excavation-damage protection.”

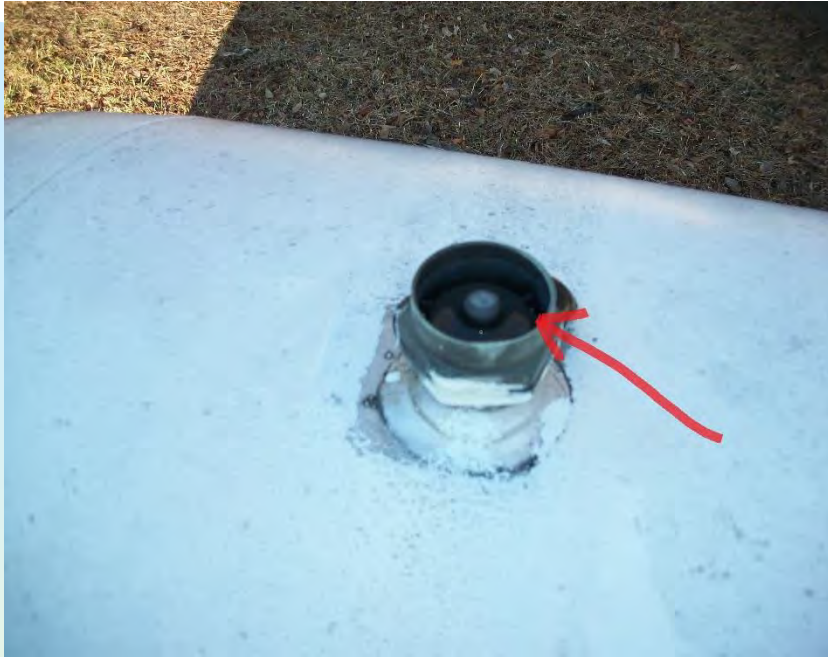
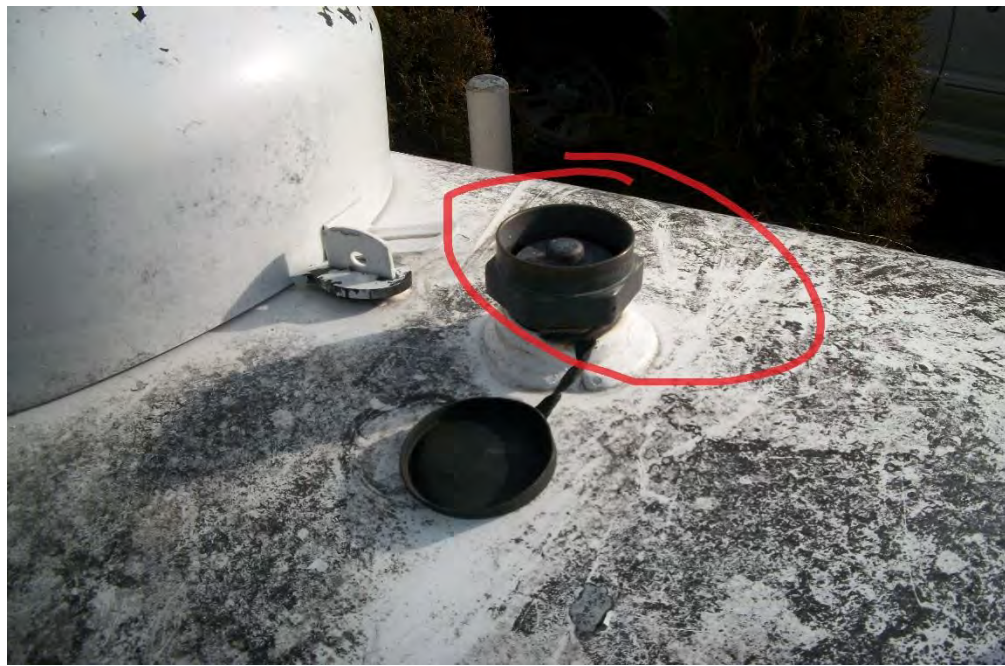
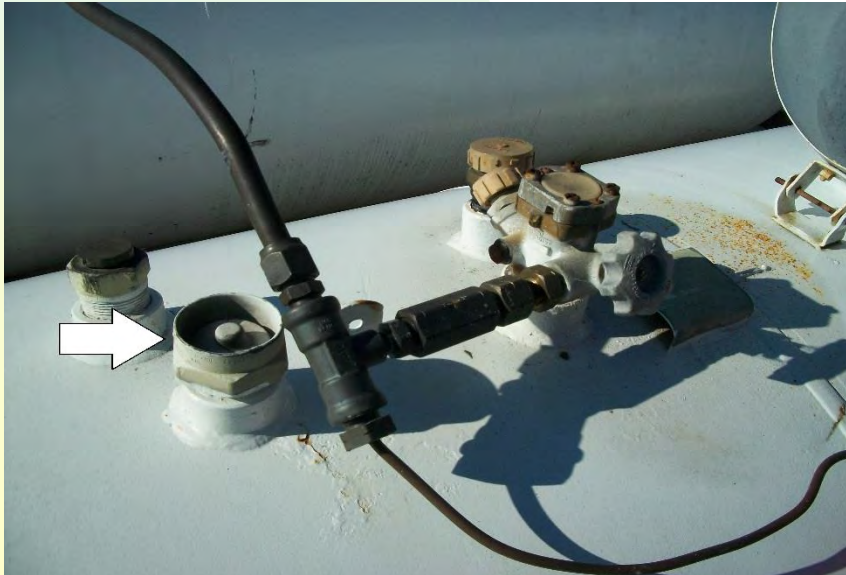
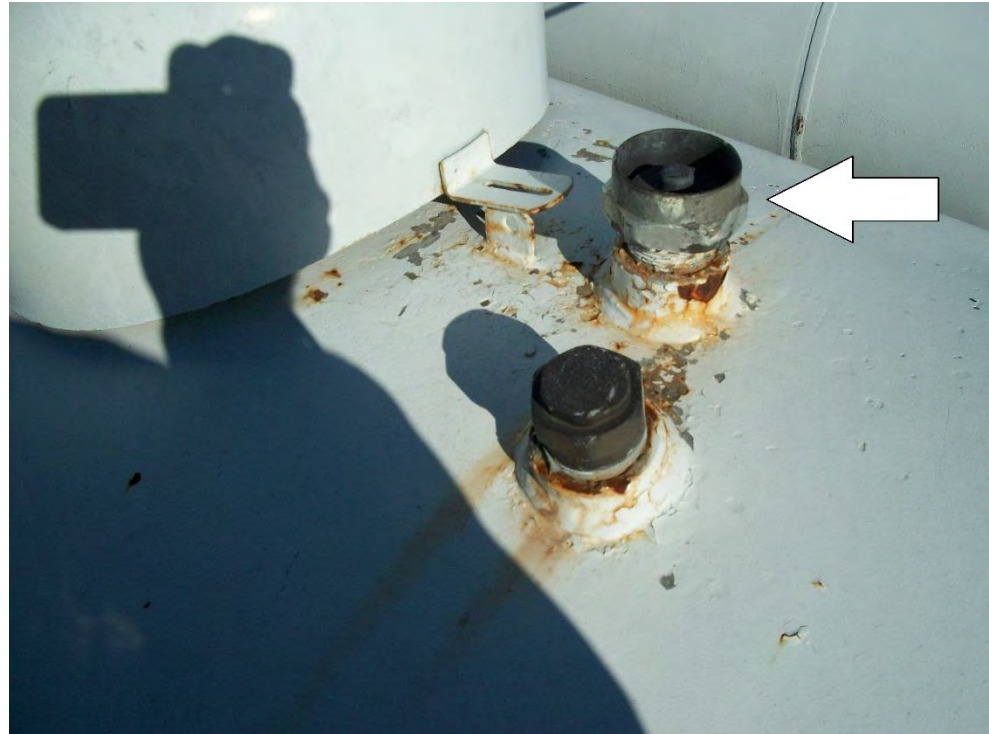
Missing Rain caps

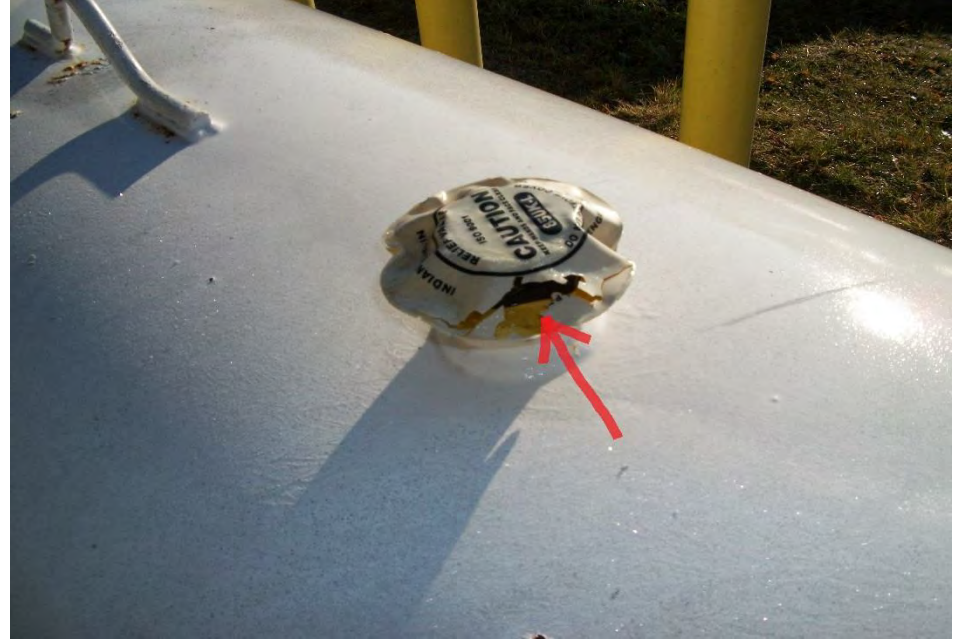
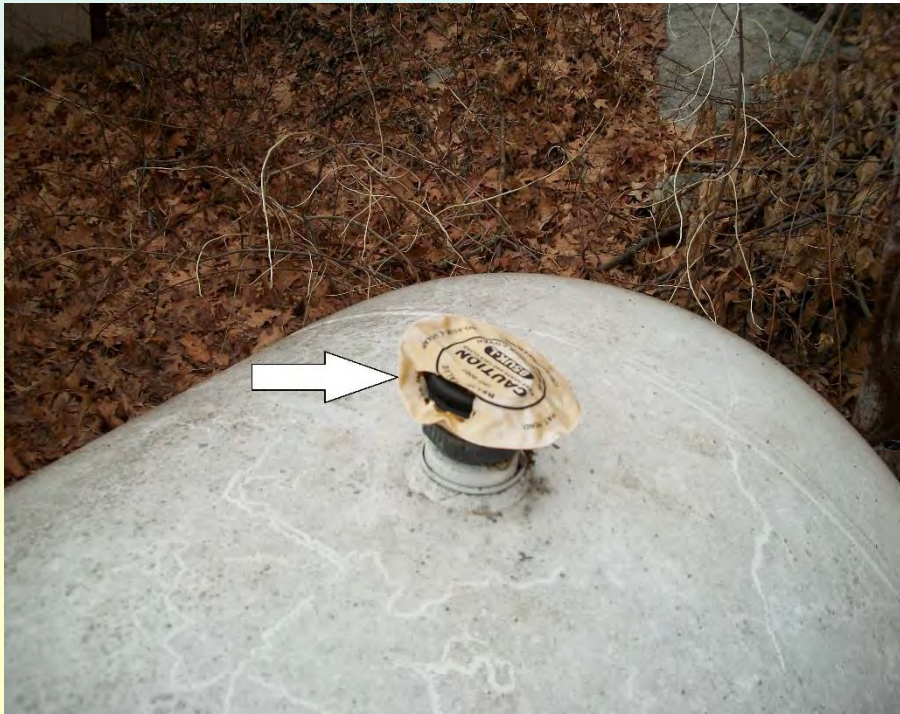
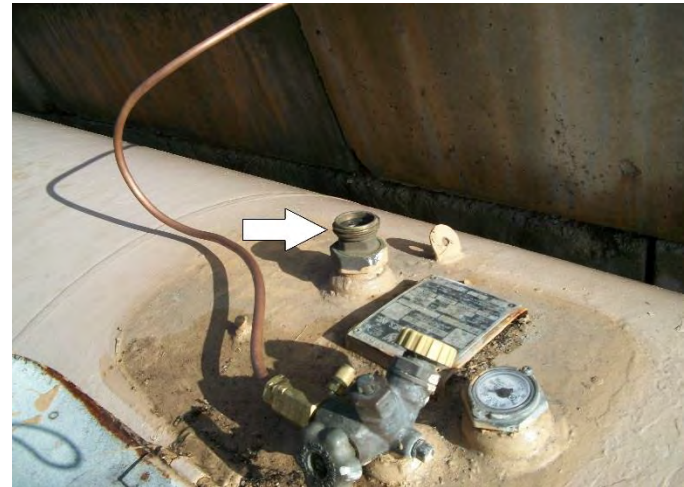
Damaged Rain caps

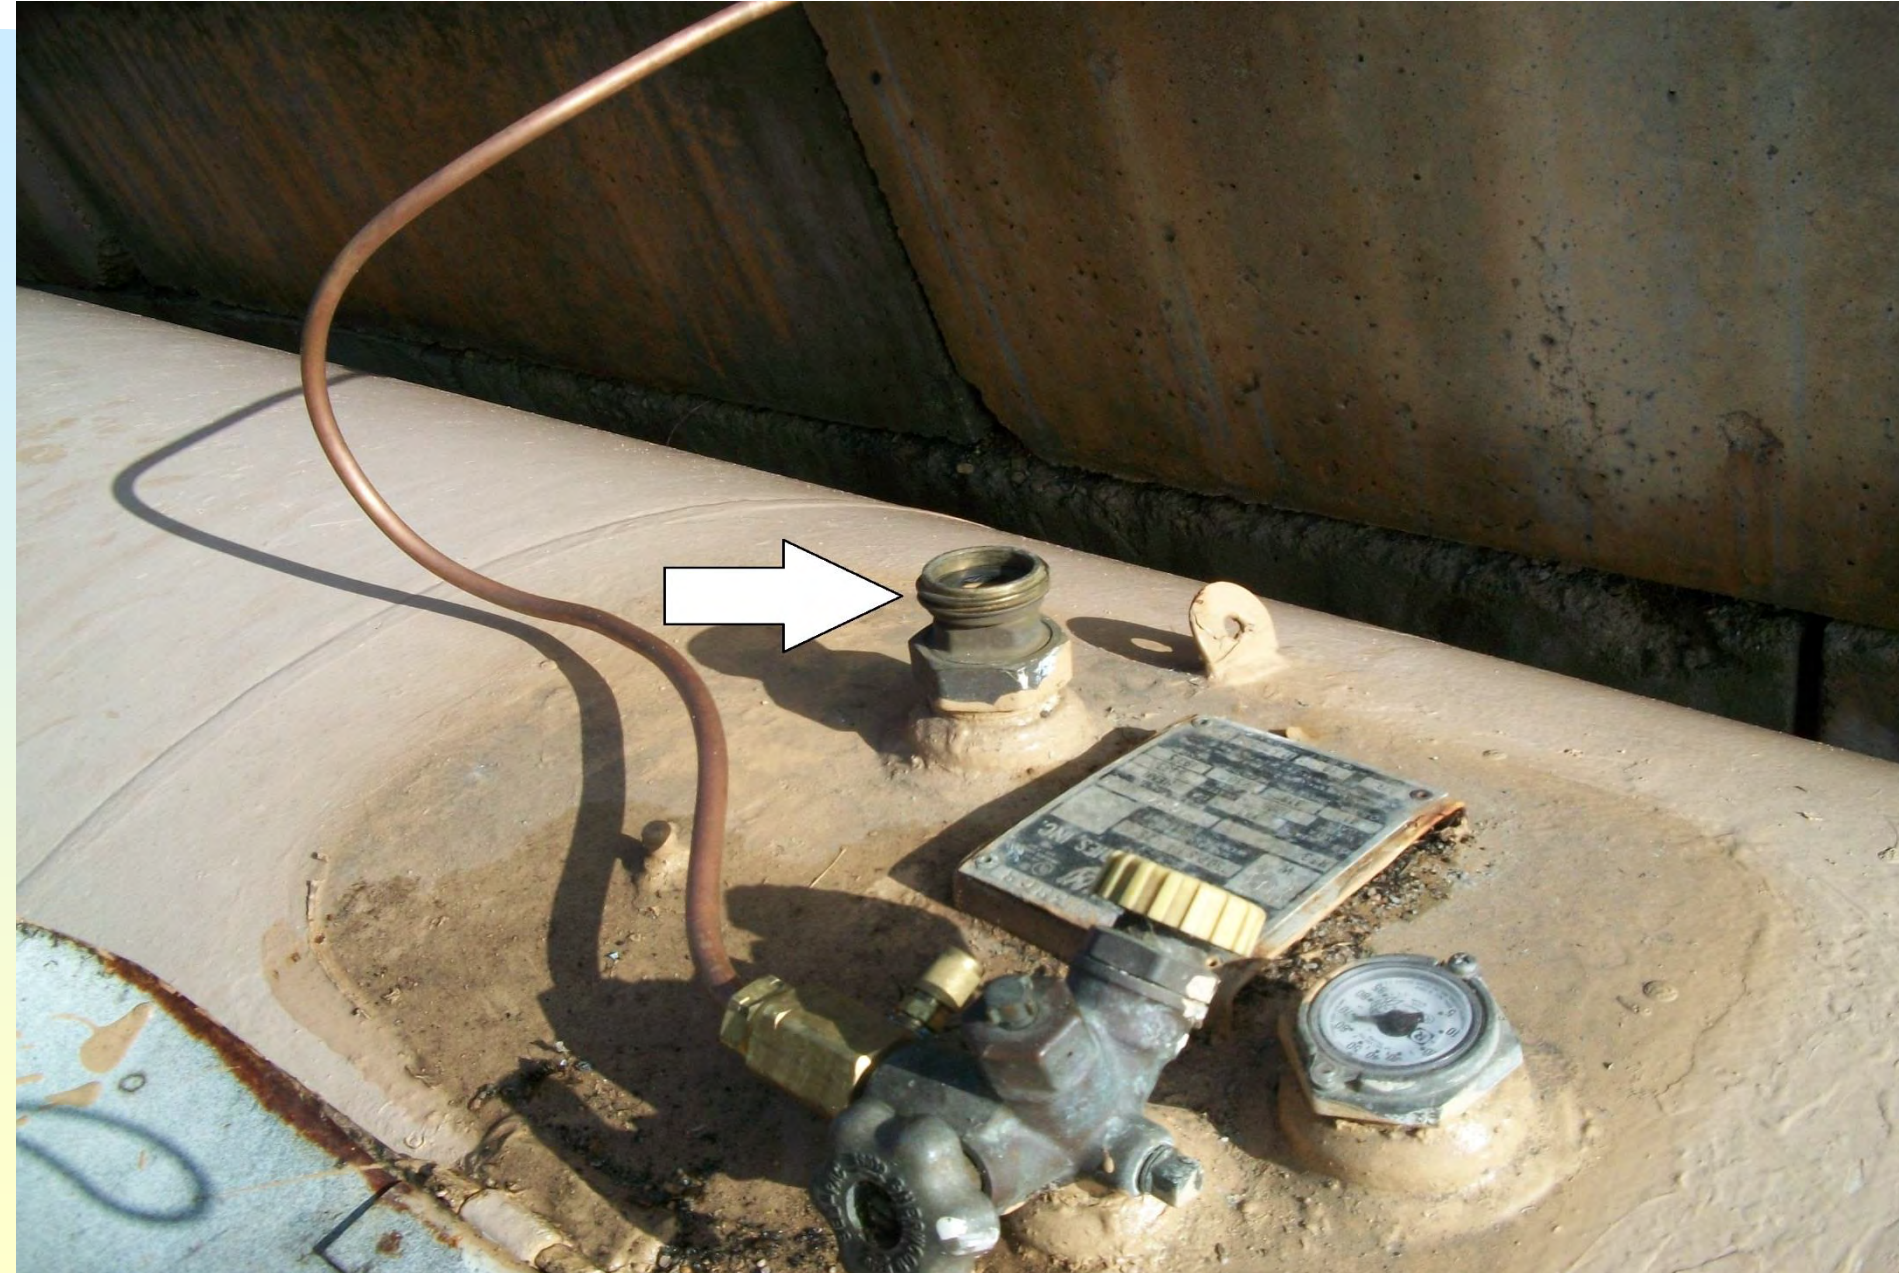
Missing Fill cap

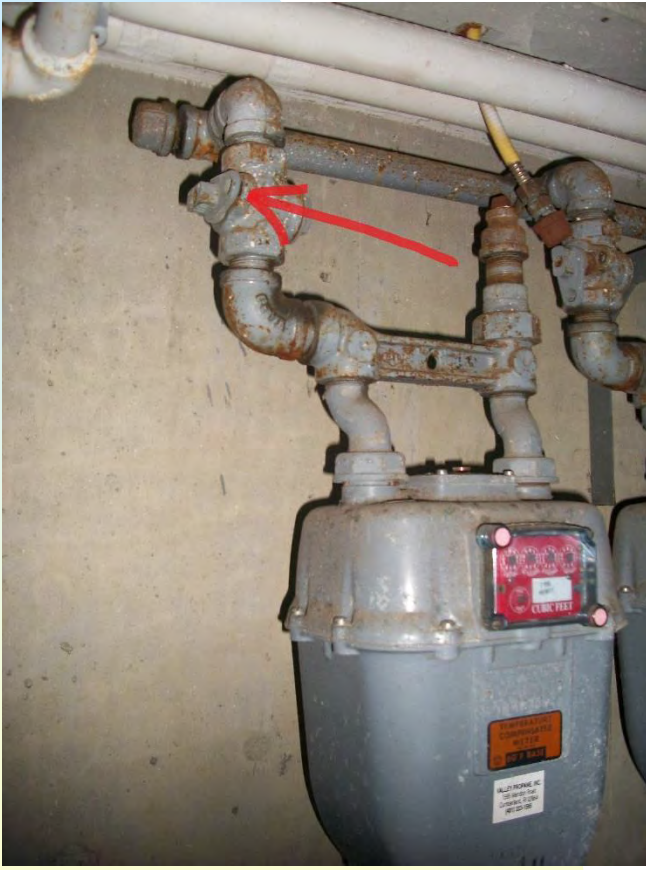
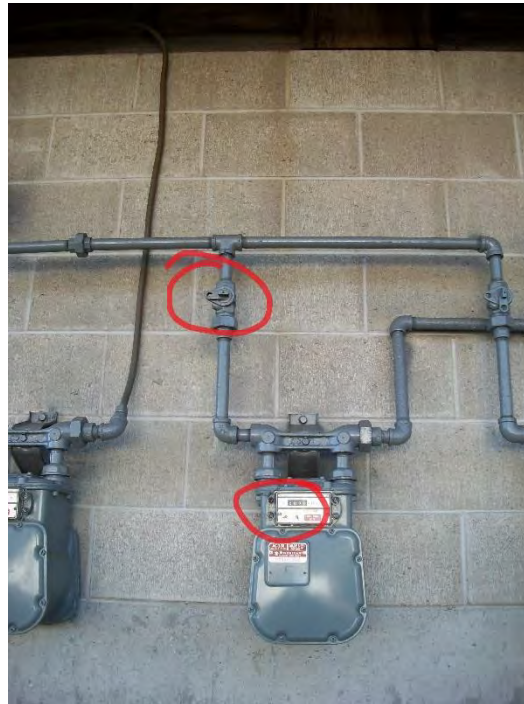
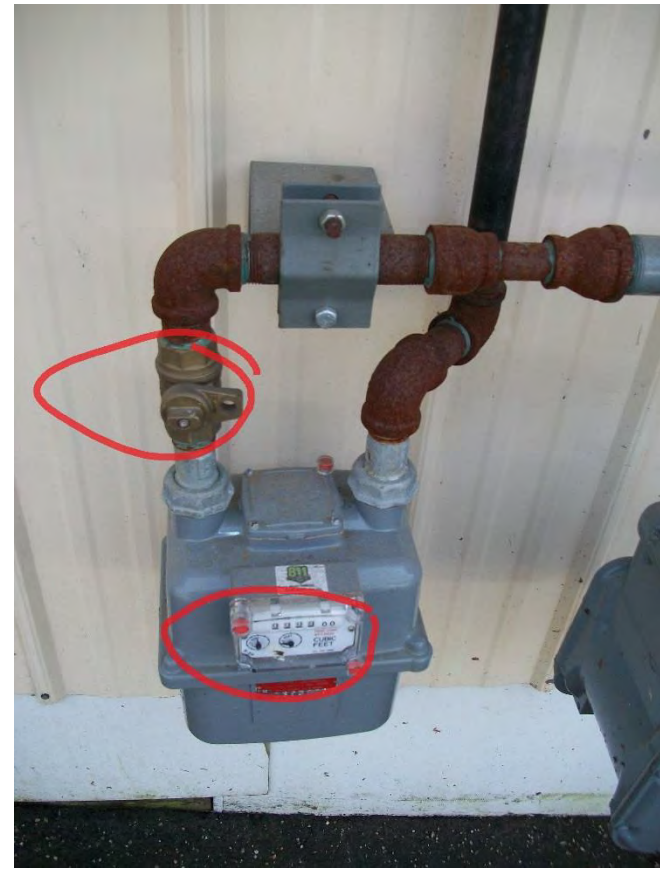
No locks on “off” meters

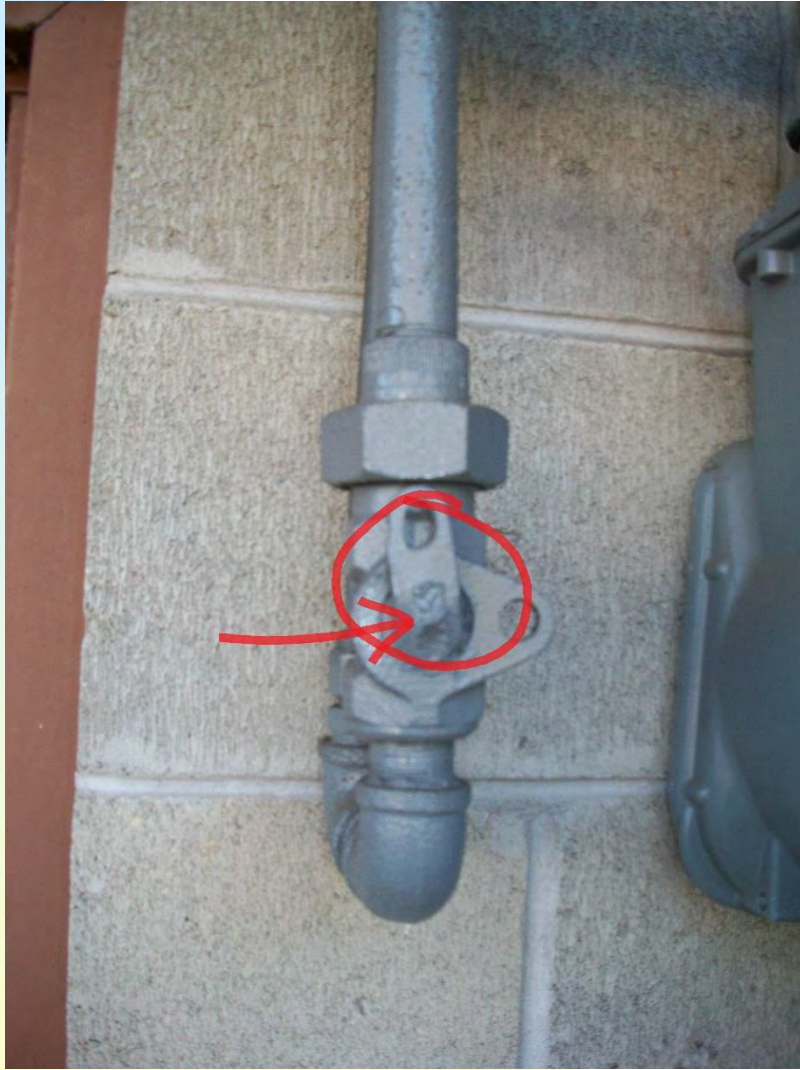
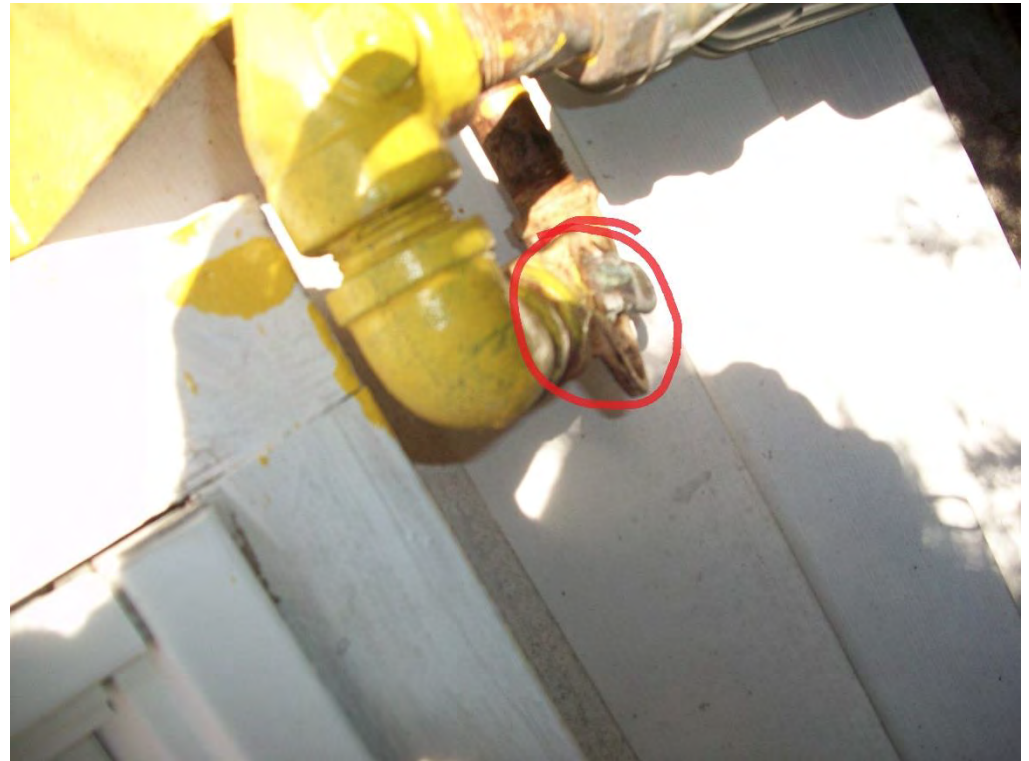
Broken shut off valves

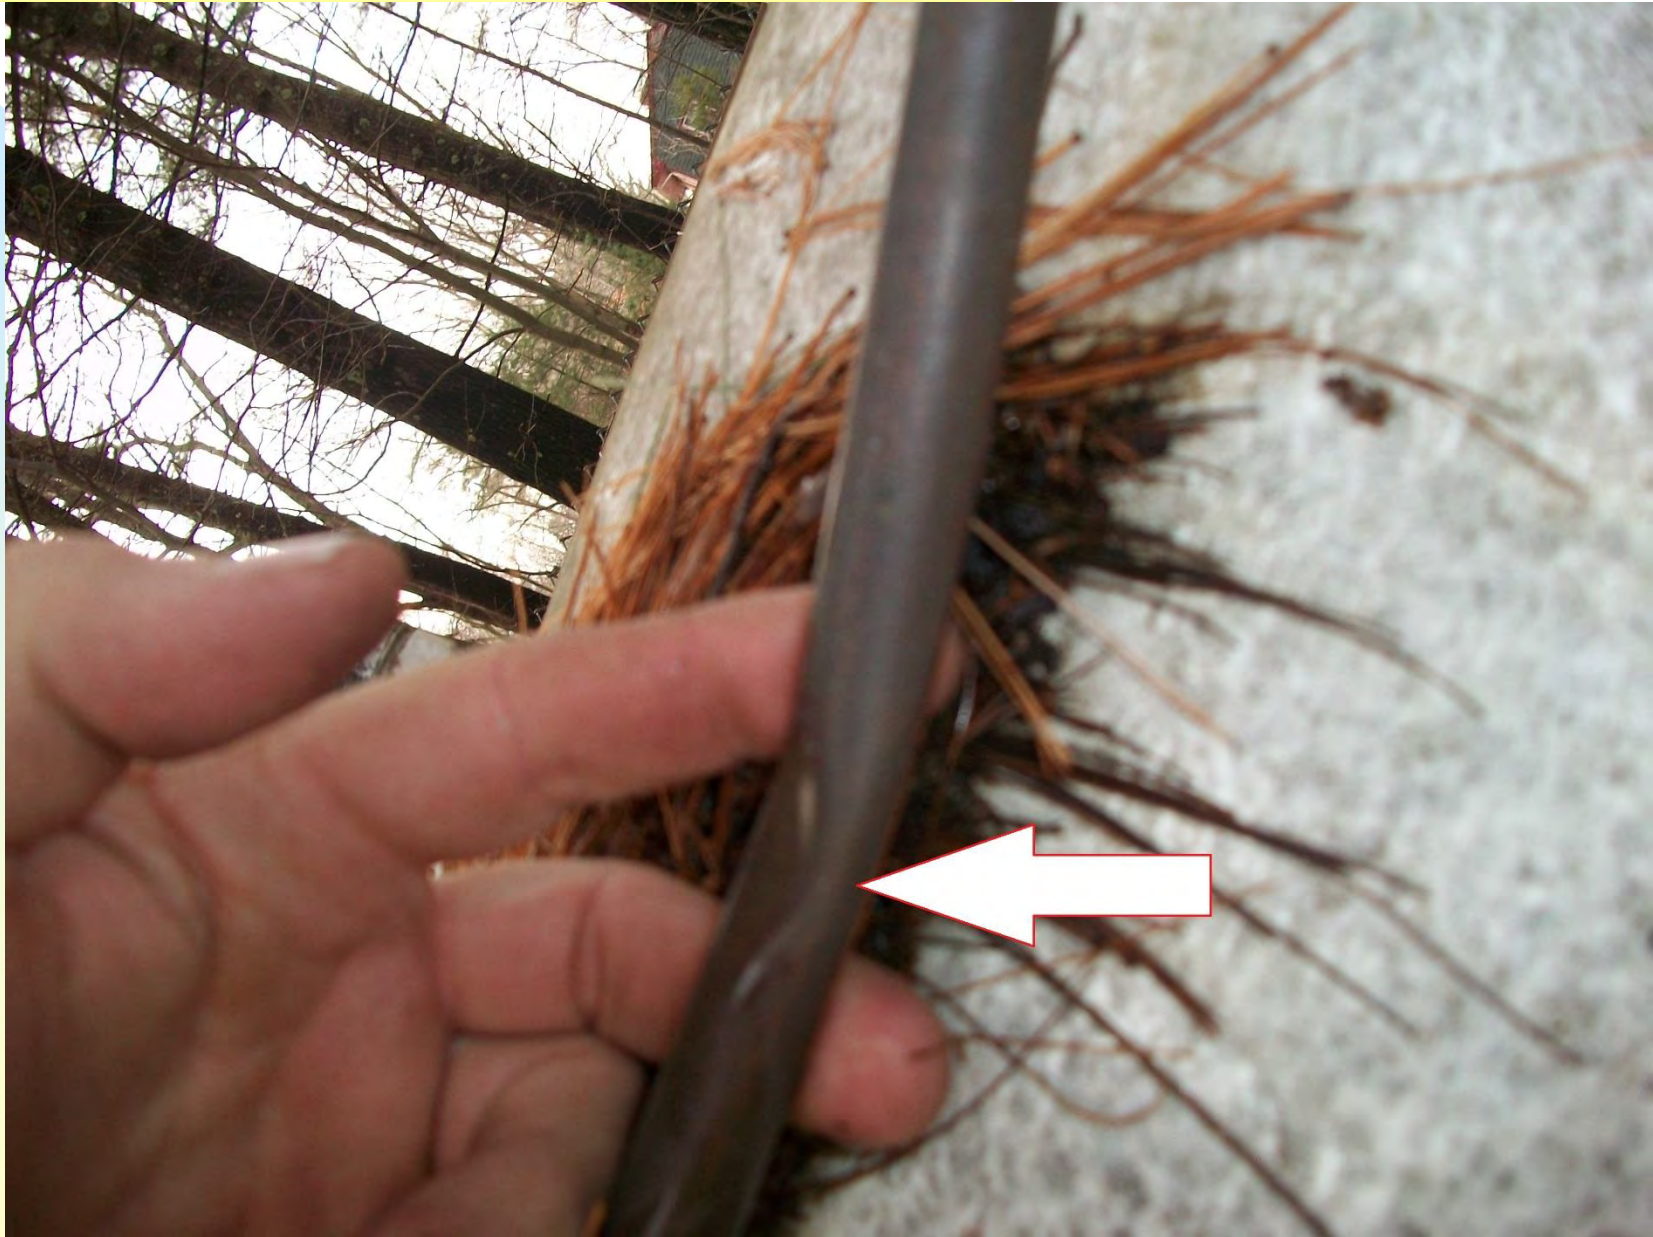
Damaged copper line

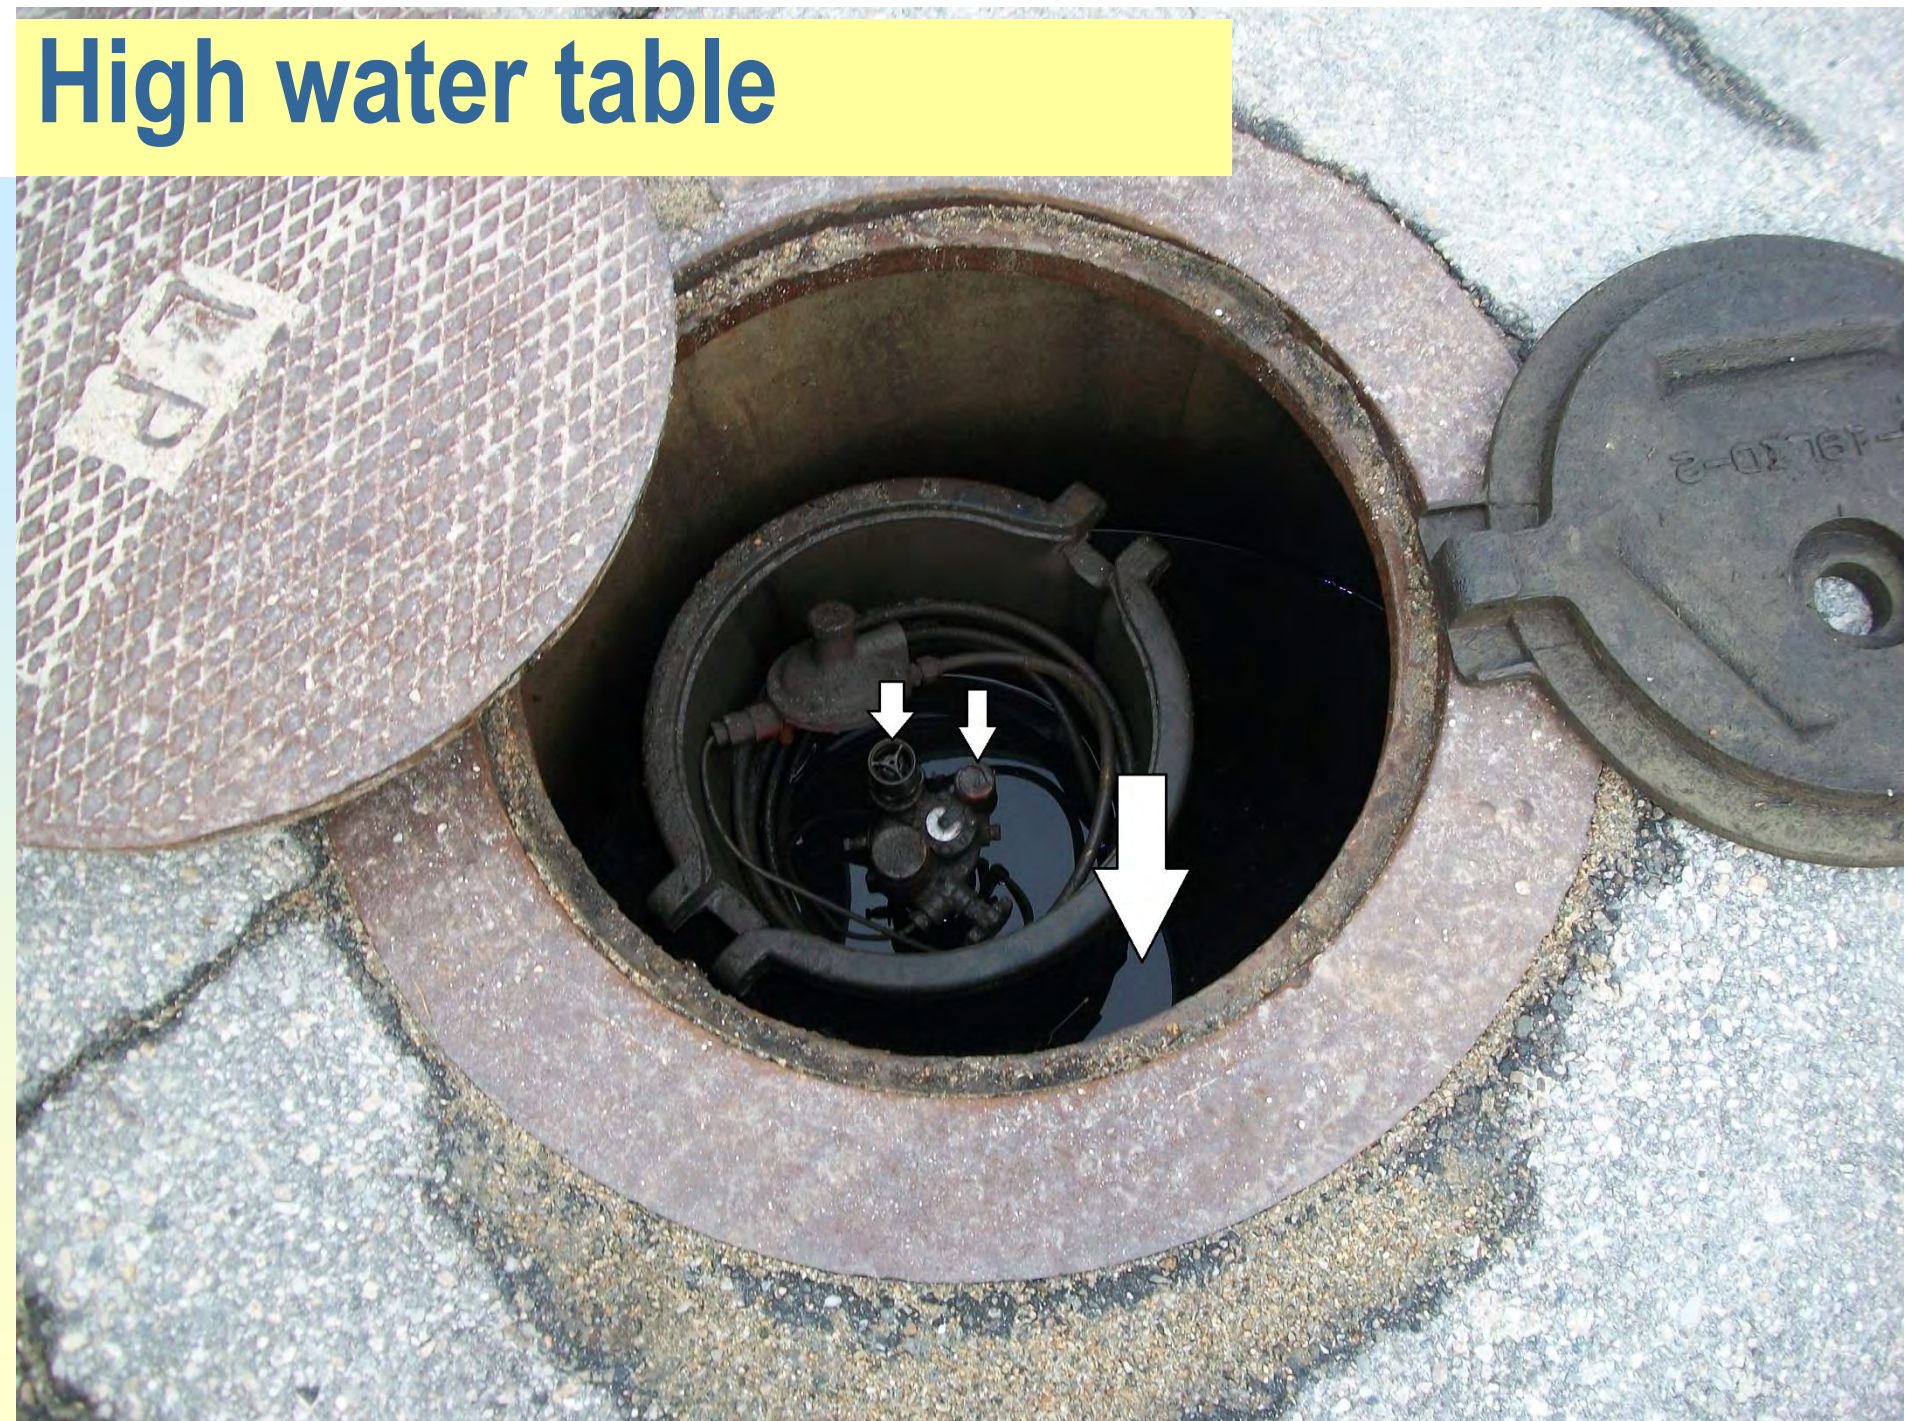
High water table
