Safety Division Investigation into Electrical Contact on February 26, 2020 in Lebanon, NH of employee of Liberty Utilities (Granite State Electric) Corp. d/b/a Liberty Utilities

Report Date

May 15, 2020

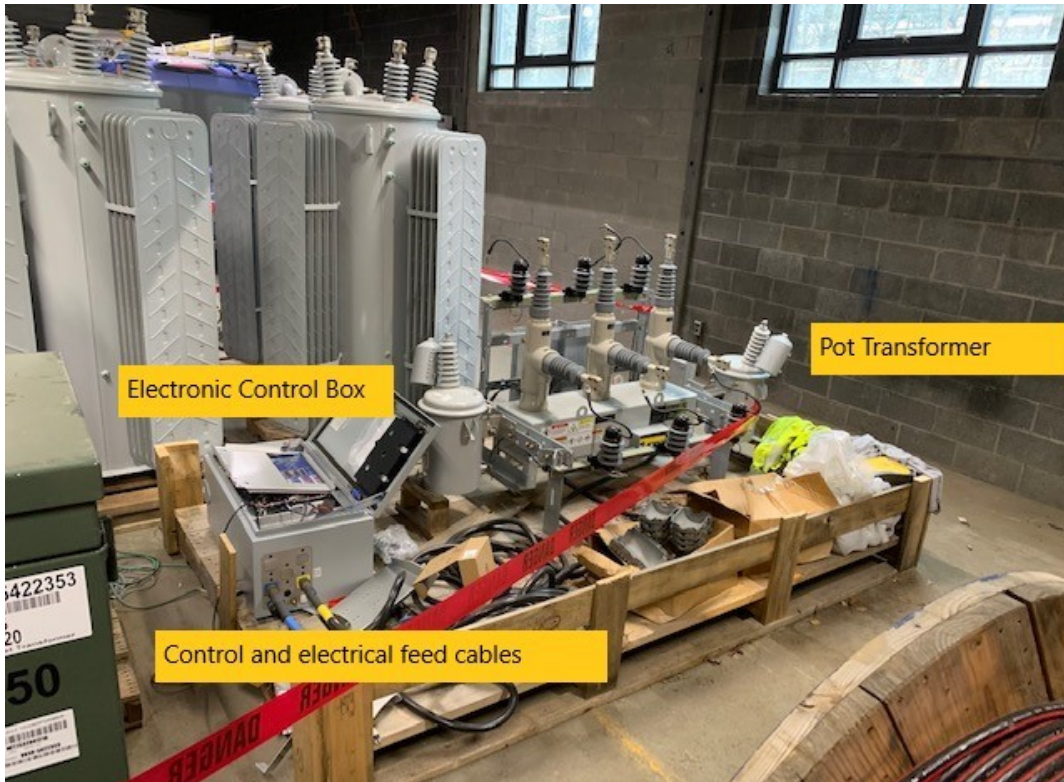
Photo # 1

Photo 1 courtesy of PUC Safety Division taken 3/6/2020. Photo inside of the warehouse at the Lebanon Area Work Center. The photo shows the electrical equipment assembly consisting of Viper S interrupters, lightning arresters, potential transforms, control and electrical feed cables, and electronic control box.

Mr. Barnes connected a 120-volt power cord from a receptacle in the warehouse to the electronic control box to bypass the use of the Potential Transformer (sometimes referred to as a power transformer) associated with the recloser assembly. In the field the Potential Transformer is the source of power for the electronic control box, but since this was an inside test, standard 120 volt power was used as the power source. A control cable was also connected to the electronic control box in order to provide an external ability to operate the recloser for testing purposes. (See Attachment 1 Photos 1 - 4). During the testing process, the control cable was draped across the recloser assembly from the control box to the area of the Potential Transformer to the right in Photo # 1.

Second, the Safety Division determined that the Liberty Utilities testing procedures for Reclosers provided to the Safety Division do not explicitly reference isolating the Power Transformer from the control box when using external power to test the Recloser when it is not installed in the field. As a piece of equipment that is routinely used within the distribution system, Liberty **should have more explicit** instructions. Liberty **does implicitly** make reference in Liberty's procedure SMP Circuit Breaker and Recloser Procedure. This procedure is used to perform Visual and Operation, Thermographic, Mechanism, Diagnostic and Acceptance Testing on all Circuit Breaker and Pole Top Reclosers used in electrical substations. In the procedure, section 3.0 Unusual Hazards, subsection 3. it states "*Make sure the manufacturer's manual is referenced and voltage testing is made during any testing or trouble shooting. Bench testing or*

Fourth, a job safety briefing was not performed prior to the testing and initiation of the electrical equipment. This is standard industry practice. If a job briefing had been performed, the discussion would have involved disconnecting the Potential Transformer secondary connections. It would have eliminated the back feed thru the secondary side of the Potential Transformer allowing the Primary bushing to be energized at 7,000 volts from the power cable that energized the electronic control box. This would have eliminated the potential hazard. Liberty’s procedure LU-EOP D011 Inspection- Maintenance Reclosers provided to the Safety Division upon request in section 8.1.5 states, *“Before work begins a “Job Brief” shall be conducted to identify the boundaries of the work area, the work methods to be used and all hazards associated with the job.”* Liberty employees did not conduct a Job Brief as required and thus did not follow the procedure.

2) Liberty Utilities shall re-write the Circuit Breaker and Recloser Procedure (Testing CB and PTR) Doc # SMP (Draft). This procedure will include a detailed safety process section emphasizing job briefings, proper PPE, management oversight and review of the testing to be performed, and qualification requirements of the Liberty Utilities employee that will perform the testing of the CB or PTR. The procedure will include the manufacturing company's recommendations concerning the testing, installation, maintenance and safe operation of the CB or PTR. The finalized procedure (no longer draft) will give detailed instructions for testing of a CB or PTR in the field and for a warehouse environment.

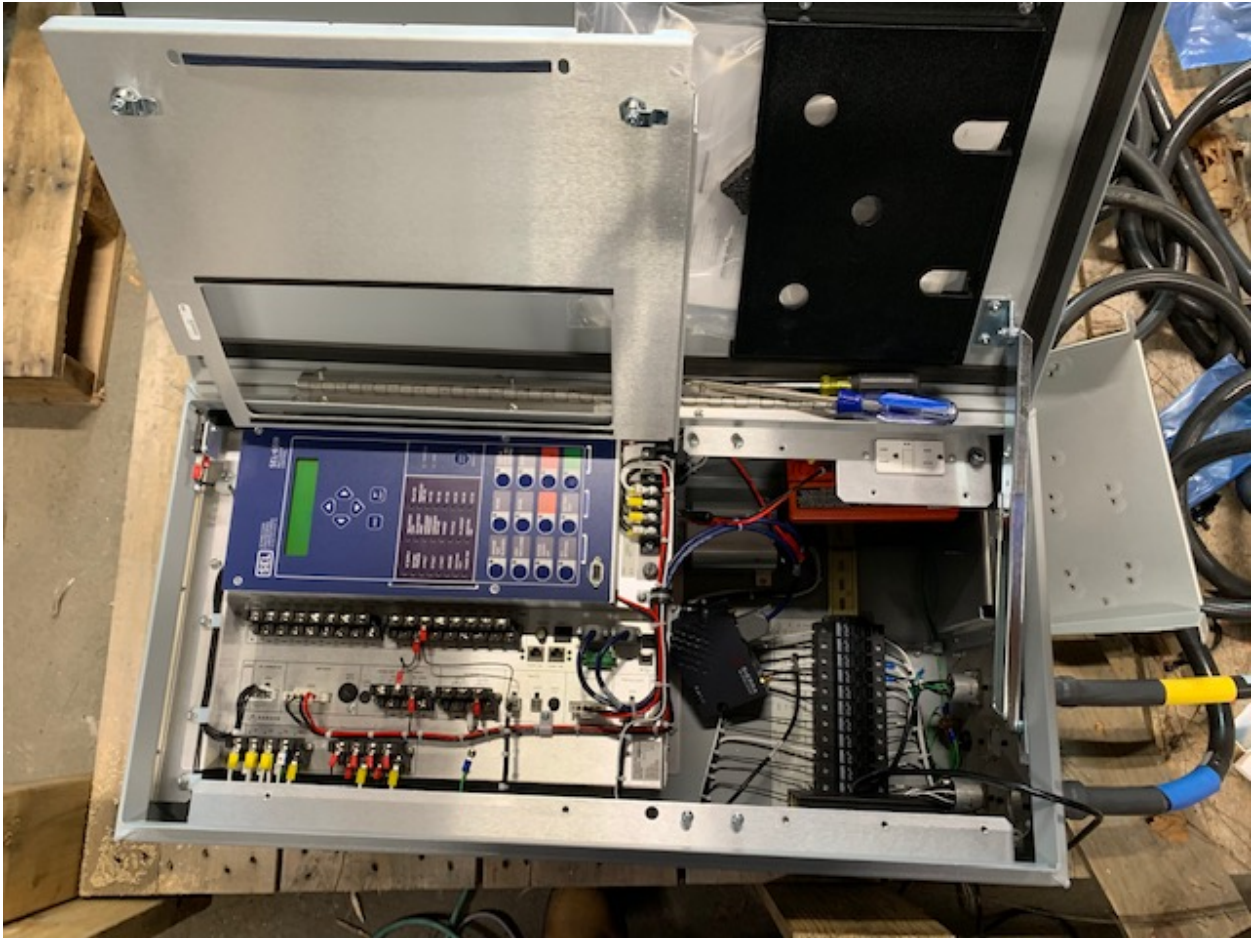
Photo # 2

Photo 2 courtesy of PUC Safety Division taken 3/6/2020 Photo inside of the warehouse at the Lebanon Area Work Center. The photos shows the electrical control and electrical feed cables, electric control box still connected to the potential transformer

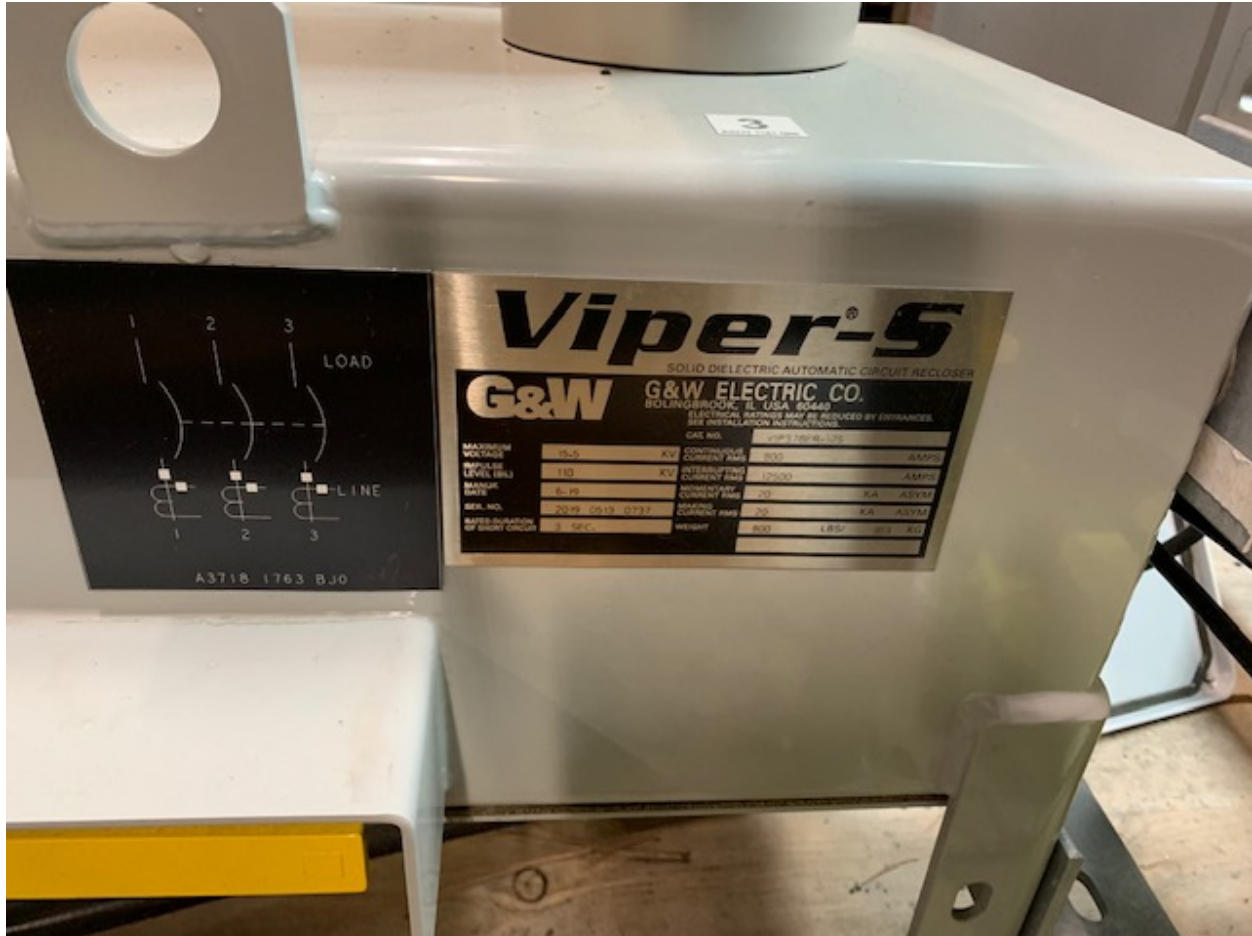
Photo # 3

Photo 3 courtesy of PUC Safety Division taken 3/6/2020. Photo inside of the warehouse at the Lebanon Area Work Center. The photos shows the Manufacturer (G& W) Viper S recloser nameplate ratings for the recloser. Specifically 15.5 kV maximum voltage rating, 110 amp impulse loading (BIL), 800 amp continuous current, manufacturing date of 6/2019, interrupting current rating of 12,500 amp, making current RMS 20 amp, 800 pound weight of assembly.

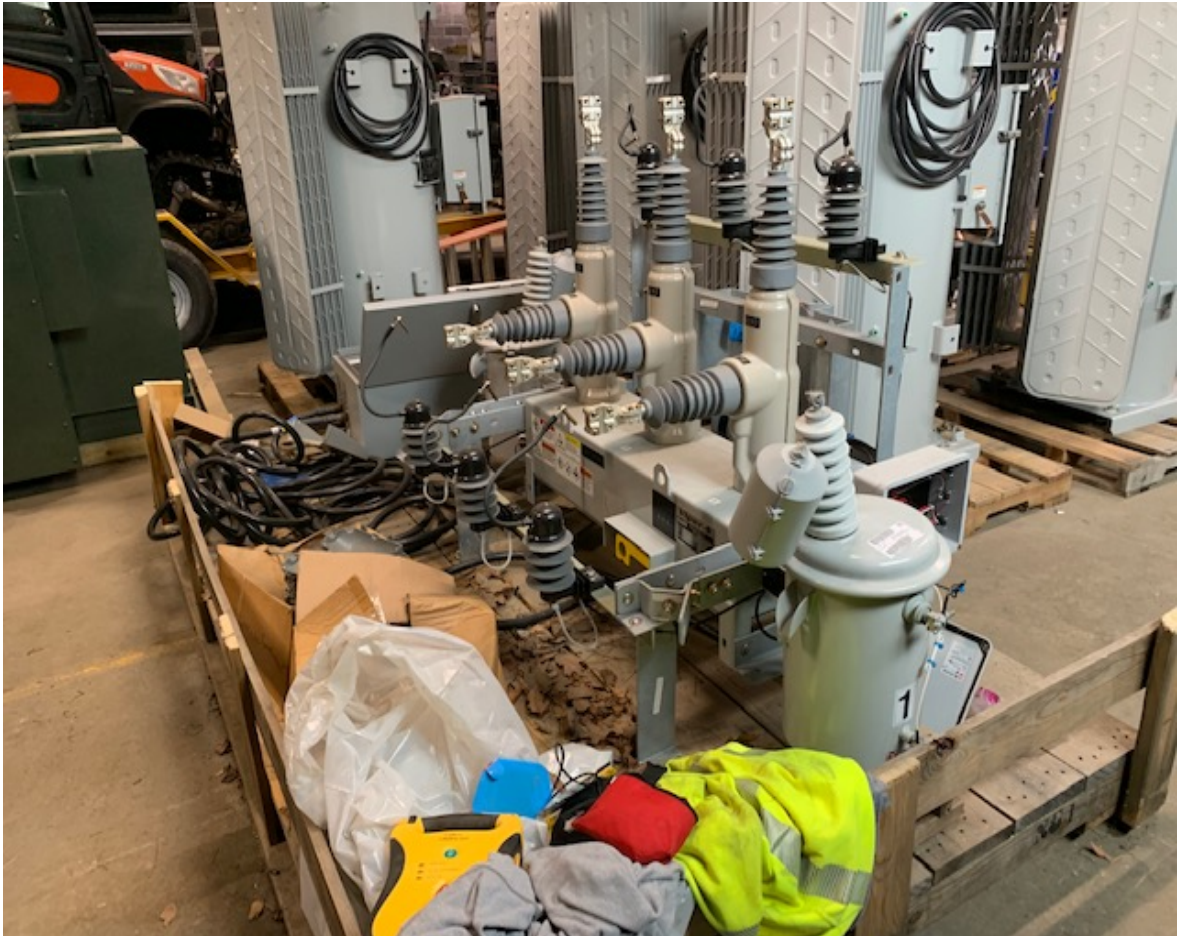
Photo # 4

Photo 4 courtesy of PUC Safety Division taken 3/6/2020. Photo inside of the warehouse at the Lebanon Area Work Center. The photo shows the electrical equipment assembly consisting of Viper S interrupters, lightning arresters, potential transforms, control and electrical feed cables, and electronic control box. Photo 4 taken from the opposite location of Photo 1

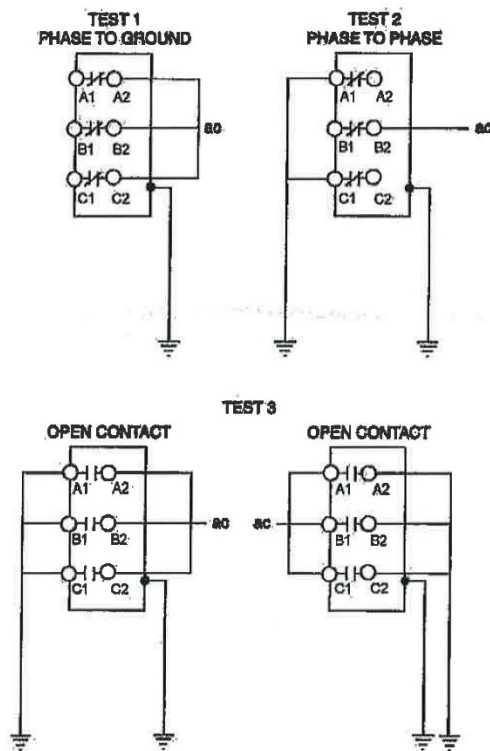
Use the following procedures to perform high potential withstand tests at 75% of the rated low-frequency withstand voltage for 60 seconds. See Table 3 for rated voltages and Figure 12 for test connection

Figure 12. Connection diagrams for high potential withstand testing.

7.3.1 Test 1 (Figure 12)

7.3.1.1 Close the recloser contacts.

7.3.1.2 Ground the recloser.

7.3.1.3 Connect terminals C2, B2 and A2 (see Figure 5) together.

7.3.1.4 Apply proper test voltage (see Table 3) to terminals C2, B2 and A2.

7.3.1.5 The recloser should withstand the test voltage for 60 seconds.

7.4.2 Test 2 (Figure 12)

7.4.2.1 Close the recloser contacts.

7.4.2.2 Ground the recloser.

7.4.2.3 Ground Phase A (terminal C2) and Phase C (terminal A2).

7.4.2.4 Apply proper test voltage to Phase B (terminal B2).

7.4.2.5 The recloser should withstand the test voltage for 60 seconds.

7.5.3 Test 3 (Figure 12)

7.5.3.1 Open the recloser contacts.

7.5.3.2 Ground the recloser.

7.5.3.3 Connect and ground terminals C1, B1 and A1 (see Figure 5).

7.5.3.4 Connect terminals C2, B2 and A2.

7.5.3.5 Apply proper test voltage to terminals C2, B2 and A2.

7.5.3.6 The recloser should withstand the test voltage for 60 seconds.

7.5.3.7 Reverse the connections, ground terminals C2, B2 and A2.

7.5.3.8 Apply test voltage to terminals C1, B1 and A1 for 60 seconds.

7.5.3.9 The recloser should withstand the test voltage for 60 seconds.
