New Hampshire December 2008 Ice Storm Assessment Report

October 28, 2009

NEI ELECTRIC POWER ENGINEERING

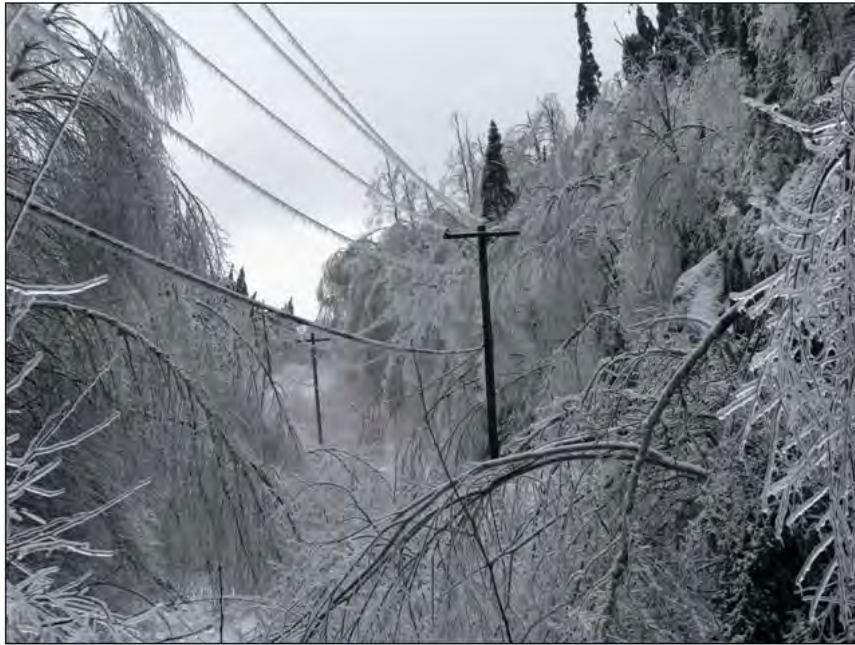
**Figure I-2 – Damage in PSNH distribution line corridor.
(Photo courtesy of PSNH. Exact location unknown.)**

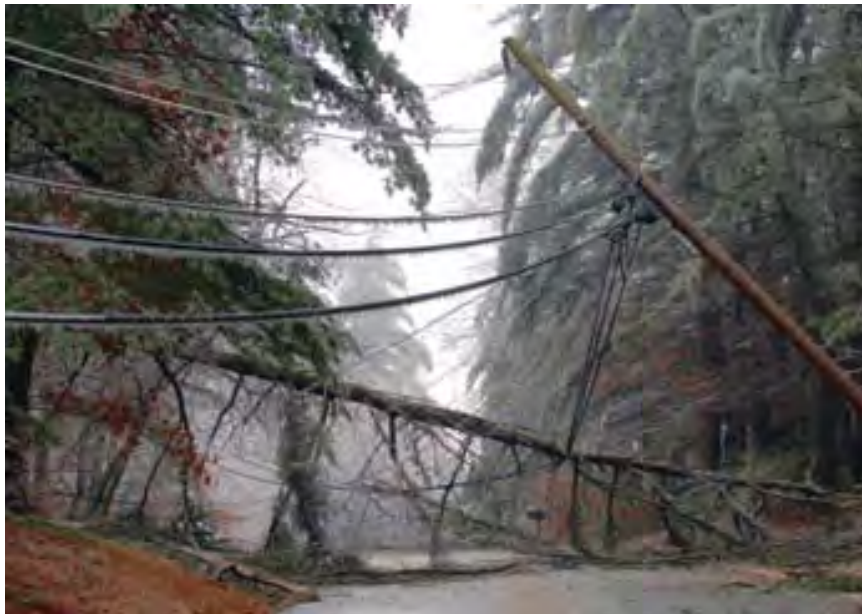
**Figure I-3 - Impassable roads due to ice damage in Londonderry, NH
(Photo courtesy of PSNH)**

The restoration of power was a long and difficult process due to the record amount of damage to the power system. In addition, ice and tree covered roads, as seen in Figure I-3, made the initial damage assessments difficult and time consuming, and hampered repair crews trying to enter damaged areas. The ice storm was followed by two snow events 4 days and 7 days later during the restoration period that further hampered the restoration of power outages. At the peak of the outage there were nearly a half-million customers without power in New Hampshire.¹ The storm

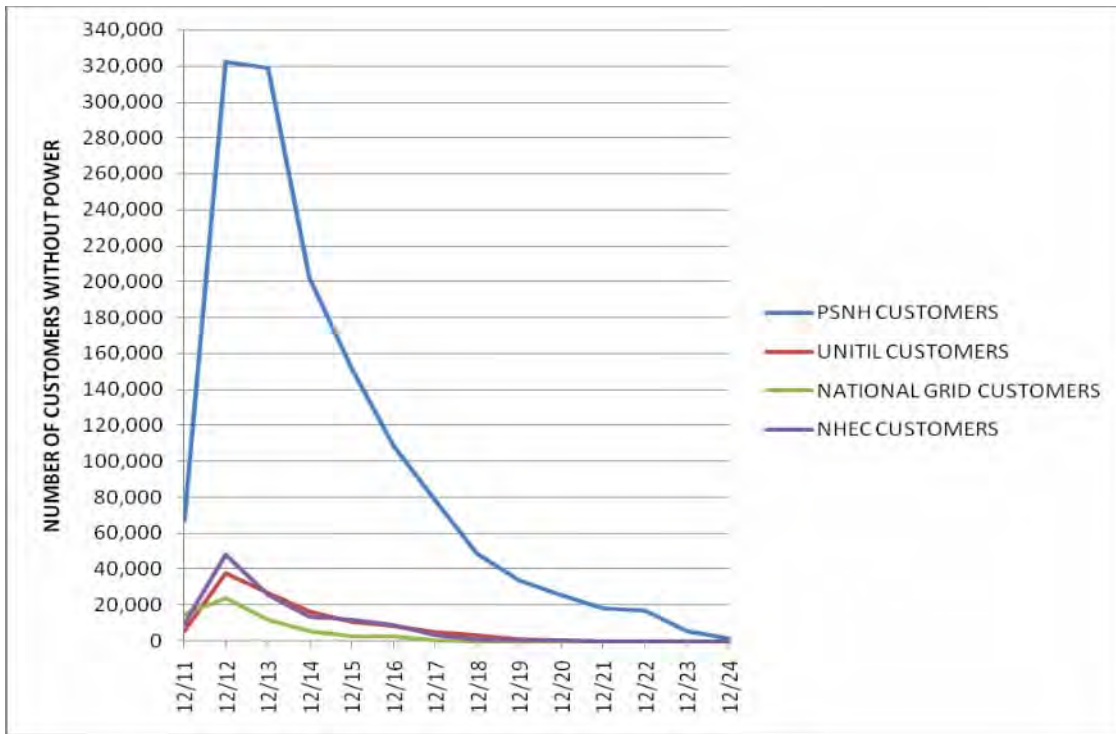
Figure II-1 – The total customers without power for each utility during the ice storm.^{2 3 4 5}

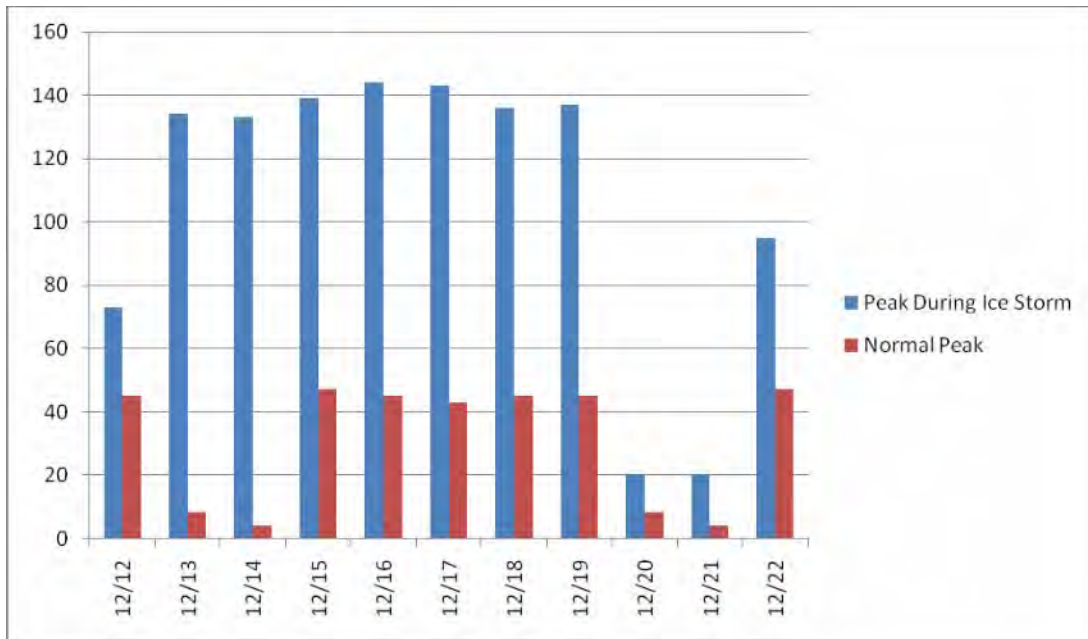
Figure II-22 – Graph showing the PSNH call center staffing levels and normal staffing levels on the days shown.¹⁶⁵

Staffing was commensurate with call volume during the period, with the exception of Day 2, Friday, December 12; Day 10, Saturday, December 20; and day 11, Sunday, December 21.¹⁶⁴ Figure II-23 shows the call volume each day compared to the normal call volume on that day of the week. It may be seen that on Day 2, Friday, December 12, call volume was about twice as high as any other day during the storm, yet call center staffing levels were only slightly above normal. It is apparent from these graphs that PSNH did not ramp up staffing in anticipation of customer calls related to the storm. On the Day 10, Saturday, December 20 and Day 11, Sunday, December 21, staffing levels dropped dramatically despite the fact that customer calls were still well above normal levels.

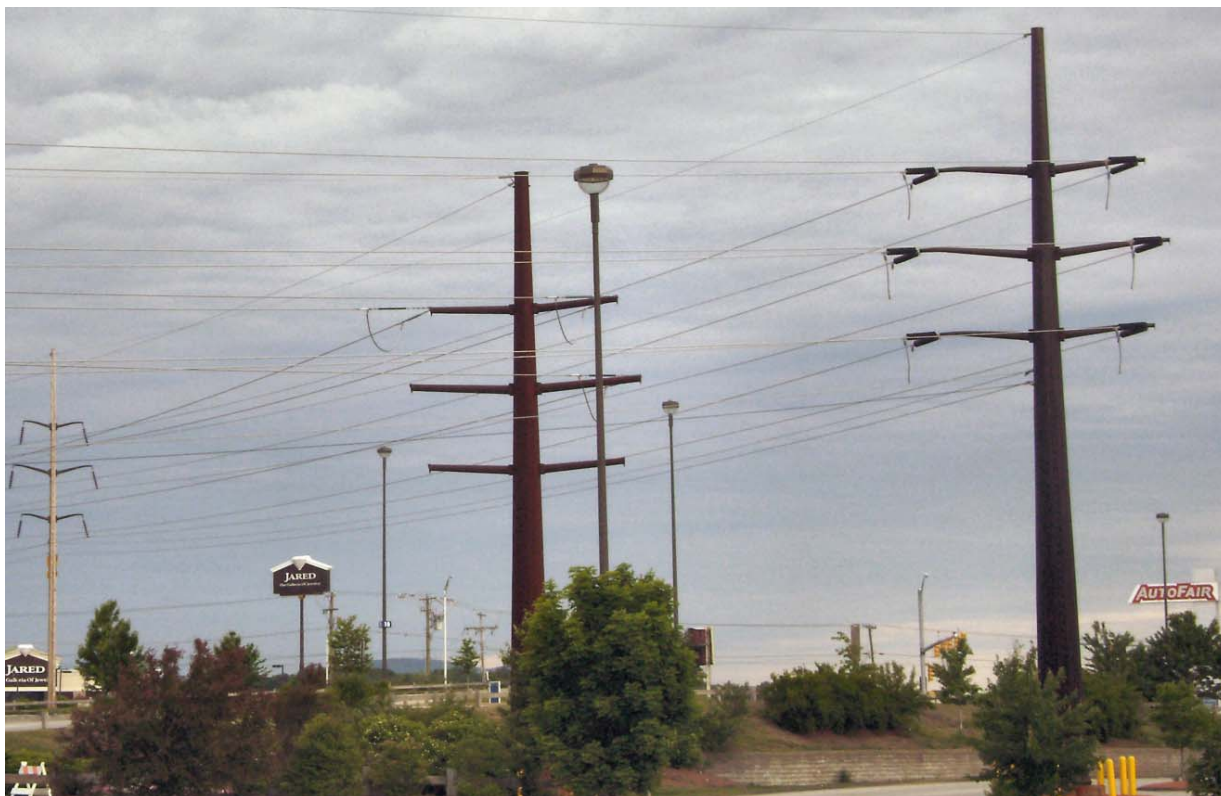
Figure IV-1 - 115kV transmission line structures located near Mall of New Hampshire in Manchester. (Photo by NEI – PSNH System)

Figure IV-1 shows a modern 115 kV transmission line located in Manchester, New Hampshire. This figure shows a common double circuit with single steel pole construction. Note the contrast with the traditional two-pole, H-Frame construction shown in Figure IV-2.

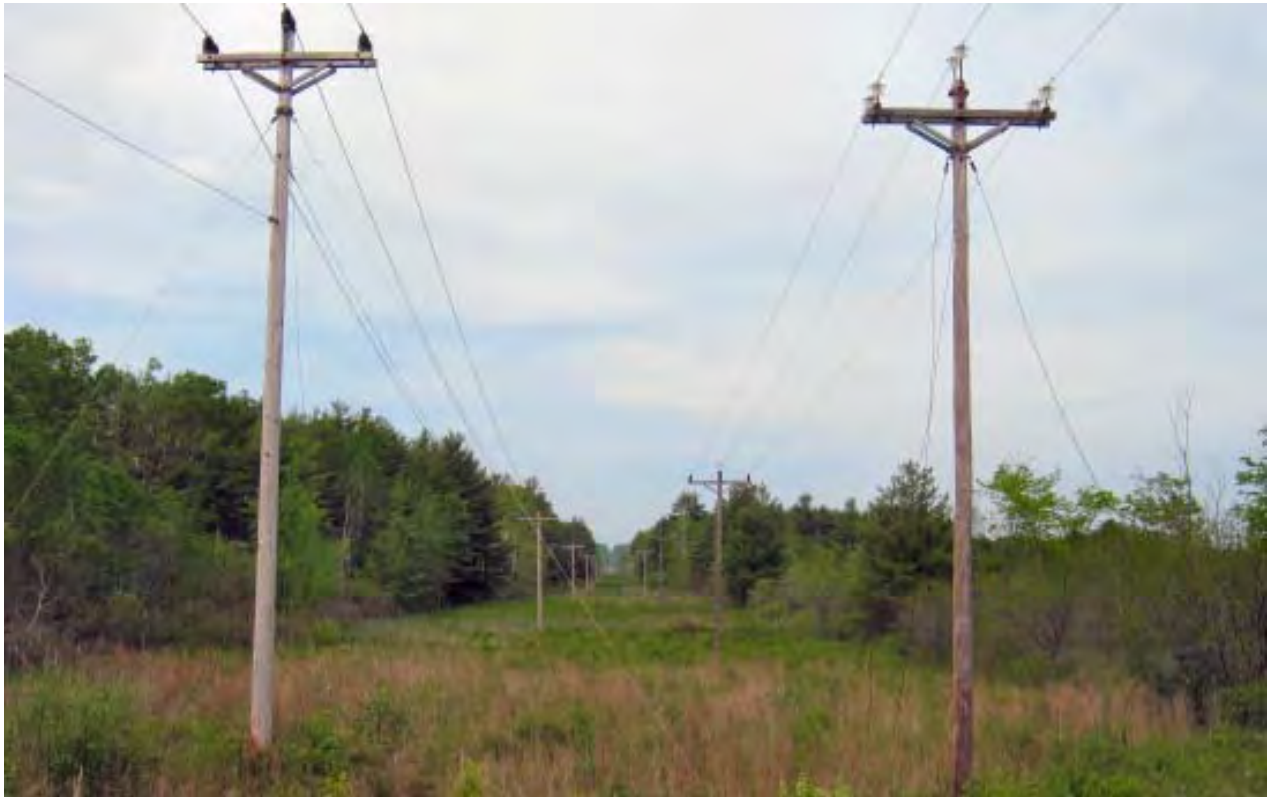
Figure IV-3 – Two 34.5kV sub-transmission lines located on the Unitil system. (Photo by NEI - Unitil System)

Figure IV-3 shows a pair of 34.5 kV sub-transmission lines on the Unitil system. The 34.5 kV circuit on the left consists of single wood poles, three current-carrying conductors attached to cross arms, and a grounded neutral wire attached to the pole below the cross arm. The 34.5 kV circuit on the right has three current carrying conductors, but has no grounded neutral wire and thus relies on the neutral of the other line in the ROW for single-phase, 19.9 kV distribution loads. In both circuits, the current carrying conductors are bare and rely on air for electrical insulation. Note that the construction of the sub-transmission lines is not as robust as the previously described transmission lines and, in this case, consists of wood poles and cross-arms that take on a similar appearance to the distribution system described below. Also note in this case that the electric sub-transmission lines are located in a dedicated ROW that is reasonably free of tall vegetation. There are no trees under or between the lines and the tall vegetation at the edges of the ROW is kept clear of the lines. The ROW in Figure IV-3 represents a very good practice and is more typical of a transmission ROW than a distribution ROW. The practice of clearing vegetation from the ROW results in greater reliability for the line. It limits incidental contact between the energized lines and vegetation and reduces the possibility that wild fires could occur under the line causing damage.

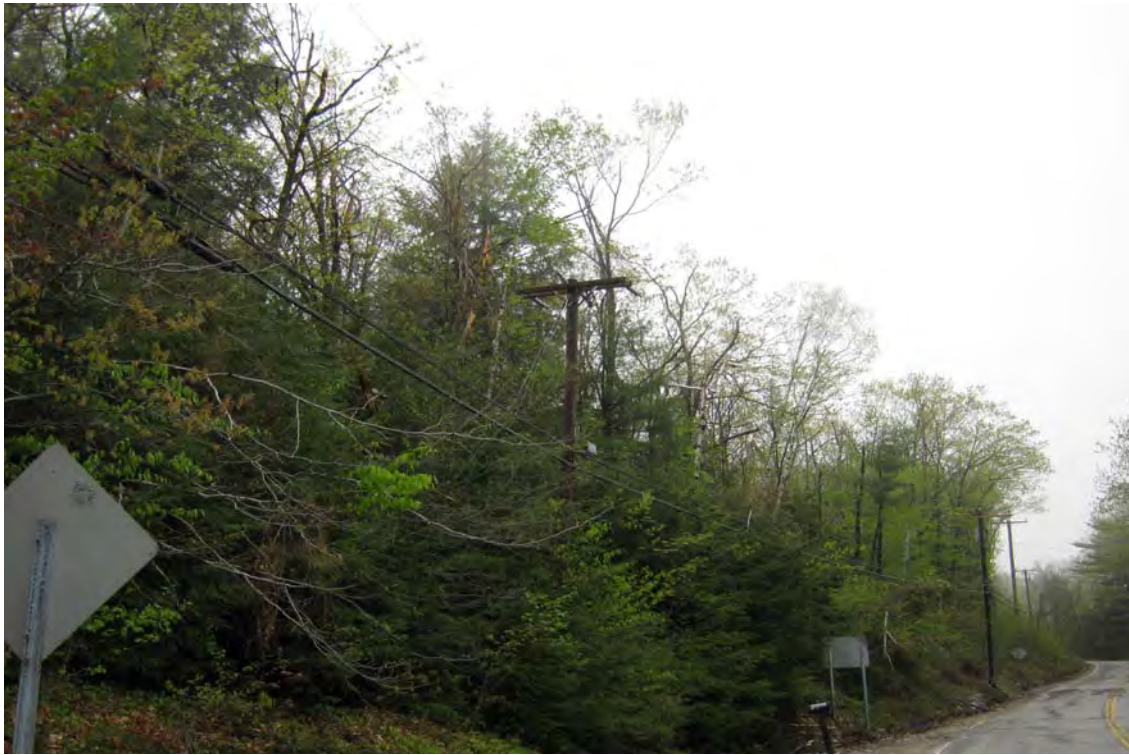
Figure IV-5 - Typical PSNH distribution circuit near Greenville, New Hampshire.
(Photo by NEI - PSNH System)

Figure IV-5 shows a typical rural overhead distribution line located in southwestern New Hampshire. Distribution lines in New Hampshire are usually constructed adjacent to roads and highways where they share a combination of public and private land and compete for space with trees. This distribution line follows the road and each pole must be capable of handling the cables and equipment shown in Figure IV-4. Unlike the transmission and sub-transmission lines shown in Figure IV-1, Figure IV-2, and Figure IV-3, the ROW under this line has not been well cleared.

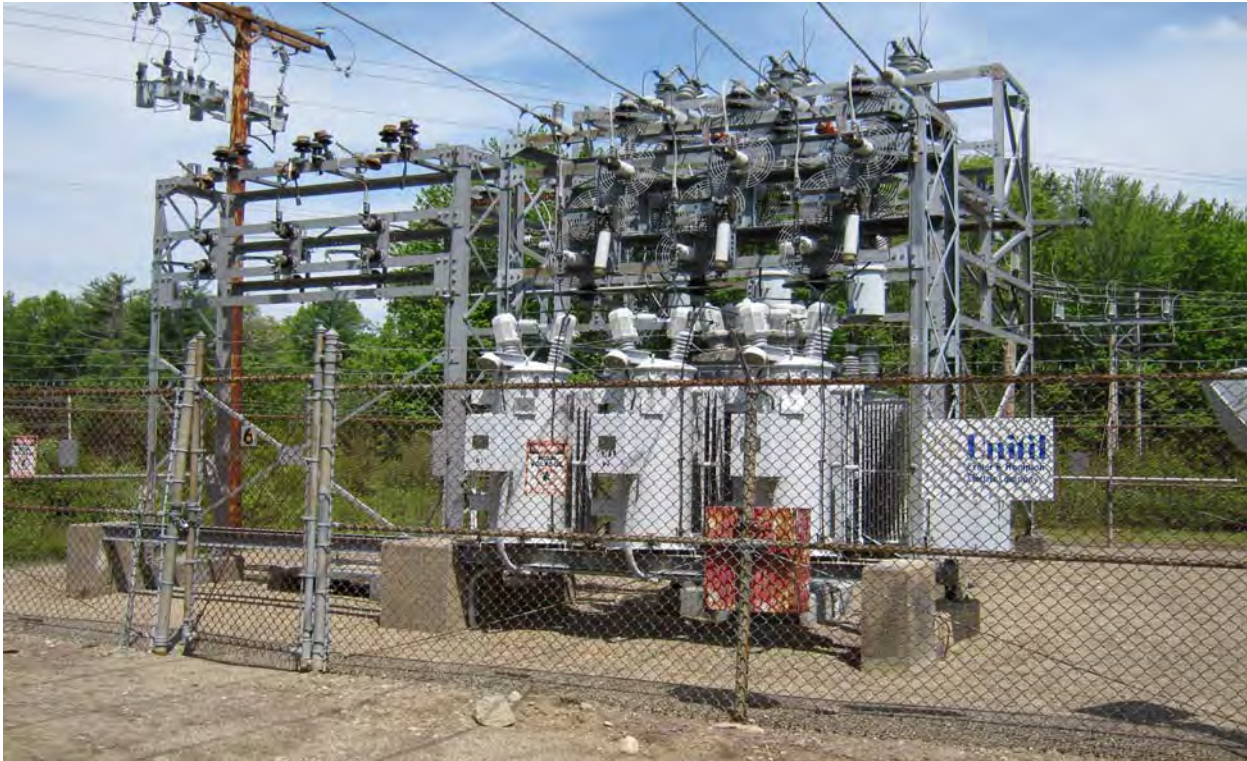
Figure IV-6 – 34.5kV to 13.8kV Unilt electric distribution substation located in East Kingston, New Hampshire. (Photo by NEI-Unilt System)

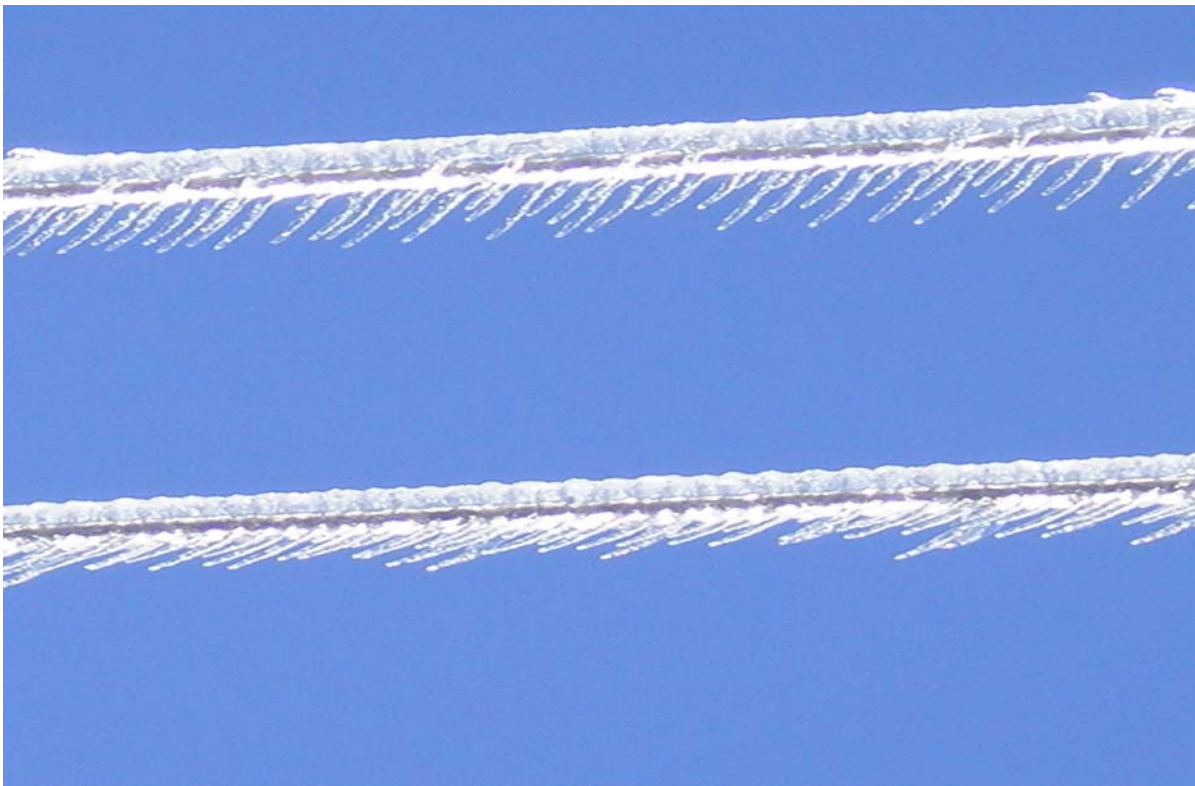
Figure IV-10 - Close-up of ice shown in Figure IV-9. (Photo courtesy of PSNH)

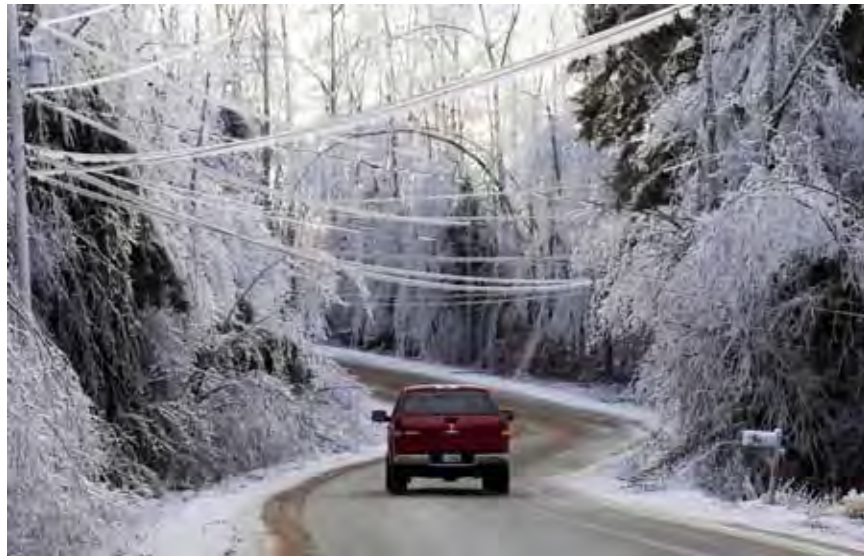
**Figure V-2 - Ice loading on lines during December 2008 ice storm.
(Photo courtesy of PSNH, location unknown.)**

For the most part, the December 2008 ice storm did not directly damage the transmission and distribution systems. Instead it damaged the woodlands of New Hampshire, causing tree limbs and whole trees to fall, which in turn damaged the power system by breaking poles, cross arms, hardware, and conductors. Poles and conductors are quite resilient to simple ice loading as is evident in Figure V-2 where it may be seen that wires, poles, and a transformer are all carrying heavy ice loads, yet are all completely intact. If a limb or a tree were to break off due to the ice and fall on the wires or against a pole, the additional stress raises the risk that that poles or wires could fail.

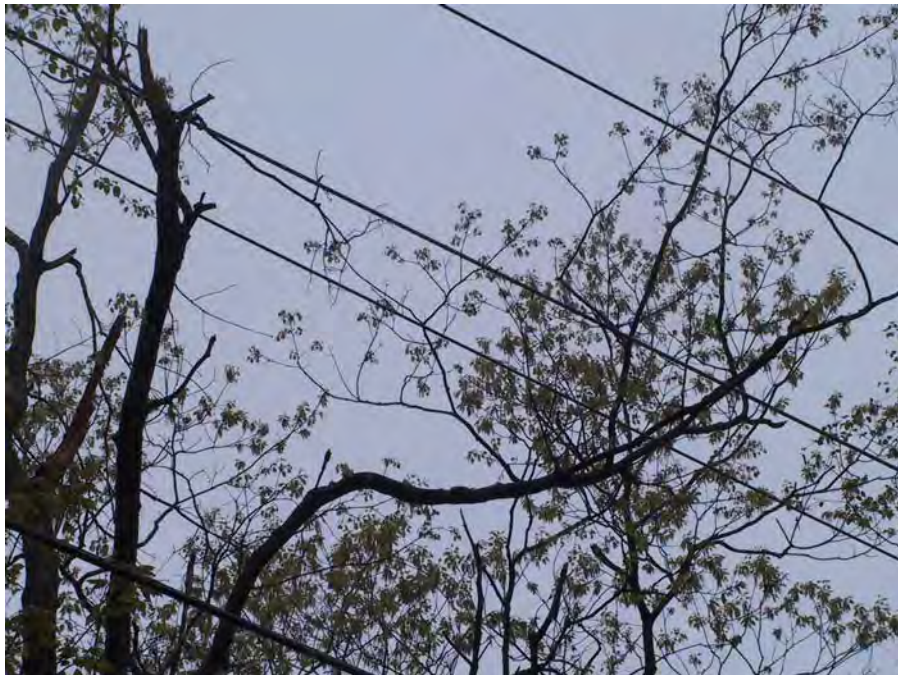
Figure V-5 - Small diameter immature trees broken above conductors in New Ipswich, NH. (Photo by NEI)

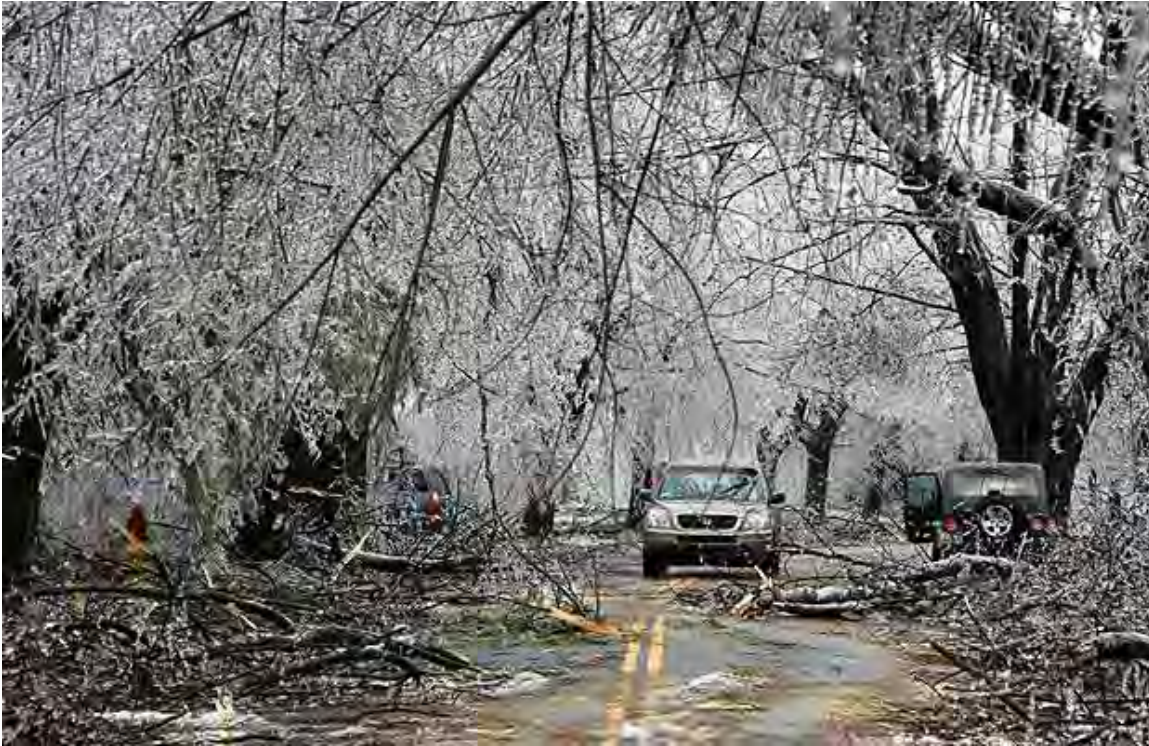
Figure V-7 - Effects of ice laden trees. (Photo source unknown)

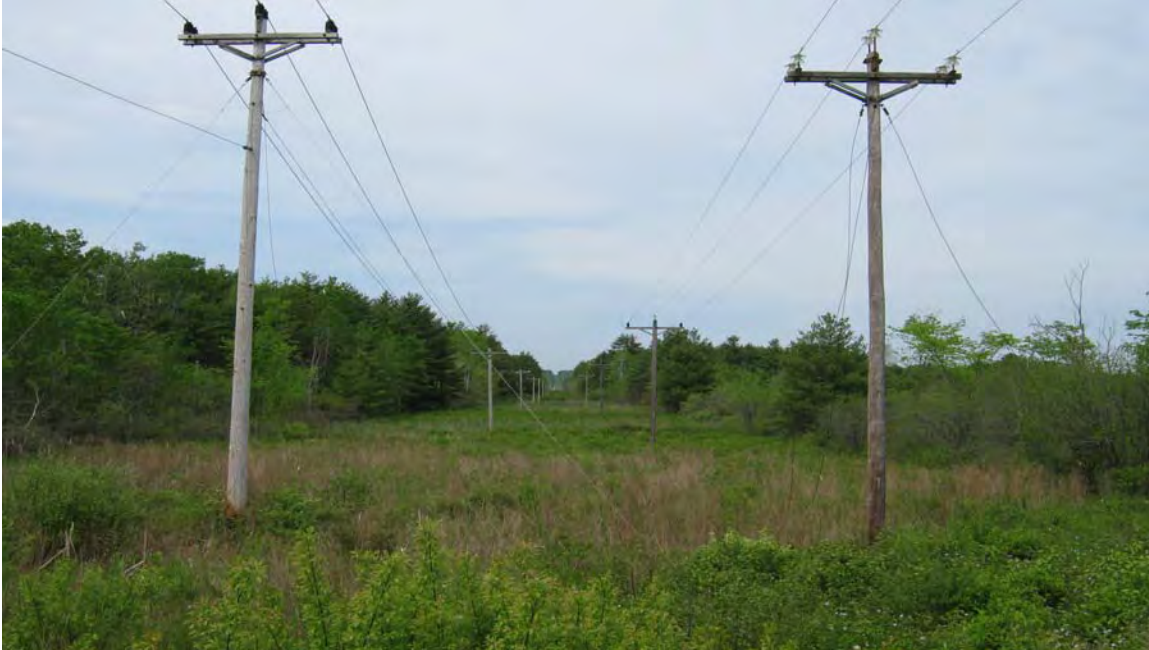
under this circuit is insufficient and if not improved could result in the trees growing into the lines or major damage if a fire were to occur in the ROW.

Figure V-9 - Example of 34.5 kV Unitil sub-transmission line ROW. (Photo by NEI)

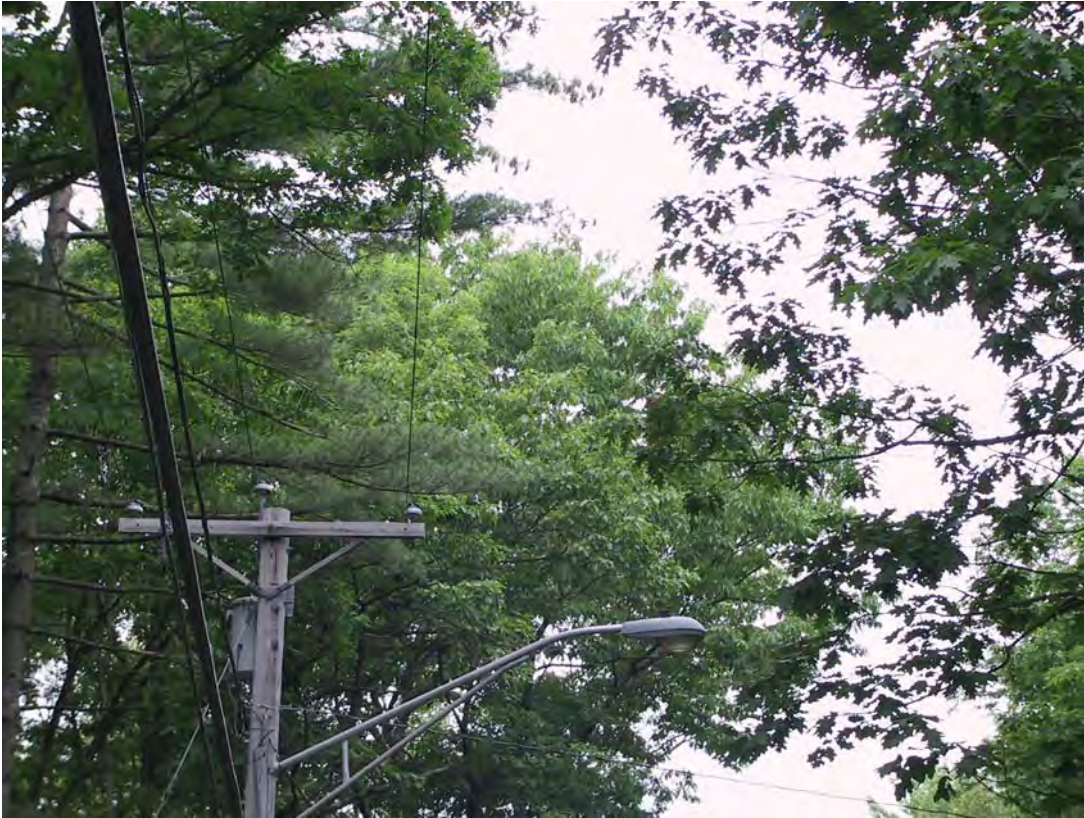
Figure V-13 - White pine recently trimmed in Pelham, New Hampshire. (Photo by NEI)

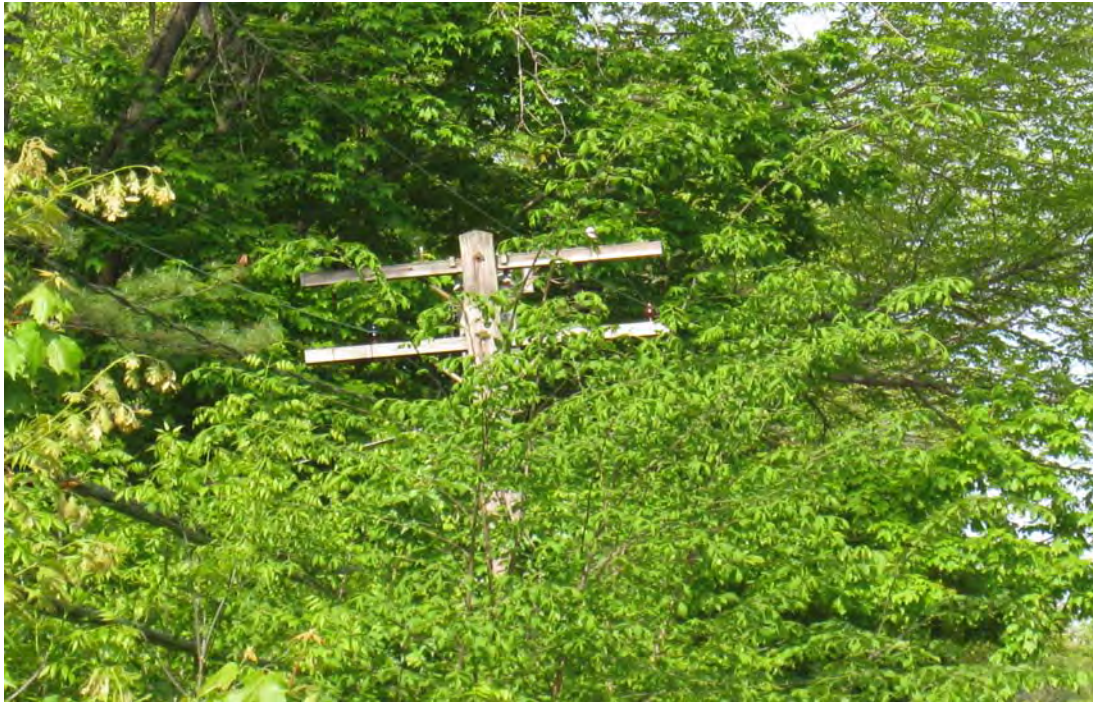
This growth is unsafe, violates the NESC, and is possibly damaging the conductors. While this photograph was taken on Unutil's system, it is not meant to single out Unutil. Similar situations occur on the systems of each utility.

**Figure V-14 – NESC Rule 218 violation in Unutil service area.
(Photo by NEI)**

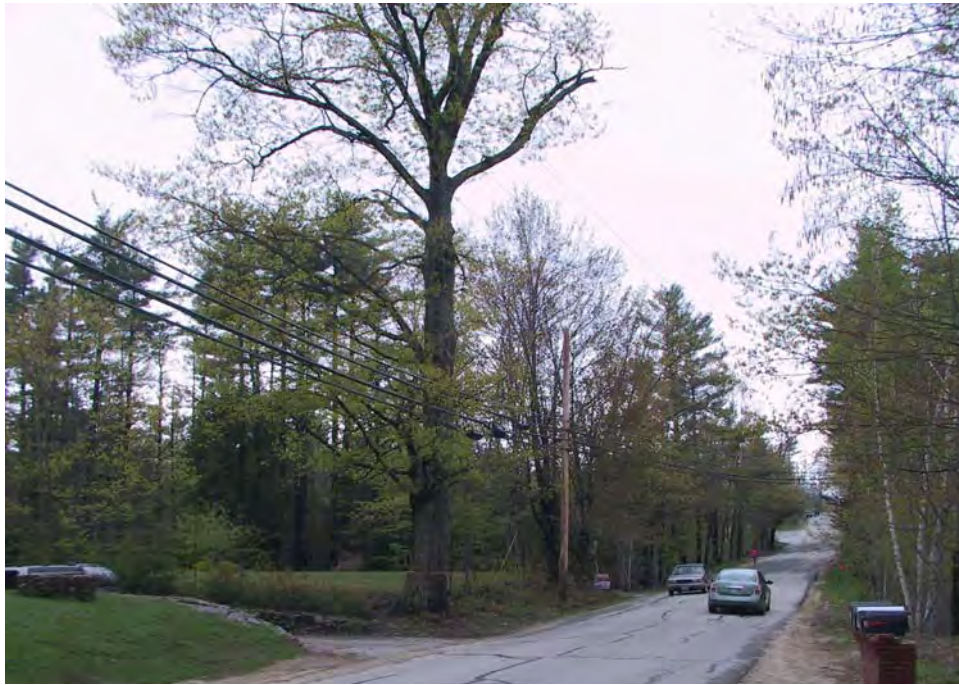
equipment most utilities have available. This particular tree was marked for removal as a "hazard tree." However, this was not done merely due to its proximity to the power line. In New Hampshire, placing the line at risk is not sufficient cause for a tree to be labeled as a hazard. To be classified as a hazard tree, it must also be either infected or dying in addition to its proximity to the line. Within the state, there are many large healthy trees which pose a hazard to power lines and should be considered for removal.

Figure V-15 - Mature oak to be removed in New Ipswich, New Hampshire. (Photo by NEI)

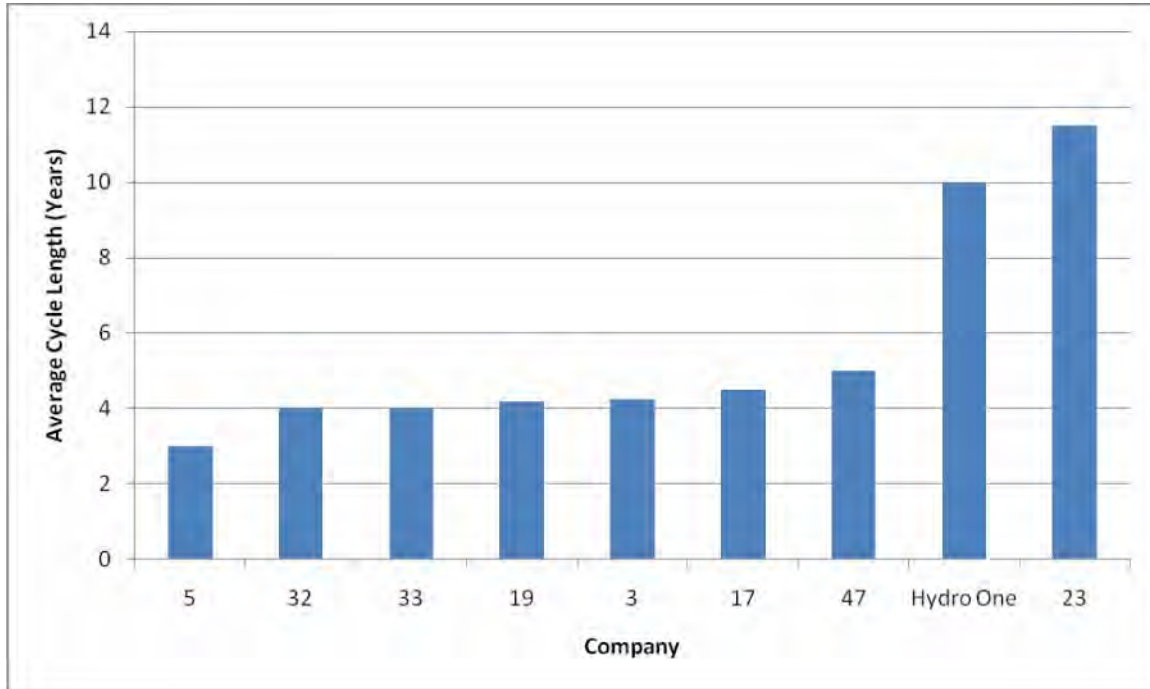
Figure V-16 -Vegetation management cycle lengths for nine utilities.

One electric utility in the Northeast, Hydro One of Quebec, Canada, performed a study⁴⁶ which included the average vegetation management cycle lengths for eight utilities in that region. Figure V-16 shows the results of that study. With the exception of company 47, Hydro One, and company 23, all the utilities shown have vegetation management cycles of around four years.

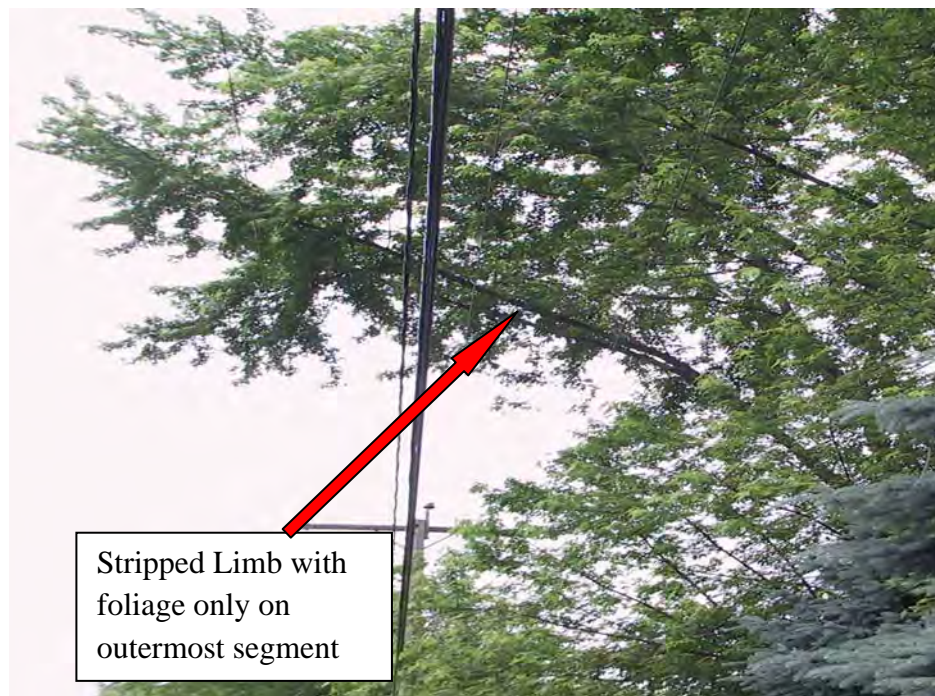
Figure VII-1 - Example of “lion-tailing.” (Photo by NEI)

- The utility’s trimmers should not strip foliage and side limbs from the part of the branch nearest the trunk and leave foliage at the outermost end of the branch. This practice, called “lion-tailing” and illustrated in Figure VII-1, leads to excess weight at the end of limbs and the reduction of limb diameter over time.

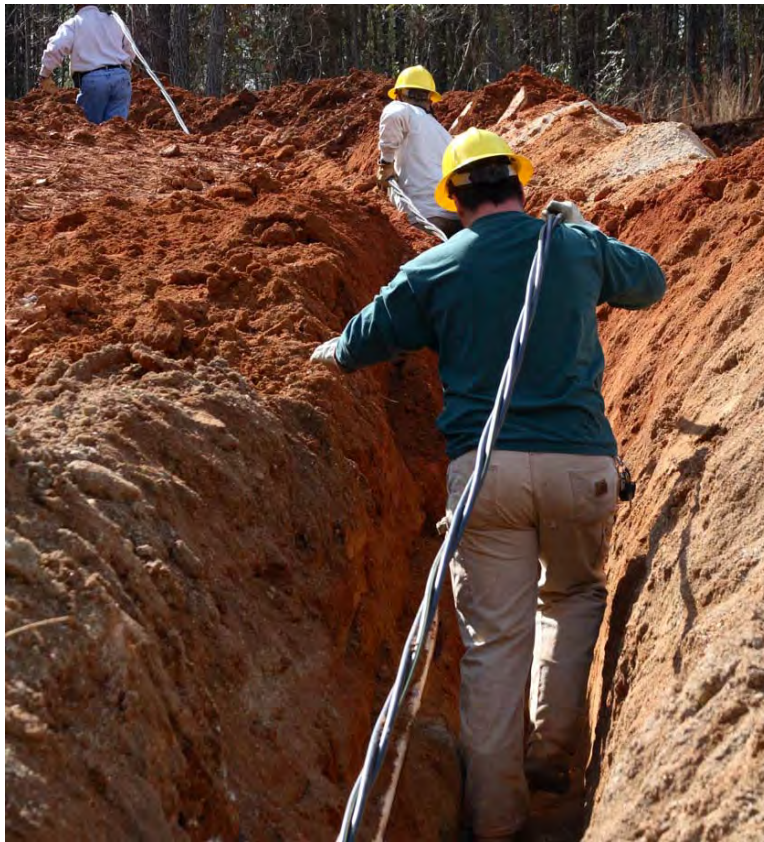
Figure B-2-Installing direct buried cable. (Photo courtesy of Southwire)

Placing an electrical conductor underground is a much more complex and costly undertaking. First of all, an un-insulated bare conductor cannot be placed underground. While overhead conductors are placed many feet apart from each other and located high above the ground, underground conductors are placed very close together and within a few inches of surrounding earth. It is common in some areas to directly bury conductors. In direct burial, a narrow trench is dug, sometimes only large enough to place the conductor in, and soil is placed directly around it. A direct bury installation is shown in Figure B-2.

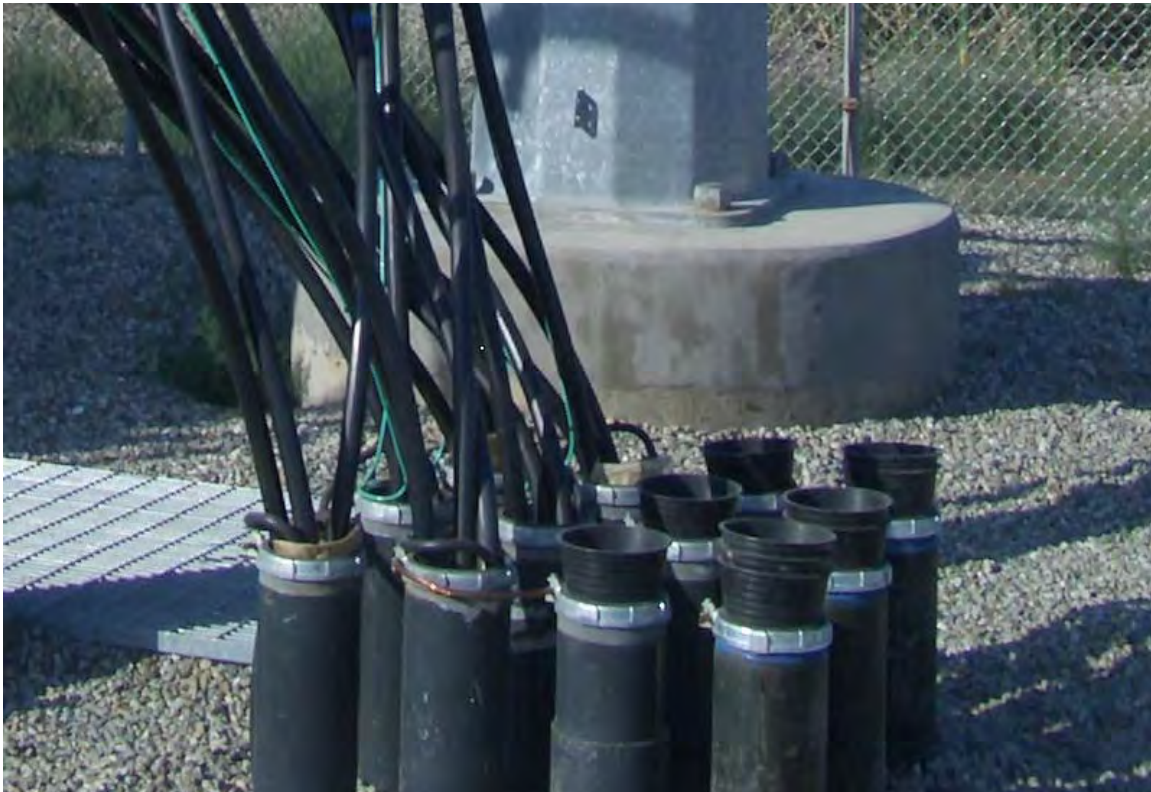
Figure B-3 – Typical underground conduit and cable. (Photo by NEI)

Another common construction is to bury a pipe (conduit) in the earth and install the electrical conductors inside this pipe. The pipe provides some protection for the conductors and makes future replacement easier than would be possible with the direct burial method. In both cases, since the conductor may be directly in contact with the earth, or directly in contact with a pipe, it cannot be merely a bare conductor (as in the case of overhead conductors). It must instead be covered in some type of insulation. The metal conductor and the various layers of insulation and shields which are necessary constitute an electrical cable. In the case of direct buried cable, the central metal current carrying part of the underground cable may be only an inch or so (the thickness of the insulation) away from surrounding earth. In the case of cables installed in pipe, the metal part of the conductor may only be a slightly further from surrounding earth (the additional distance caused by the thickness of the pipe wall). A typical installation of underground cable in conduit is shown in Figure B-3.

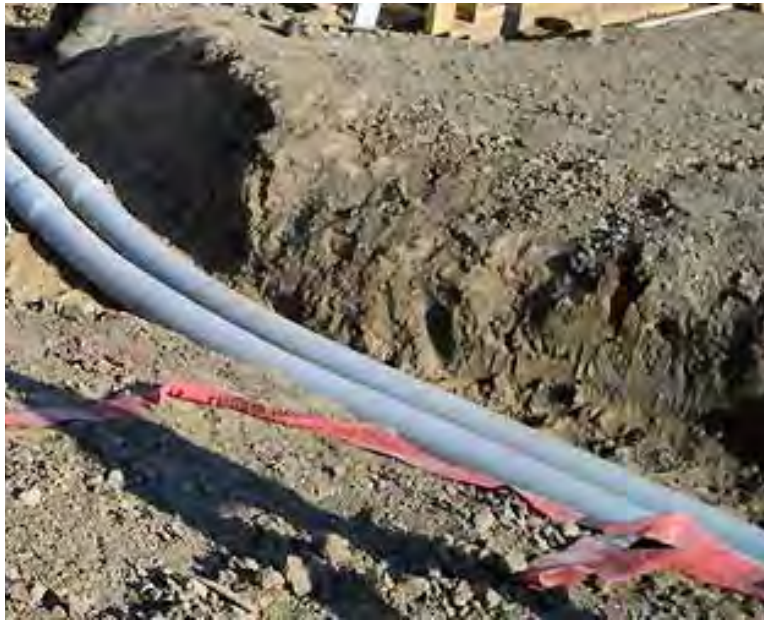
Figure B-5 - Conduit and Trench for Underground Distribution
(Photo by NEI-Grand Prairie, Alberta)

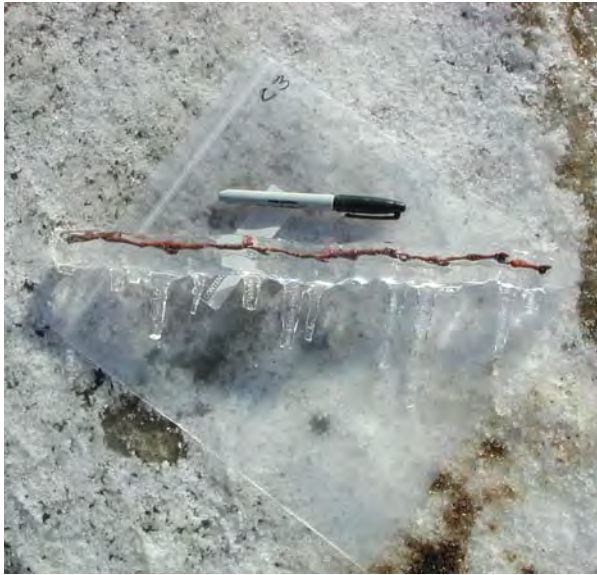
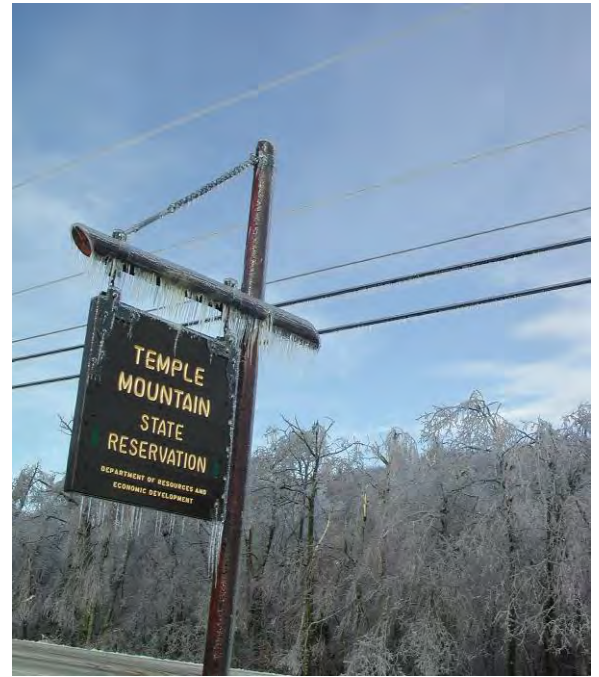
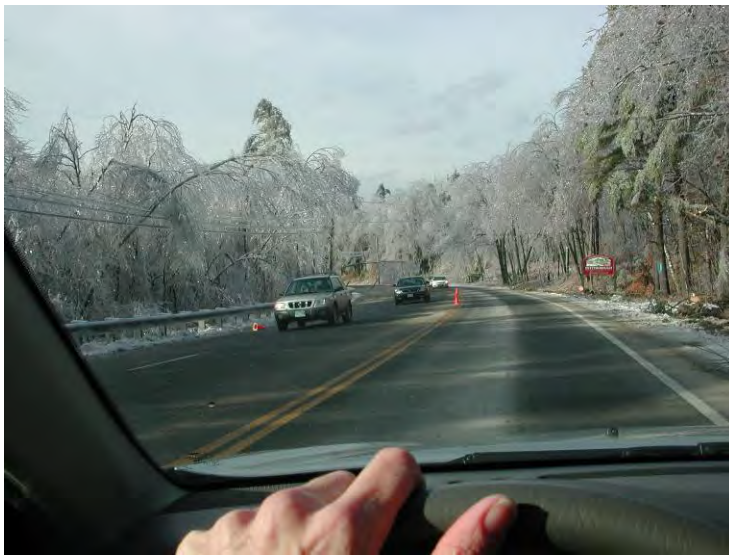
Figure D-6 - CRREL Ice Storm Team Site 9:

- a) Ice sample with $R_{eq} = 14$ mm
- b) Icicle covered Temple Mountain sign and wires, with ice-covered trees in the background
- c) Route 101 headed toward Peterborough; wires sagging, trees on wires, and broken pole in road.

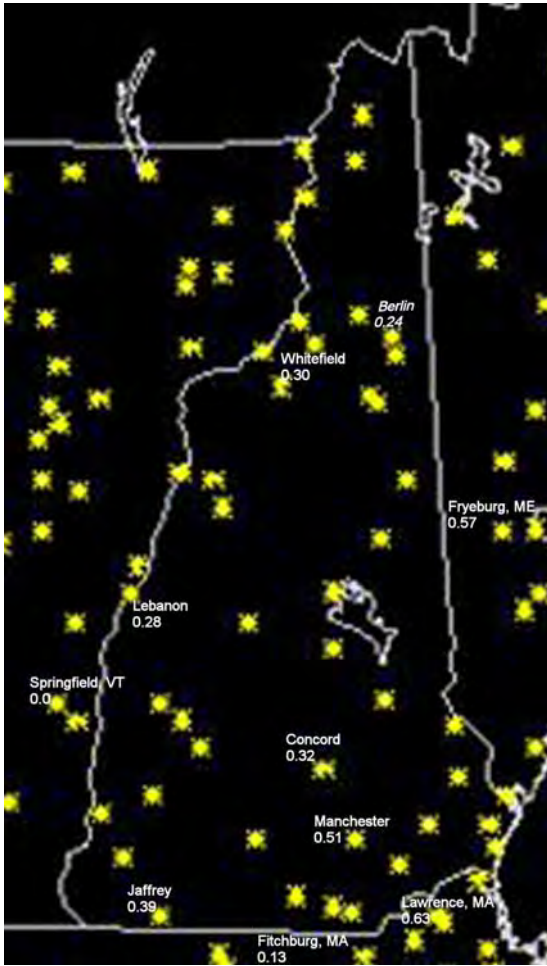
Figure F-5-Weather stations in New Hampshire and the surrounding area and equivalent radial glaze ice in inches.

Figure F-5 shows the locations of the weather stations in New Hampshire and nearby. All the stations shown below are automated and all are able to record precipitation levels. However not all the stations shown are capable of recording all of the types of data needed to compute equivalent radial glaze ice using the CREEL model. Only those stations which are labeled in Figure F-5 record all the parameters needed for this computation. There are six labeled stations shown in New Hampshire, one in Maine, two in Massachusetts, and one in Vermont. The values below these stations are the equivalent radial glaze ice in inches as reported in the CREEL report.²⁴ Not all the stations shown reported complete data. Some data was missing for Fitchburg, MA, Lawrence, MA, and Jaffrey, NH and the values shown should be considered lower limits of ice. Only the station at Manchester has automated data augmented with human observations. Figure F-6 shows the footprint of the area where damage was reported due to ice. Both maps below were developed by CREEL.
