SUBJECT: Report of Investigation of August 10, 2015 Electric Fatality
Benton, New Hampshire

Safety Division Findings of the August 10, 2015
Electrical Contact and Fatality with a New England Power/
National Grid 230 kV Transmission Line in Benton, NH

Safety Division Staff Final Report

May 12, 2017

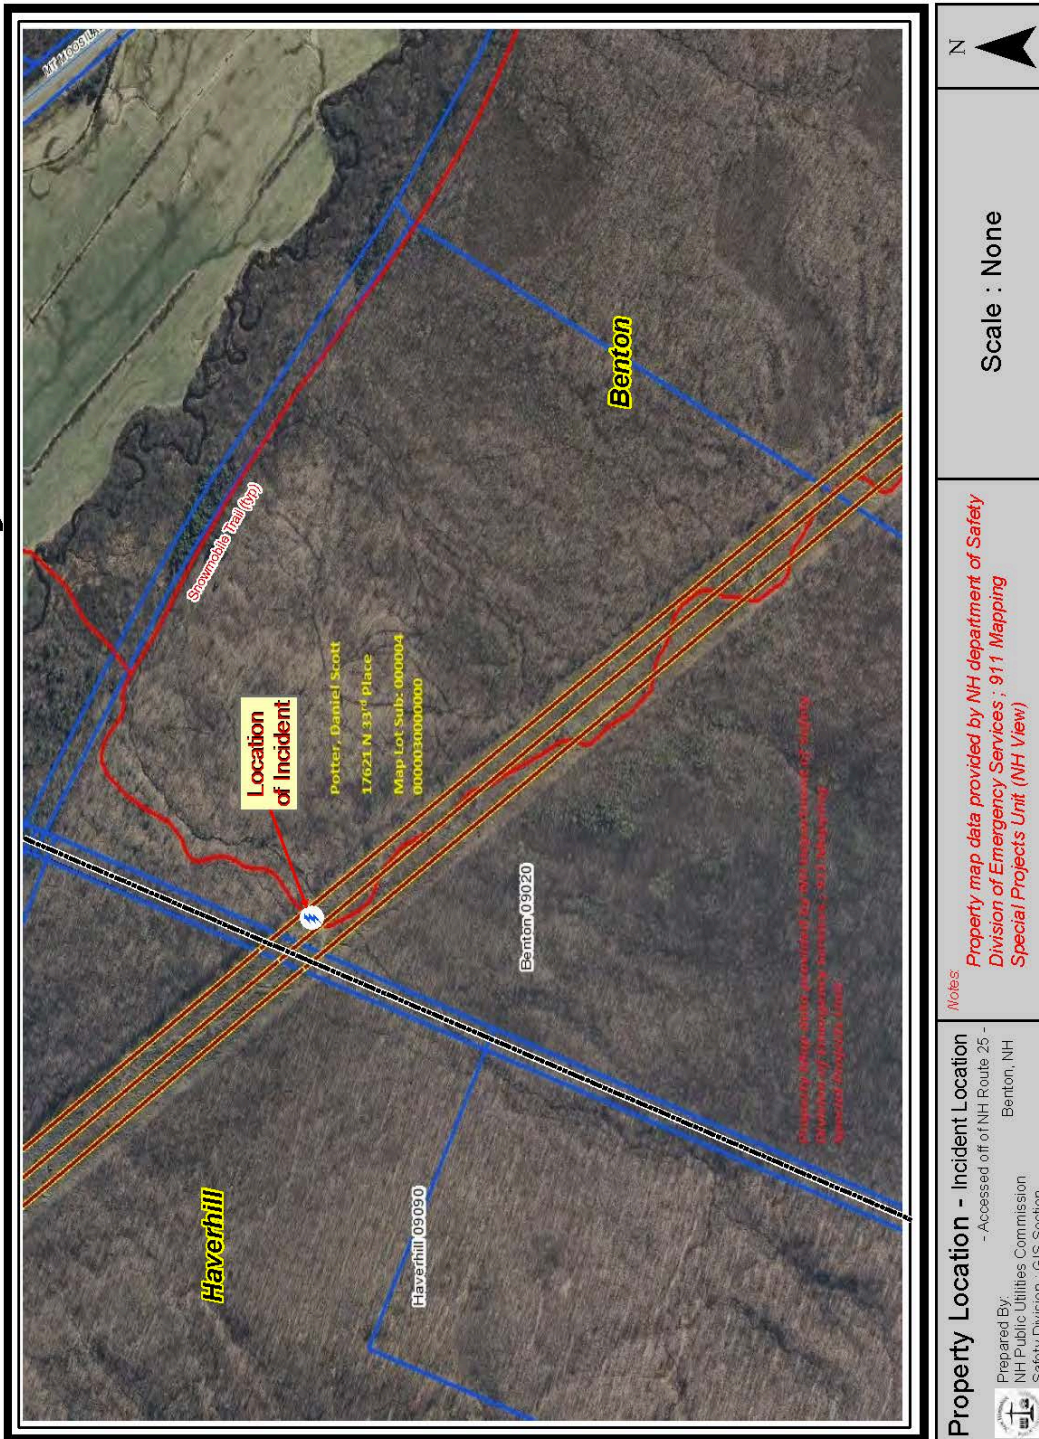
Attachment 1

Property Location - Incident Location - Accessed off of NH Route 25 - Benton, NH	Scale : None	Notes Property map data provided by NH Department of Safety Division of Emergency Services ; 911 Mapping Special Projects Unit (NH View)
Prepared By: NH Public Utilities Commission Safety Division, GIS Section

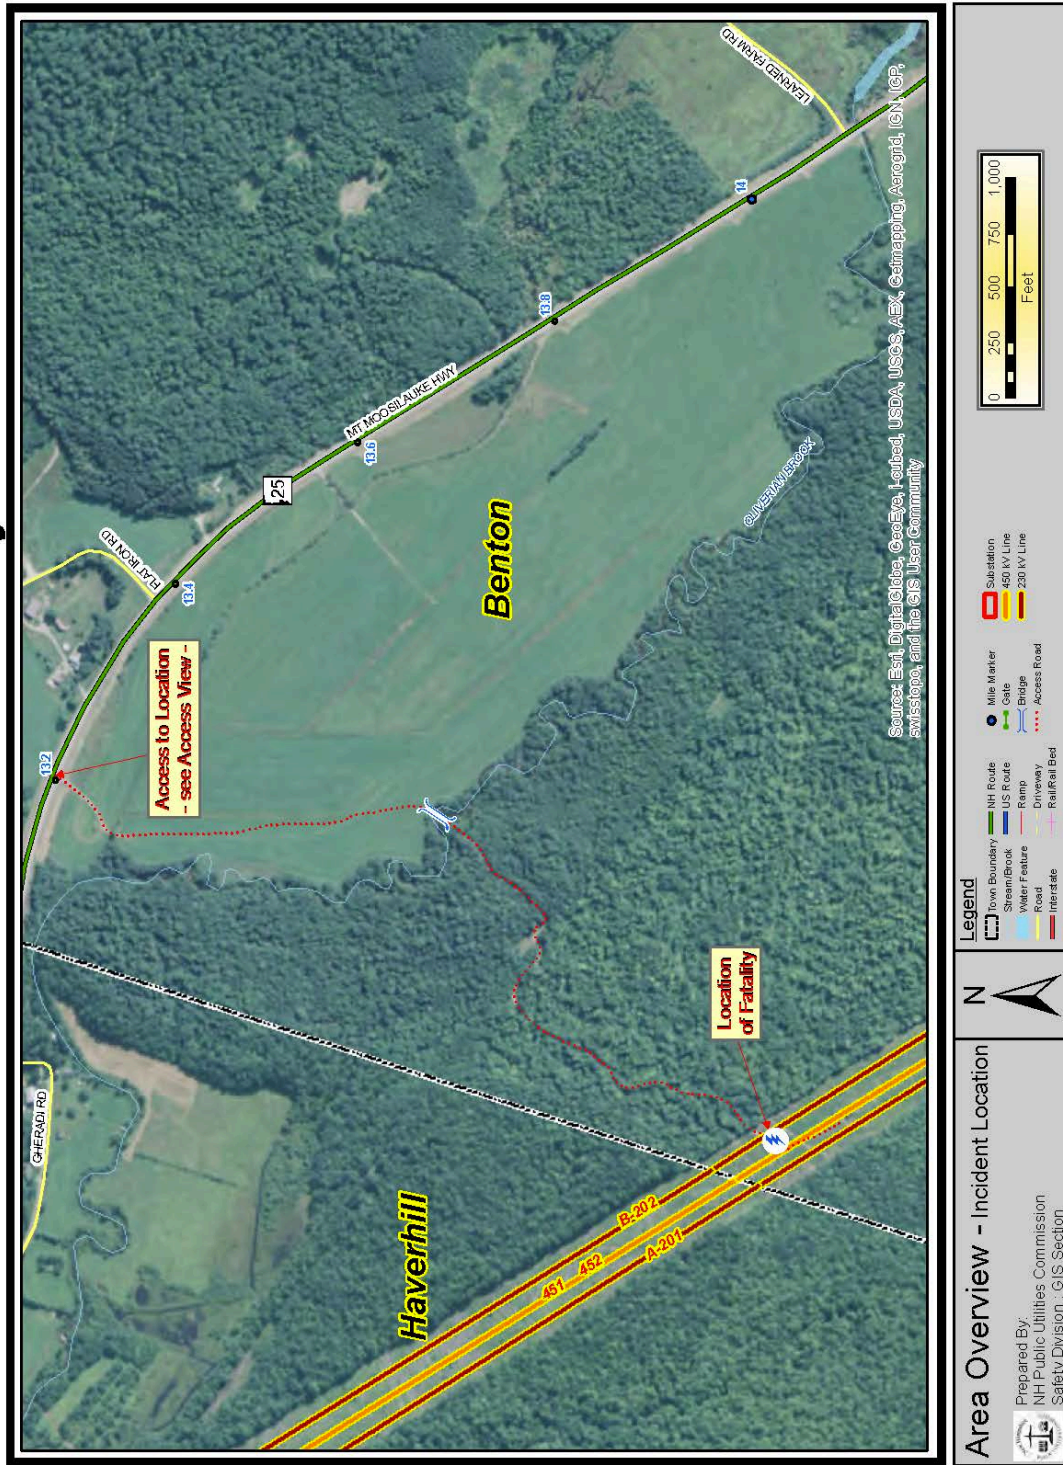
Attachment 2

Area Overview - Incident Location

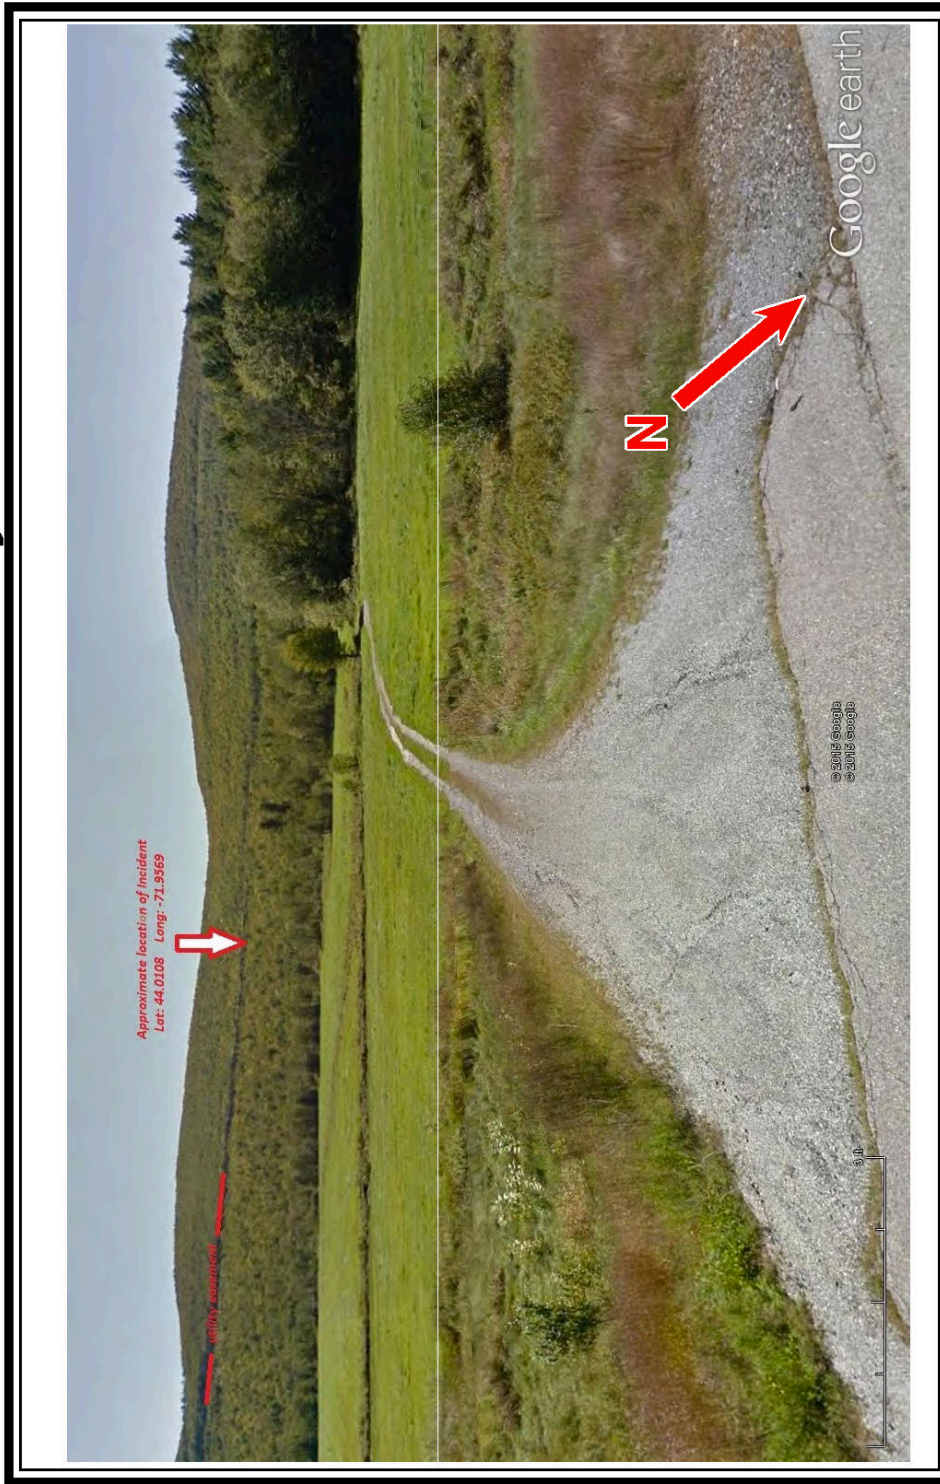
Attachment 3

Notes	
Access View	Incident Location
Prepared By: NH Public Utilities Commission Safety Division, GIS Section	- Access off of NH Route 25 - Benton, NH
