LIBERTY UTILITIES BARE STEEL REPLACEMENT PROGRAM

2009-2020

Prepared by the New Hampshire Public Utilities Commission
Safety Division

2020 Bare Steel Replacement Reports

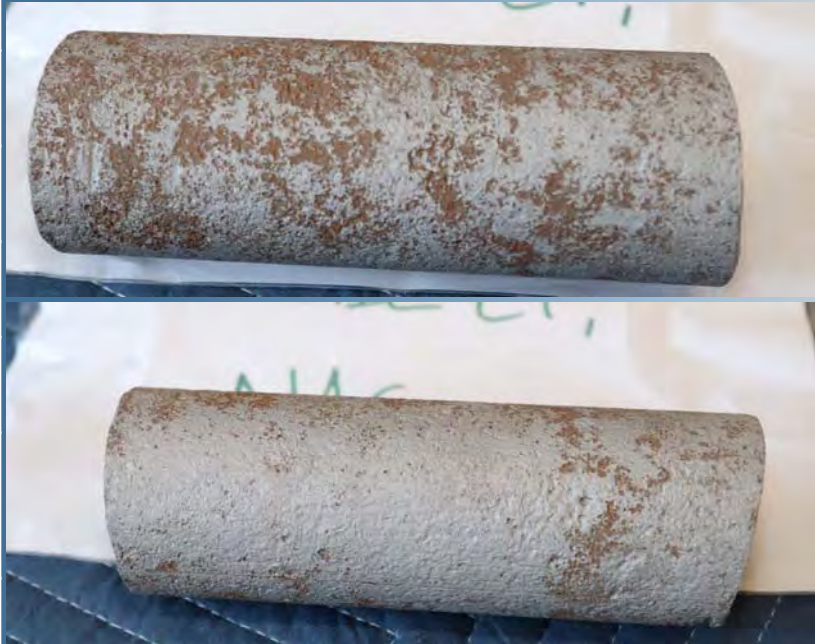
FY 2020

Address	Salvail Ct & Canal St
Town	Nashua
Pipe Size	2"
Install Date	1928
Wall Thickness	0.154"
Age	91
Pressure	12 in water column
Ground PH	7.6
Pipe Condition	10-20% wall loss/ light corrosion

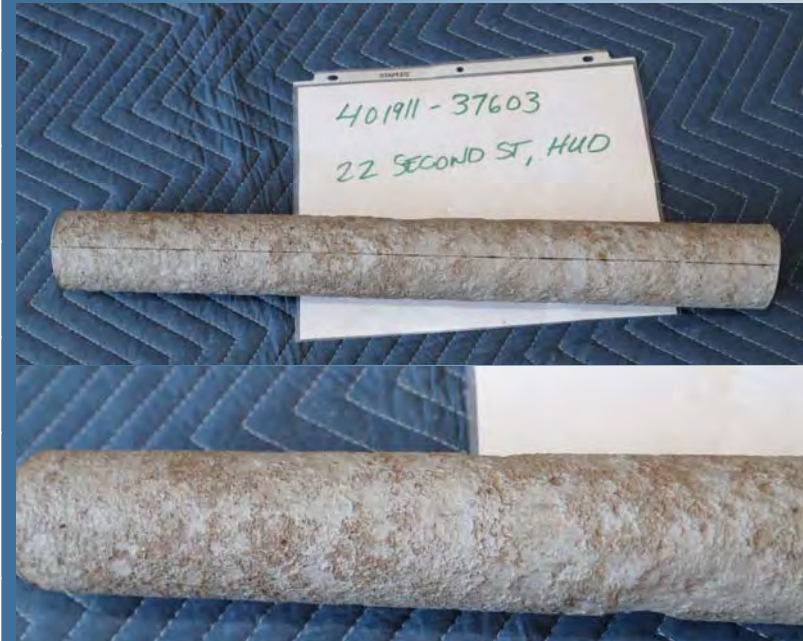
FY 2020

Address	Second St & Oakwood St
Town	Hudson
Pipe Size	2"
Install Date	1949
Wall Thickness	0.154"
Age	70
Pressure	12 in water column
Ground PH	7
Pipe Condition	Heavy corrosion/50% wall loss/ open seam

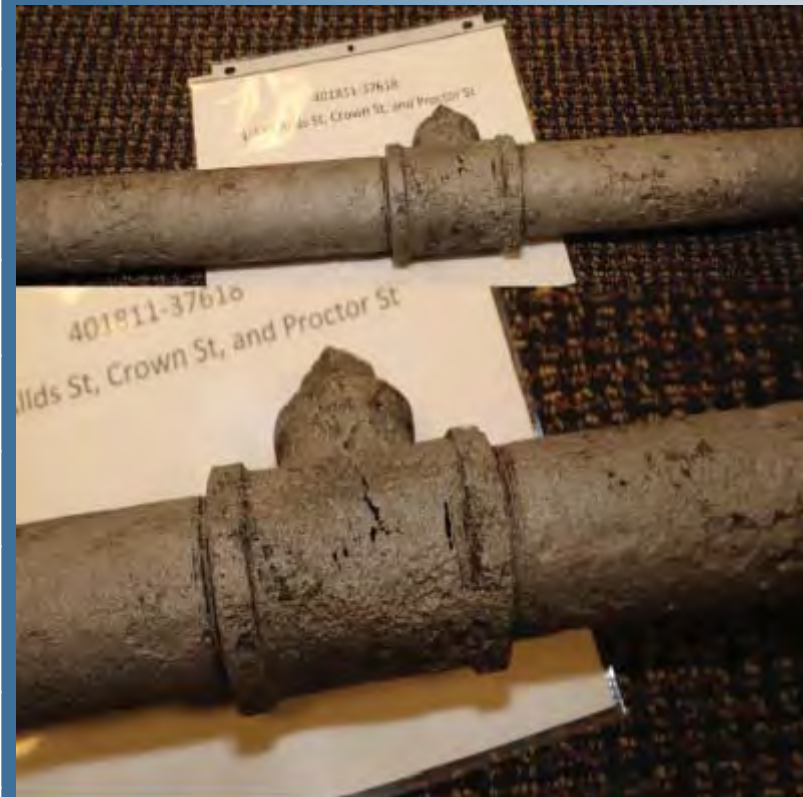
FY 2019

Address	1-132 Allds St Mulvaney St sample
Town	Nashua
Pipe Size	2"
Install Date	1940
Wall Thickness	0.154"
Age	78
Pressure	12 in water column
Ground PH	6
Pipe Condition	100 % wall loss in areas

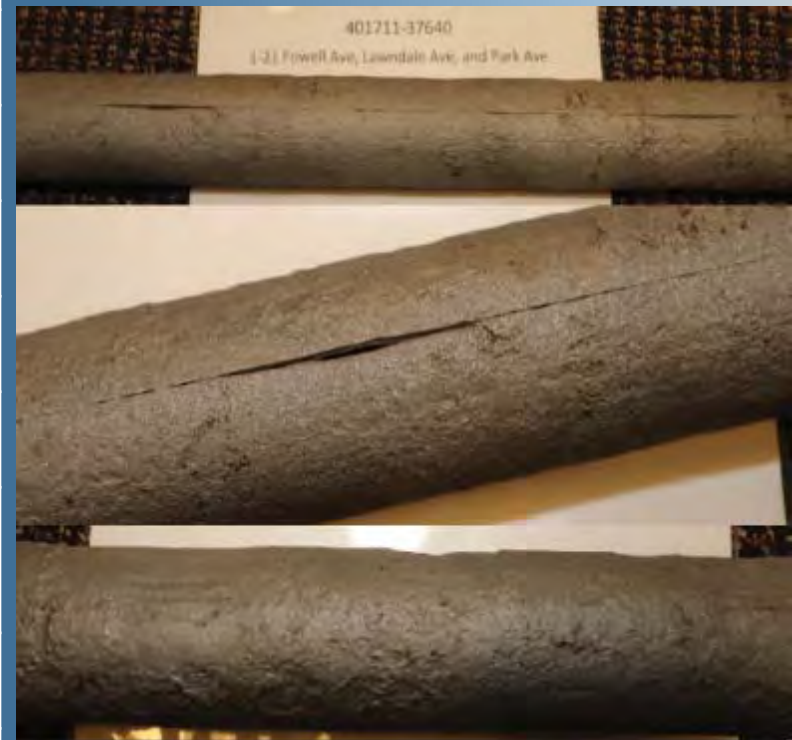
FY 2019

Address	1-21 Fowell Ave
Town	Nashua
Pipe Size	2"
Install Date	1924
Wall Thickness	0.154"
Age	94
Pressure	12 in water column
Ground PH	7
Pipe Condition	30-50% wall loss in pits

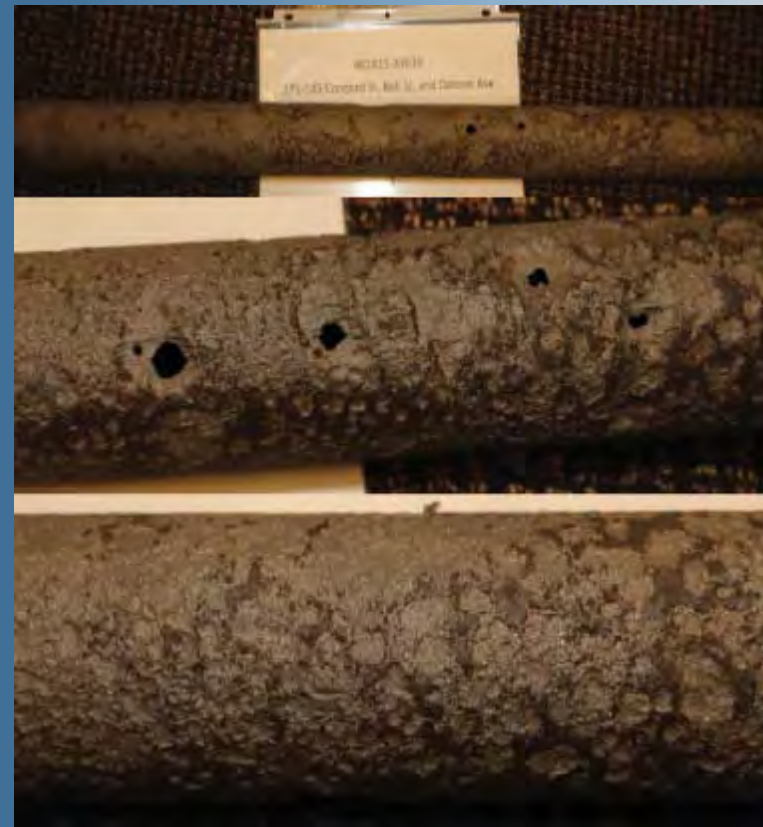
FY 2019

Address	171-185 Concord St Damon Ave sample
Town	Nashua
Pipe Size	2"
Install Date	1954
Wall Thickness	0.154"
Age	64
Pressure	12 in water column
Ground PH	7
Pipe Condition	100% wall loss in pits

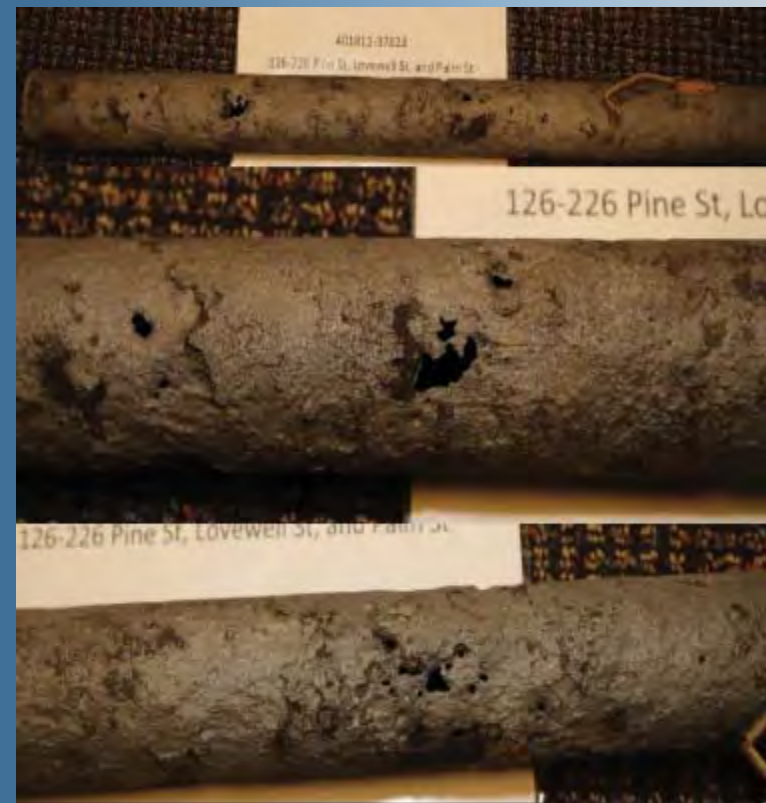
FY 2019

Address	126-226 Pine St Lovell St sample
Town	Nashua
Pipe Size	2"
Install Date	1957
Wall Thickness	0.154"
Age	61
Pressure	12 in water column
Ground PH	6
Pipe Condition	100% wall loss in pits

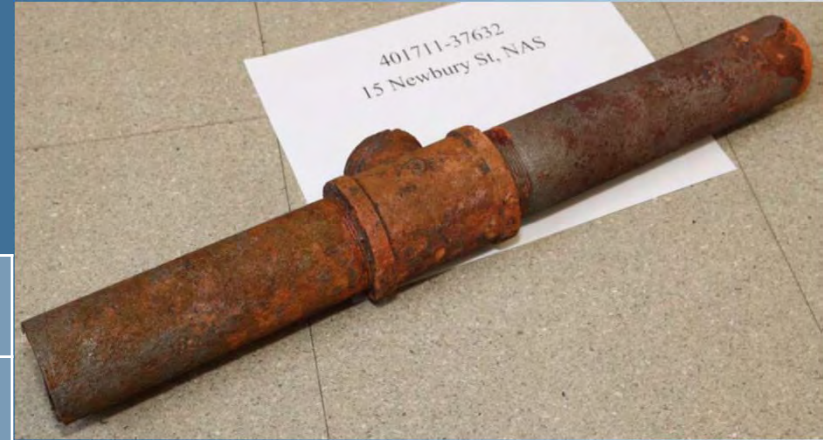
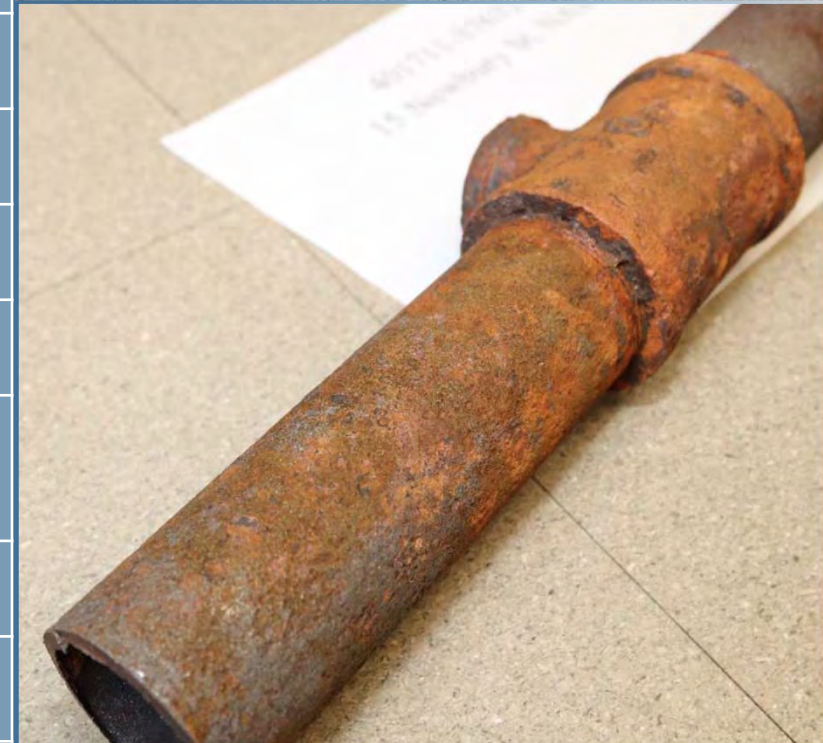
FY 2018

Address	5-67 Williams St
Town	Nashua
Pipe Size	2"
Install Date	1940
Wall Thickness	0.154"
Age	77
Pressure	12 in water column
Ground PH	7.5
Pipe Condition	30% wall loss in pits

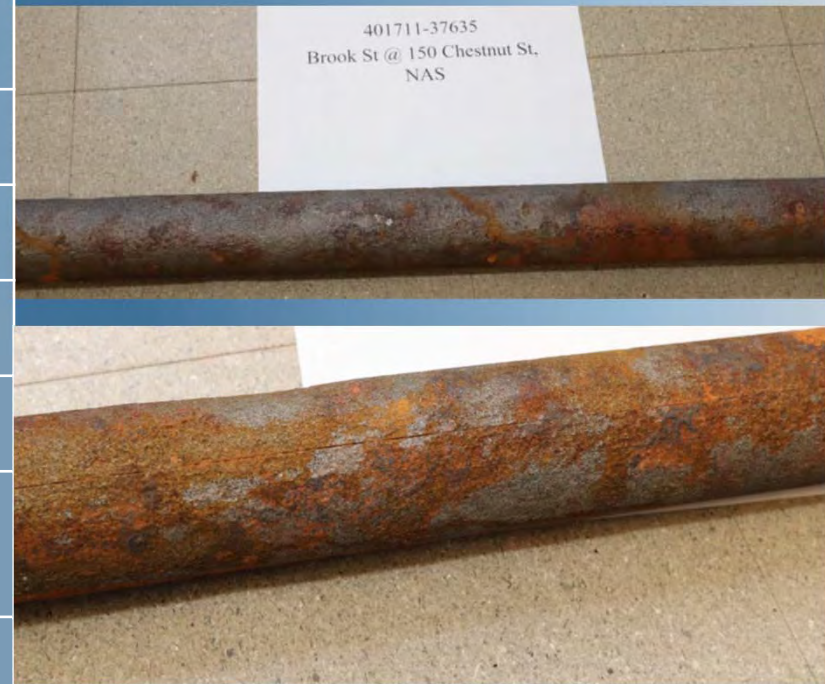
FY 2018

Address	14-38 Brook St
Town	Nashua
Pipe Size	2"
Install Date	1924
Wall Thickness	0.154"
Age	93
Pressure	12 in water column
Ground PH	7
Pipe Condition	25-50% wall loss in pits

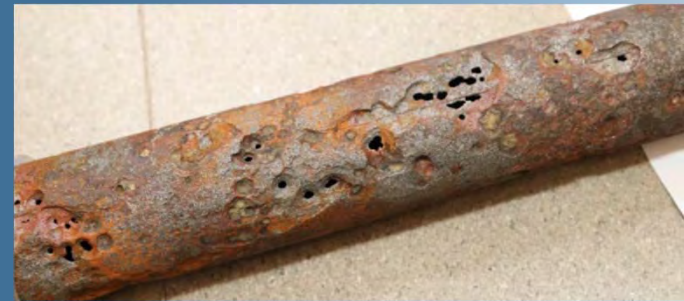
FY 2018

Address	4-26 Nutt St
Town	Nashua
Pipe Size	2"
Install Date	1924
Wall Thickness	0.154"
Age	93
Pressure	12 in water column
Ground PH	6
Pipe Condition	100% wall loss in pits Heavy Corrosion

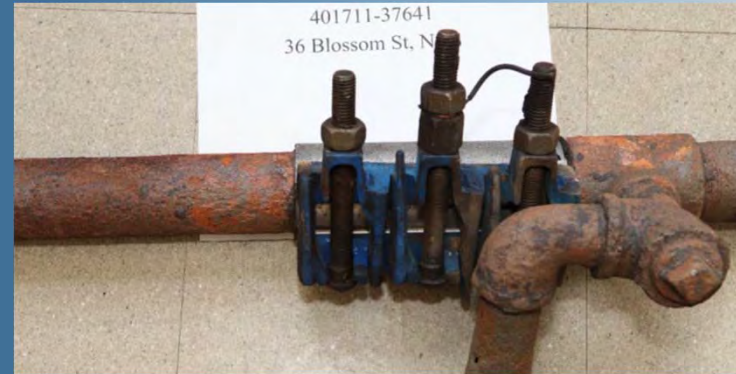
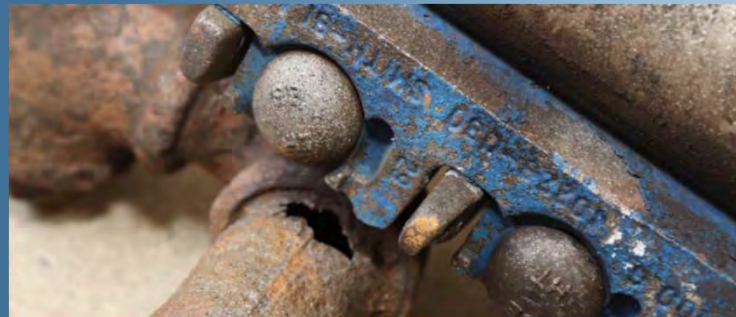
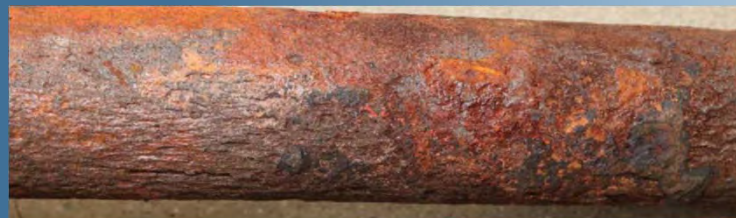
FY 2018

Address	3-75 Blossom St
Town	Nashua
Pipe Size	2"
Install Date	1915
Wall Thickness	0.154"
Age	102
Pressure	12 in water column
Ground PH	6
Pipe Condition	100% wall loss in pits Very Poor Condition

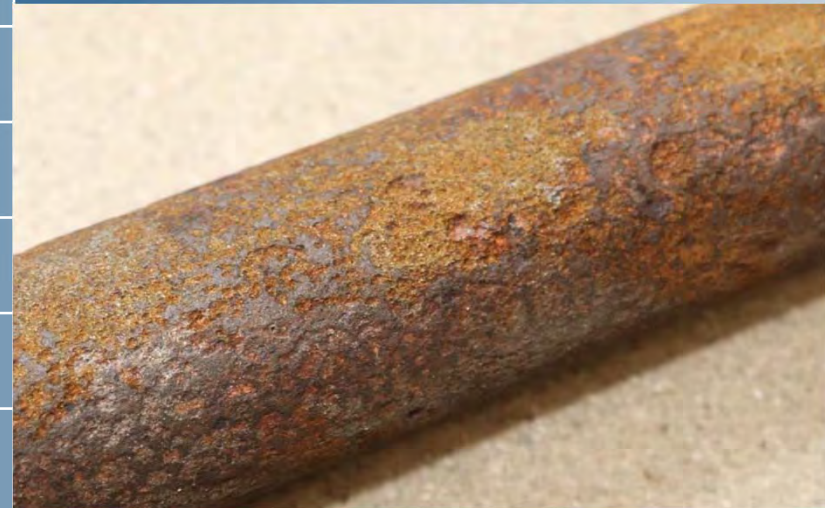
FY 2018

Address	28-36 Fifield St & Winnwood St
Town	Nashua
Pipe Size	2"
Install Date	1959
Wall Thickness	0.154"
Age	58
Pressure	12 in water column
Ground PH	7
Pipe Condition	30% wall loss in pits General Corrosion/Pitting

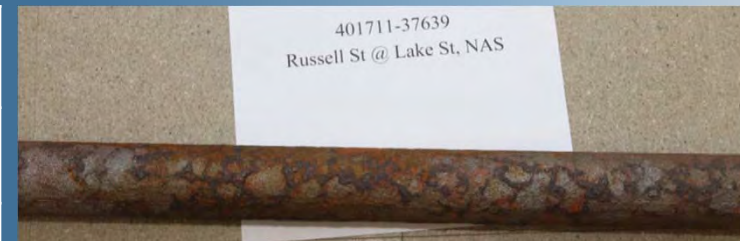
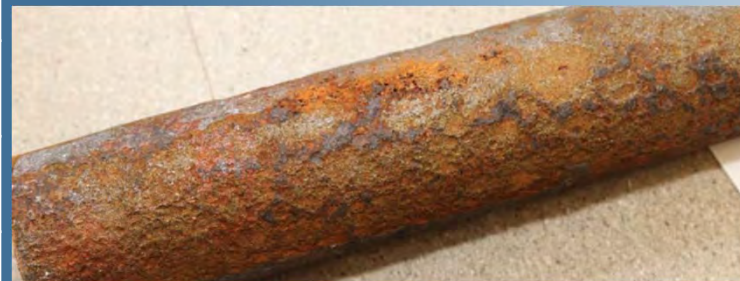
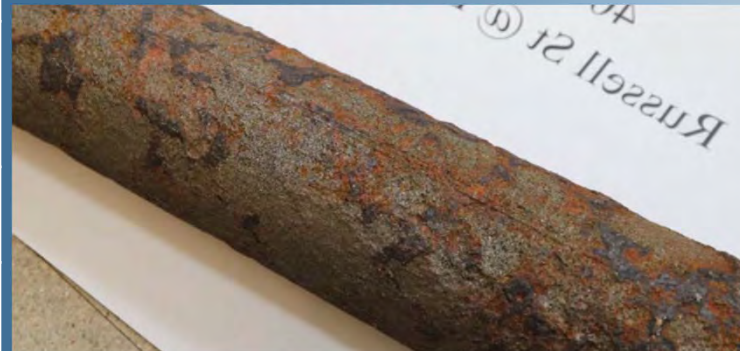
FY 2018

Address	75-235 Lake St
Town	Nashua
Pipe Size	2"
Install Date	1900
Wall Thickness	0.154"
Age	117
Pressure	12 in water column
Ground PH	7
Pipe Condition	30% wall loss in pits General Scaling/Pitting

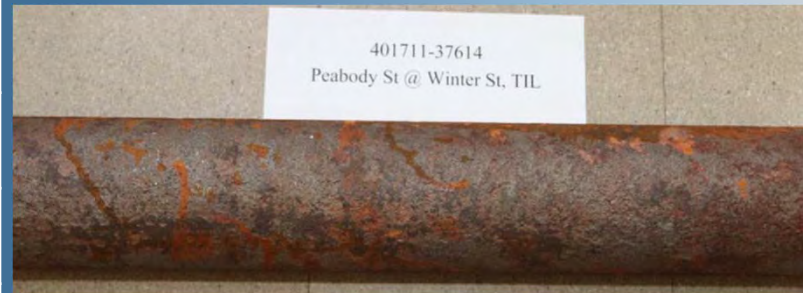
FY 2018

Address	4-22 Peabody St
Town	Tilton
Pipe Size	4"
Install Date	1931
Wall Thickness	0.237"
Age	86
Pressure	60 psig
Ground PH	7
Pipe Condition	20% wall loss in pits Light Corrosion/Pitting

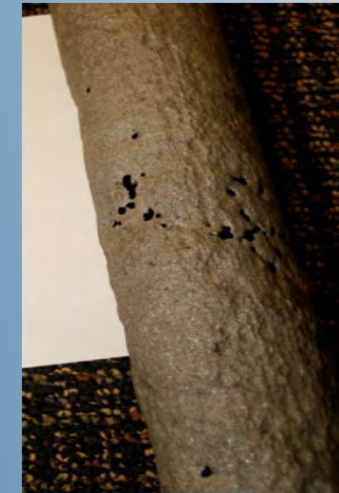
FY 2017

Address	2-15 Columbia Ave
Town	Nashua
Pipe Size	2"
Install Date	1915
Wall Thickness	0.188 in
Age	101
Pressure	12 in water column
Ground PH	6
Pipe Condition	100% Wall Loss/ Very Poor Condition

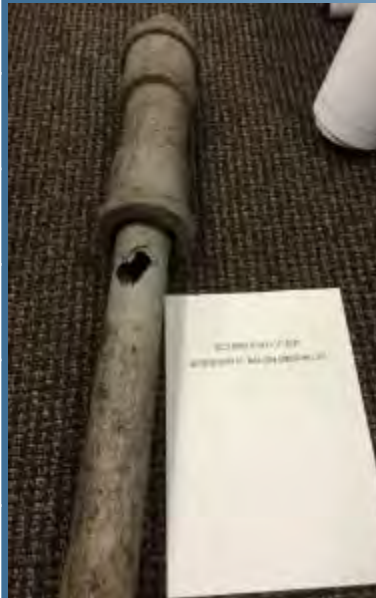
FY 2016

Address	48 Newbury St NAS (On Underhill St)
Town	Nashua
Pipe Size	2"
Install Date	Unknown
Wall Thickness	0.188 in
Age	Unknown
Pressure	12 in water column
Ground PH	6
Pipe Condition	100% Wall Loss/ Very Poor Condition

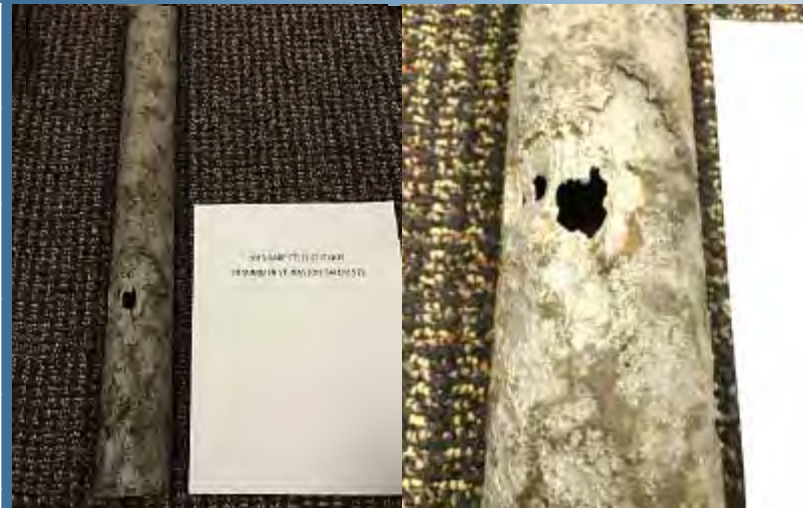
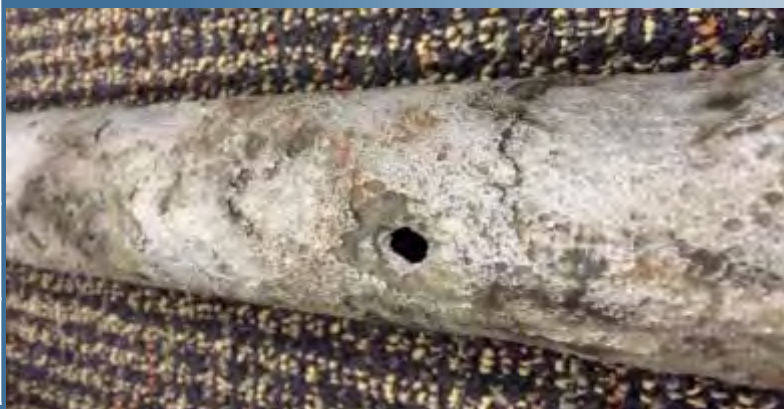
FY 2016

Address	49 Summer St (On Salem St)
Town	Nashua
Pipe Size	2"
Install Date	1924
Wall Thickness	0.218 in
Age	91
Pressure	12 in water column
Ground PH	6
Pipe Condition	100% Wall Loss/ Very Poor Condition

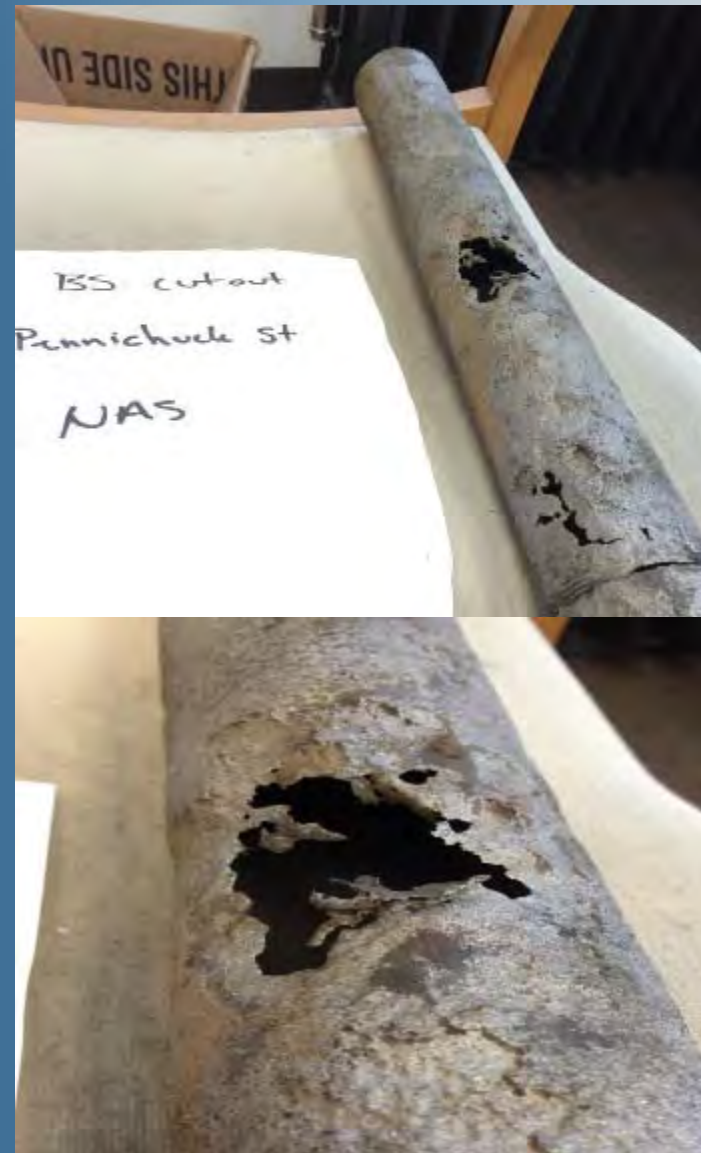
FY 2015

Address	Pennichuck St & Caron Ave
Town	Nashua
Pipe Size	2"
Install Date	1956/1960
Wall Thickness	0.143 in
Age	58
Pressure	12 in water column
Ground PH	6
Pipe Condition	100% Wall Loss/ Very Poor Condition

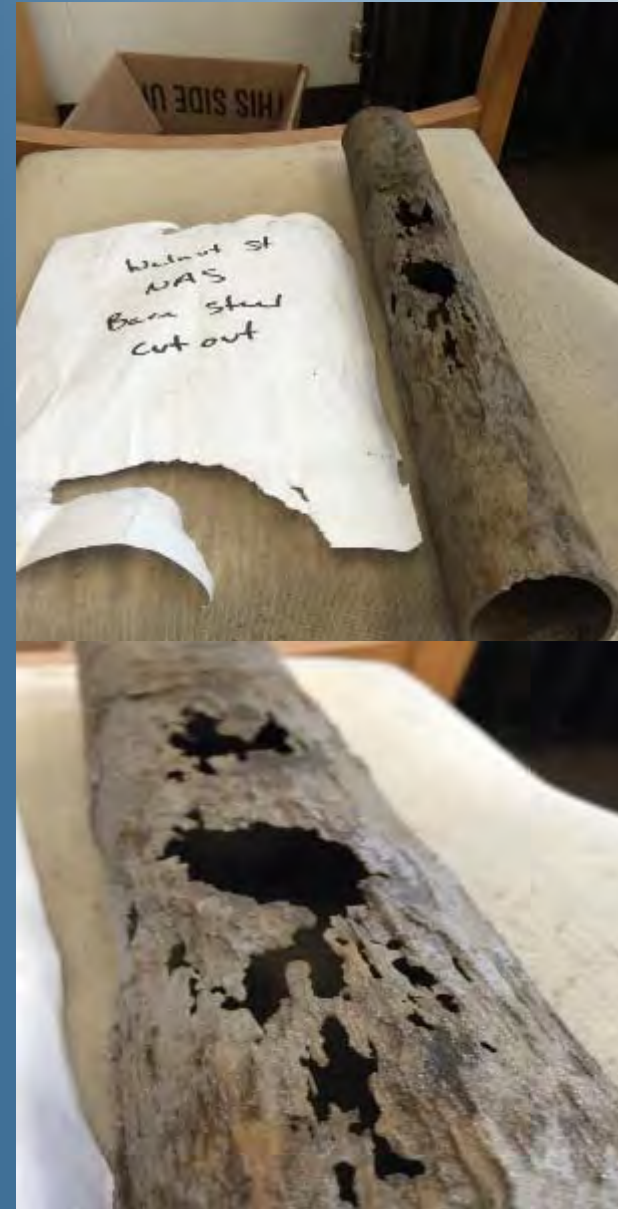
FY 2015

Address	93 Walnut St
Town	Nashua
Pipe Size	2"
Install Date	1913
Wall Thickness	0.160 in
Age	101
Pressure	12 in water column
Ground PH	6
Pipe Condition	100% Wall Loss/ Very Poor Condition

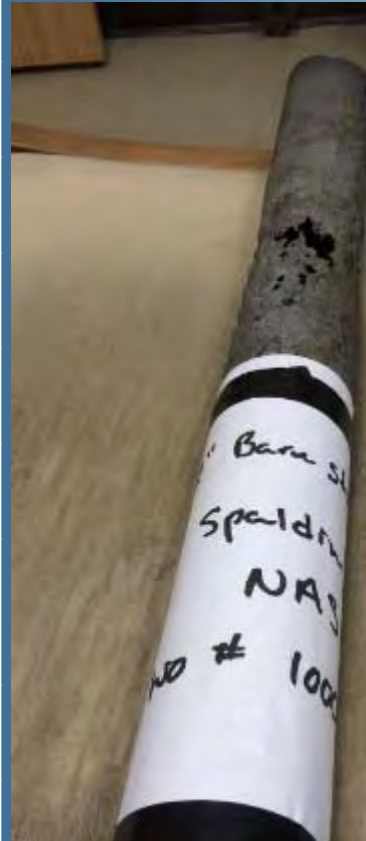
FY 2015

Address	57 Spaulding St
Town	Nashua
Pipe Size	2"
Install Date	1956
Wall Thickness	0.139 in
Age	58
Pressure	12 in water column
Ground PH	6
Pipe Condition	100% Wall Loss/ Very Poor Condition

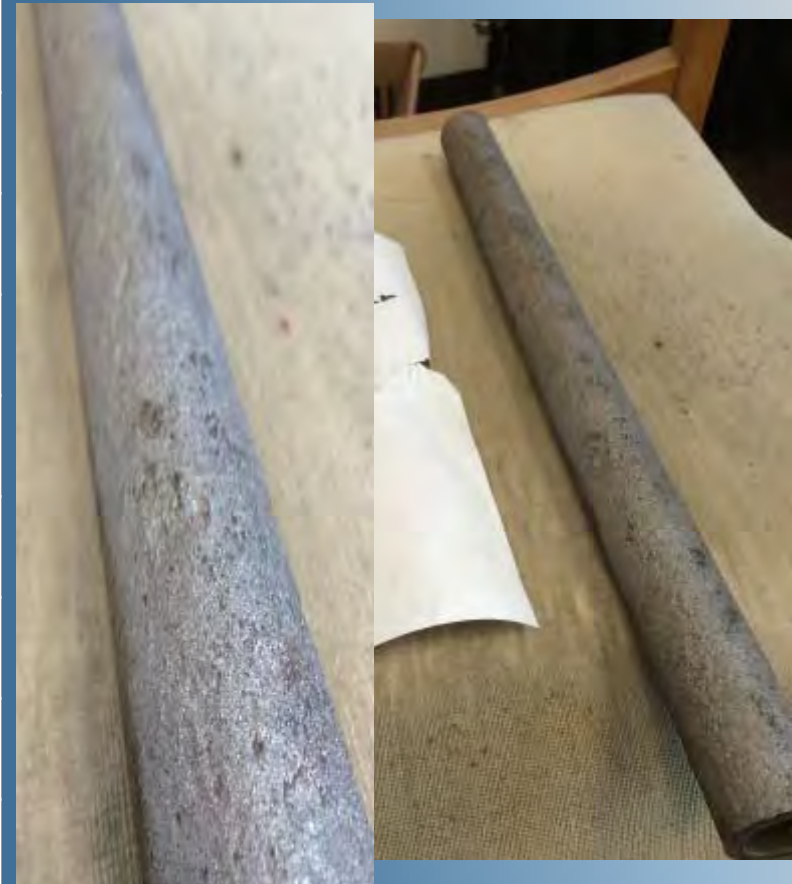
FY 2015

Address	95 Shaker Road (Shaker Rd School)
Town	Concord
Pipe Size	1"
Install Date	Unknown
Wall Thickness	0.133 in
Age	Unknown
Pressure	60 psig
Ground PH	6
Pipe Condition	27% Wall Loss/ Fair Condition

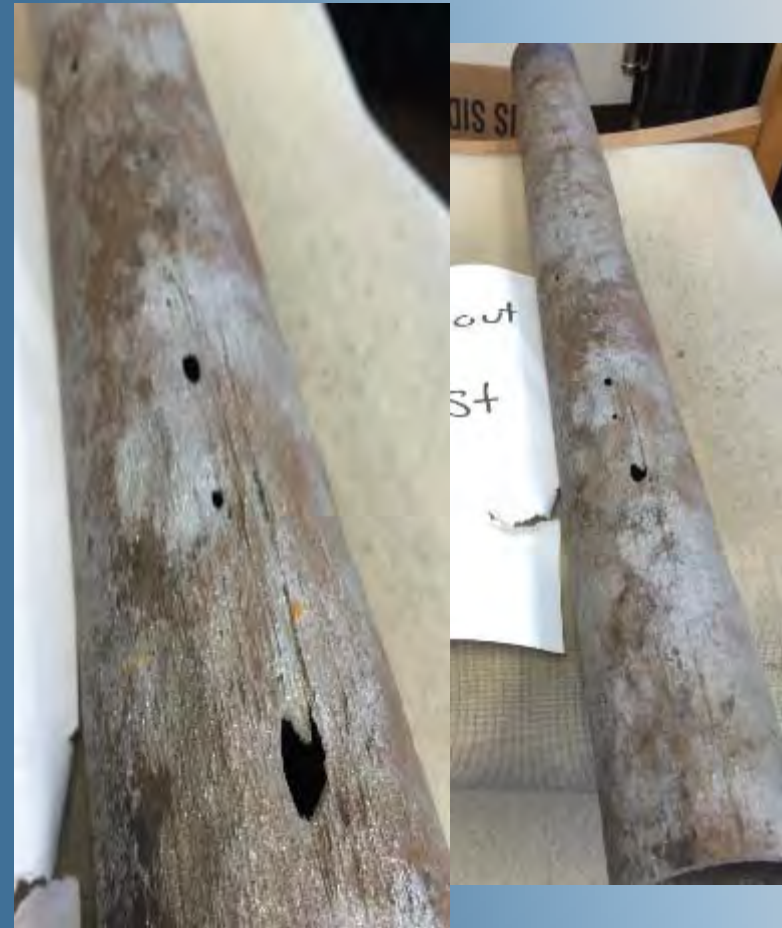
FY 2015

Address	249 Medford St
Town	Manchester
Pipe Size	2"
Install Date	1956/1960
Wall Thickness	0.160 in
Age	58
Pressure	60 psig
Ground PH	6
Pipe Condition	100% Wall Loss/ Very Poor Condition

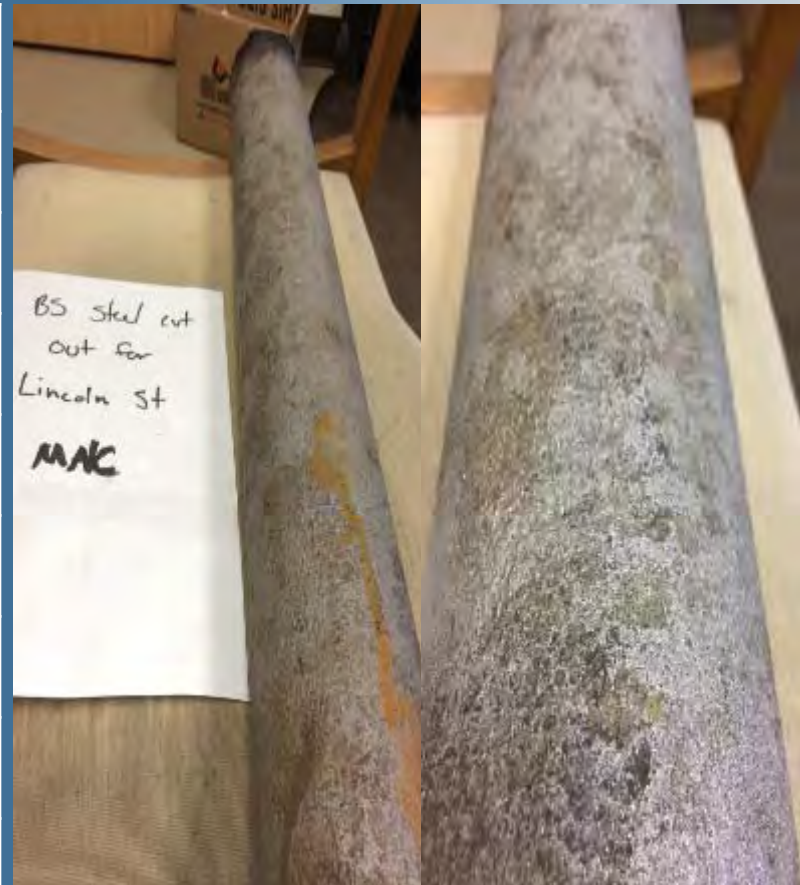
FY 2015

Address	348 Lincoln St
Town	Manchester
Pipe Size	3"
Install Date	1954
Wall Thickness	0.234 in
Age	60
Pressure	60 psig
Ground PH	6
Pipe Condition	12% Wall Loss/ Fair Condition

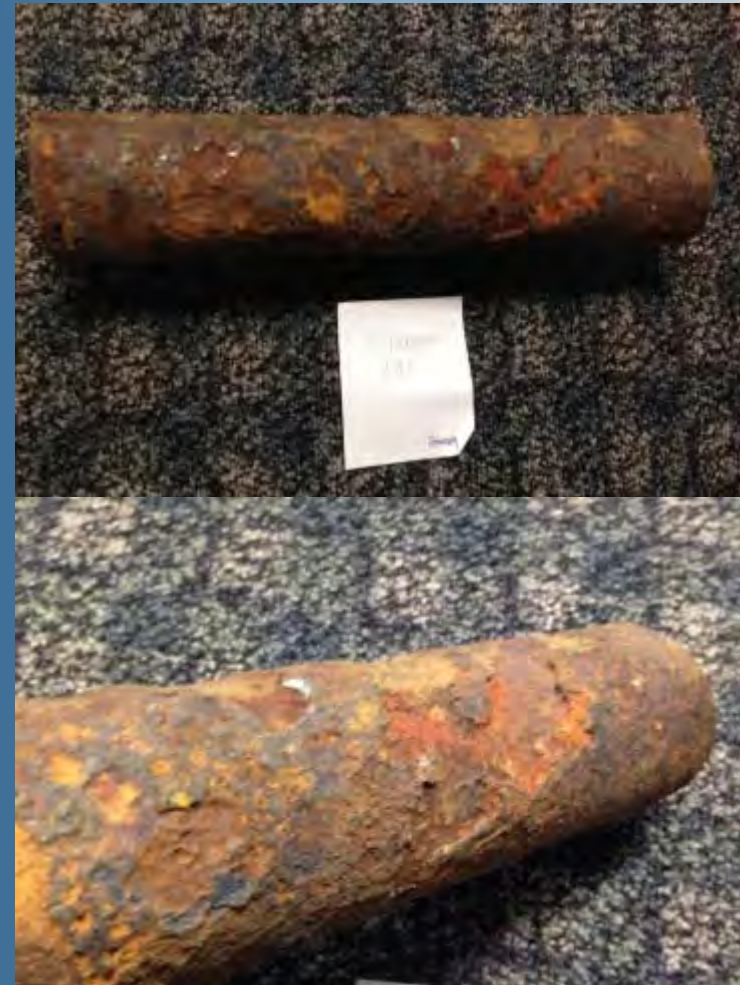
FY 2014

Address	1-34 Dickerman St
Town	Nashua
Pipe Size	2"
Install Date	1902/1925
Wall Thickness	0.154 in
Age	111
Pressure	12 in water column
Ground PH	7.5
Pipe Condition	90% Wall Loss/ Poor Condition

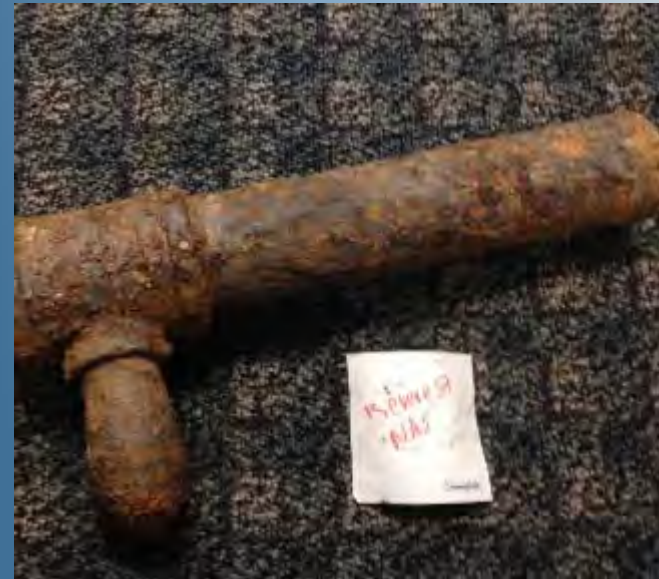
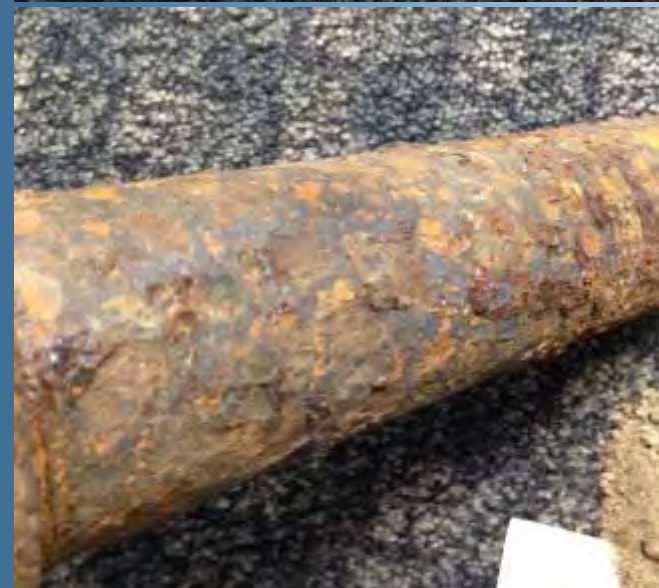
FY 2014

Address	1-44 Revere St & Fernwood St
Town	Nashua
Pipe Size	2"
Install Date	1902/1925
Wall Thickness	0.188 in
Age	111
Pressure	12 in water column
Ground PH	7
Pipe Condition	37% Wall Loss/ Moderate Condition

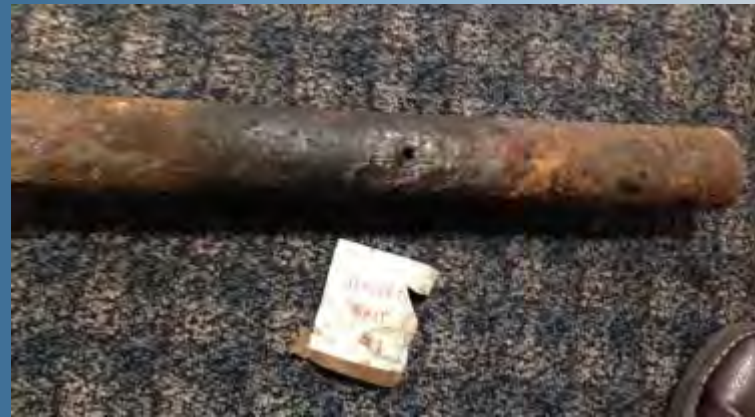
FY 2014

Address	17-28 Sunset Dr
Town	Belmont
Pipe Size	2"
Install Date	Unknown
Wall Thickness	0.188 in
Age	Unknown
Pressure	60 psig
Ground PH	6
Pipe Condition	100% Wall Loss/Very Poor Condition

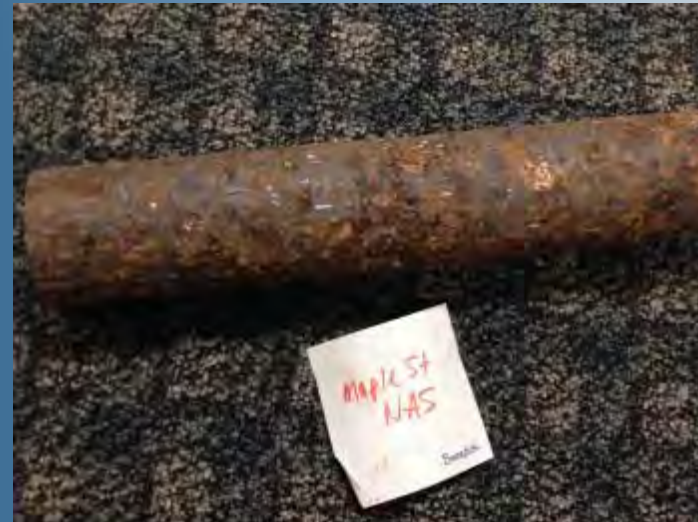
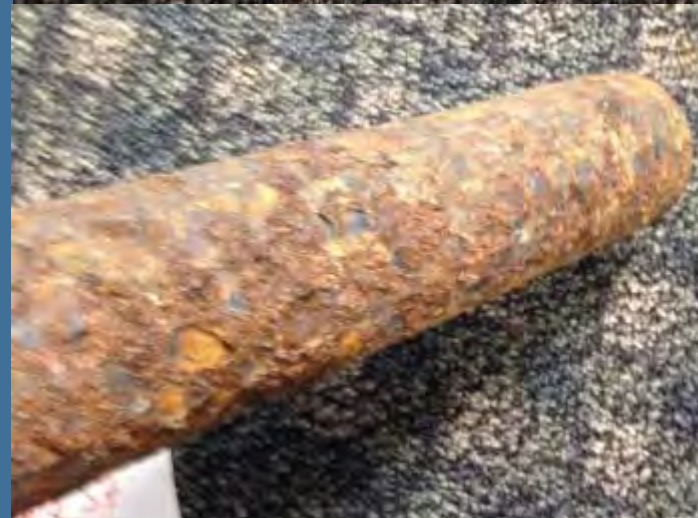
FY 2014

Address	8-18 Maple St
Town	Nashua
Pipe Size	2"
Install Date	1957
Wall Thickness	0.154 in
Age	56
Pressure	12 in water column
Ground PH	6.5
Pipe Condition	39% Wall Loss/Moderate Condition

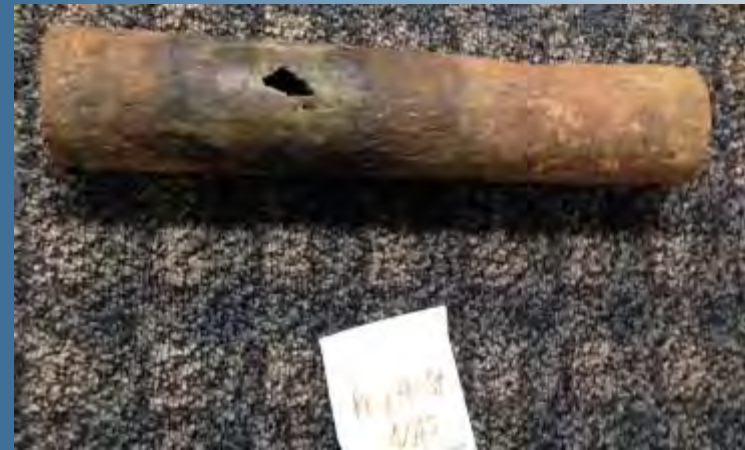
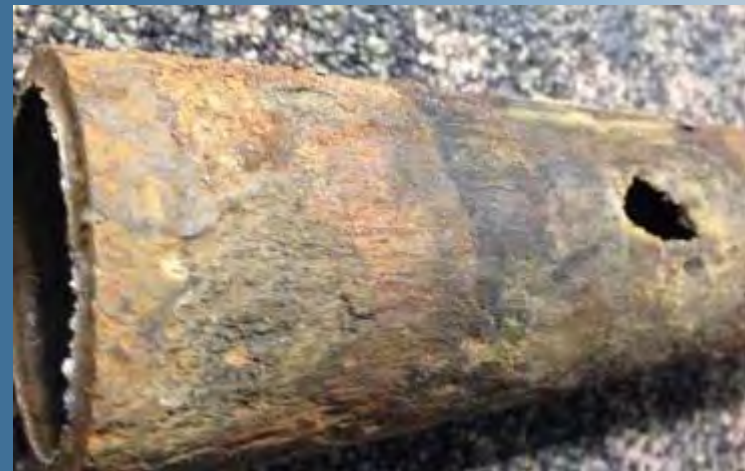
FY 2014

Address	3-25 Pratt St & Zellwood St
Town	Nashua
Pipe Size	2"
Install Date	1894/1914
Wall Thickness	0.188 in
Age	119
Pressure	60 psig
Ground PH	7
Pipe Condition	100% Wall Loss/ Very Poor Condition

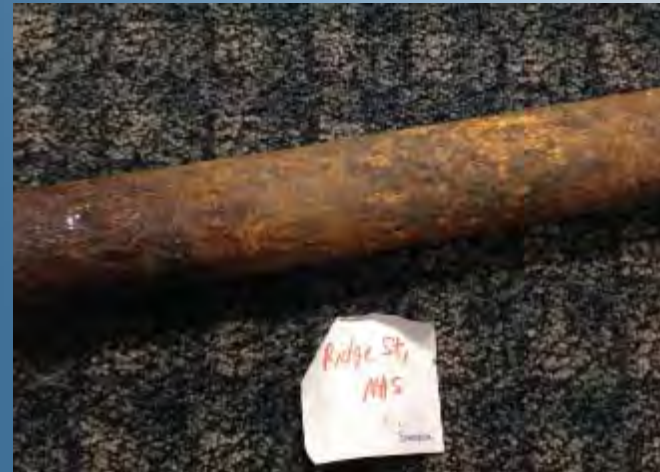
FY 2014

Address	5-21 Ridge St
Town	Nashua
Pipe Size	2"
Install Date	Unknown
Wall Thickness	0.154 in
Age	119
Pressure	12 in water column
Ground PH	6.5
Pipe Condition	39% Wall Loss/ Moderate Condition

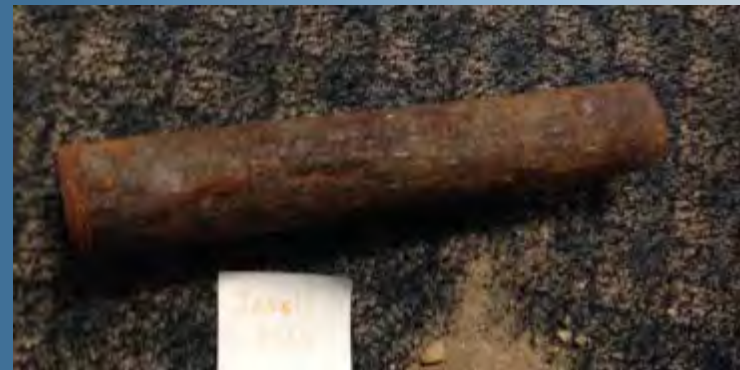
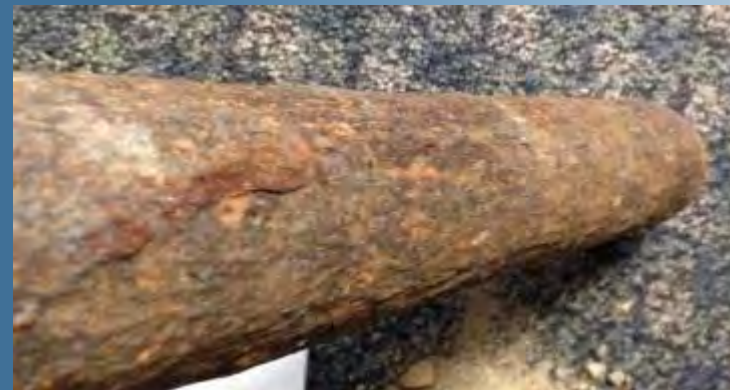
FY 2014

Address	1-6 Jewell Lane
Town	Nashua
Pipe Size	2"
Install Date	1947
Wall Thickness	0.154 in
Age	66
Pressure	12 in water column
Ground PH	7
Pipe Condition	32% Wall Loss/ Moderate Condition

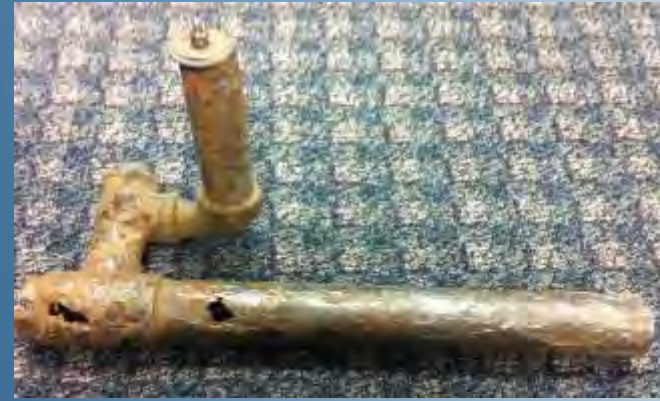
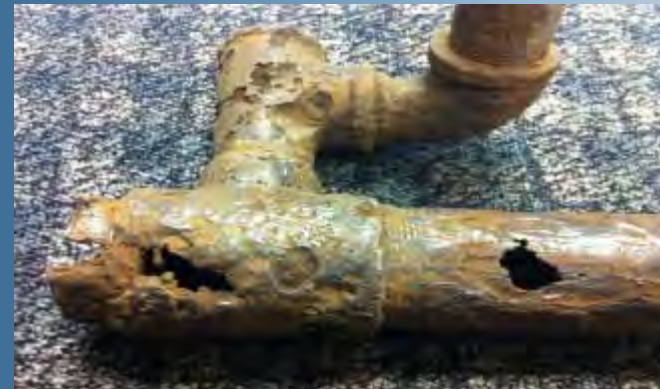
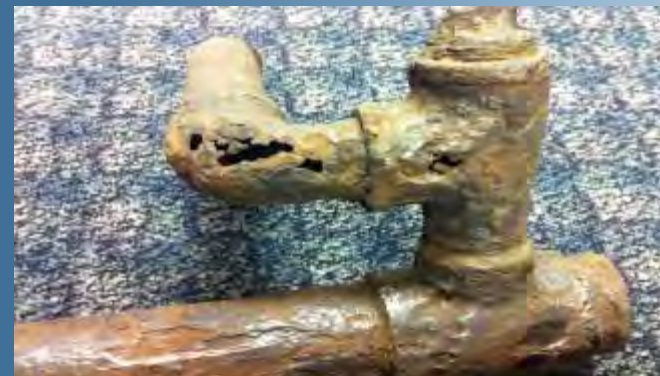
FY 2013

Address	5-19 Lemon St
Town	Nashua
Pipe Size	2"
Install Date	1902/1925
Wall Thickness	Unknown
Age	110
Pressure	12 in water column
Ground PH	6
Pipe Condition	100% Wall Loss/ Very Poor Condition

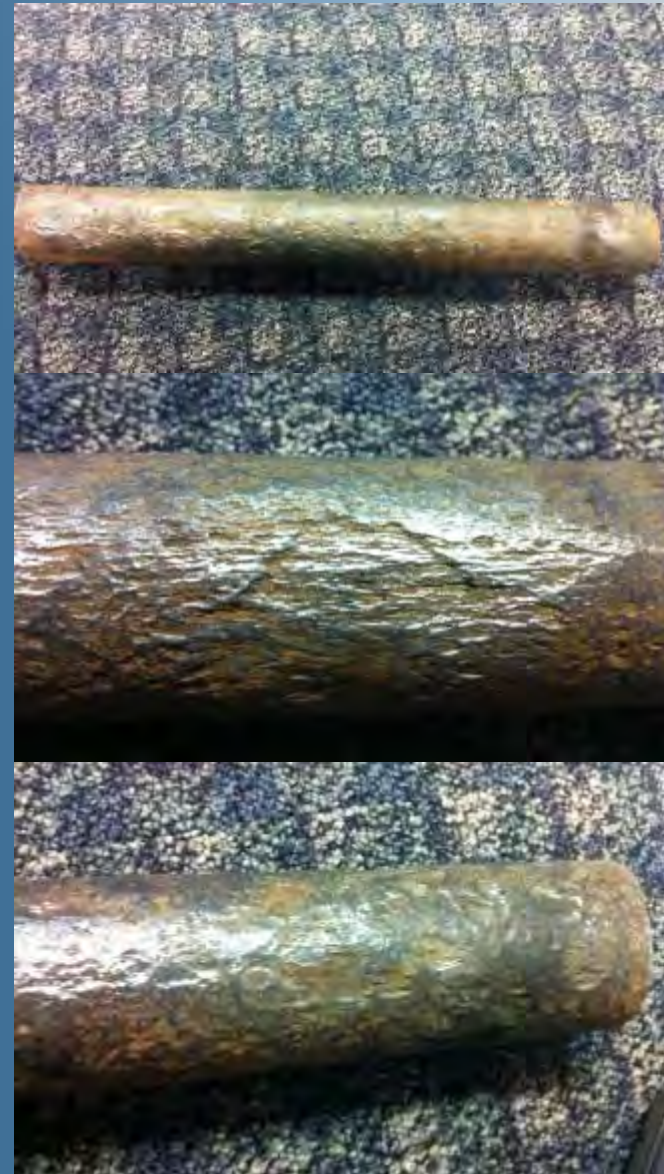
FY 2013

Address	2-13 Grove St
Town	Nashua
Pipe Size	2"
Install Date	1910
Wall Thickness	Unknown
Age	102
Pressure	12 in water column
Ground PH	7
Pipe Condition	Deep Pitting/ Poor Condition

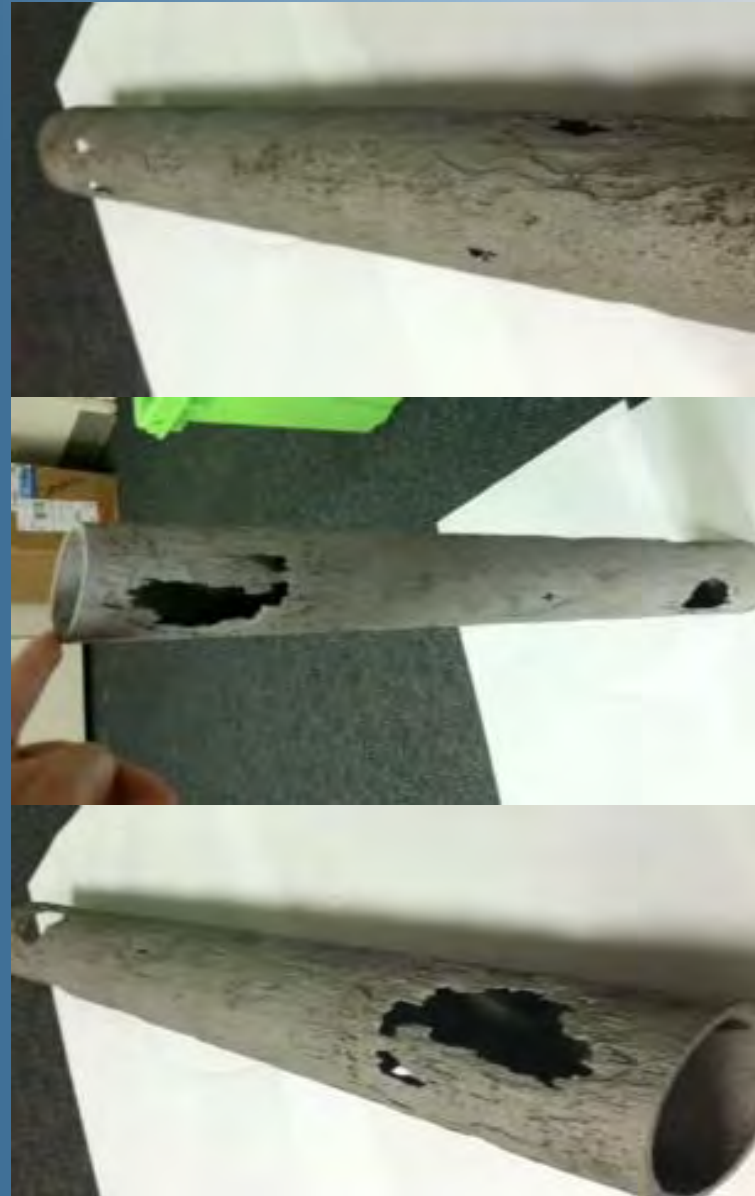
FY 2012

Address	18-56 Ash St
Town	Nashua
Pipe Size	2"
Install Date	1928
Wall Thickness	Unknown
Age	83
Pressure	12 in water column
Ground PH	6.5
Pipe Condition	100% Wall Loss/ Very Poor Condition

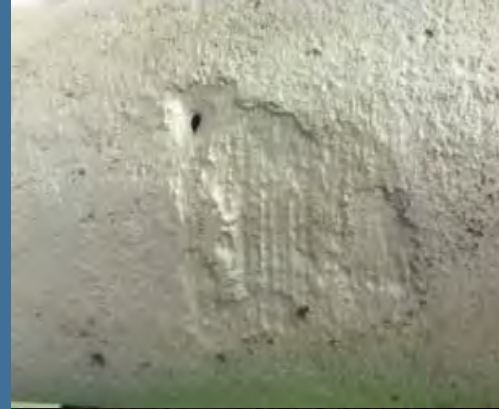
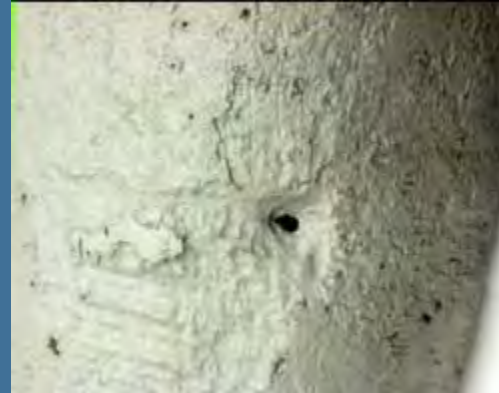
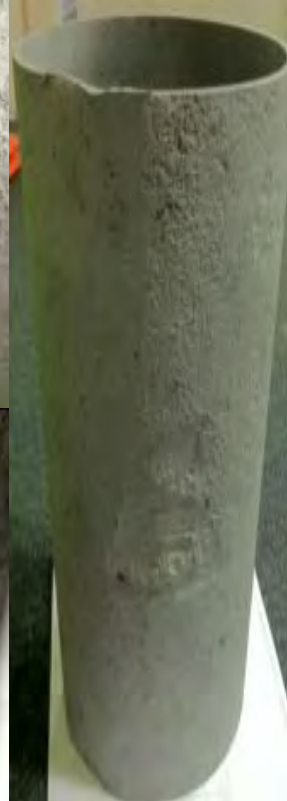
FY 2012

Address	55-100 W North St
Town	Manchester
Pipe Size	8"
Install Date	1960
Wall Thickness	Unknown
Age	51
Pressure	12 in water column
Ground PH	6
Pipe Condition	Deep Pitting/ Poor Condition

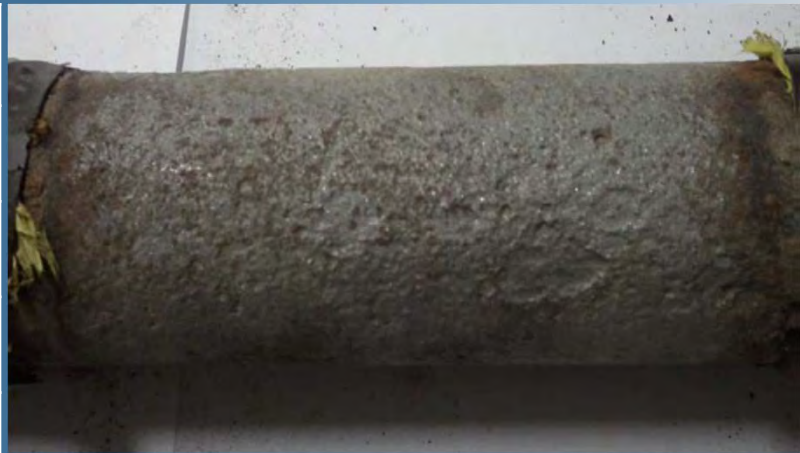
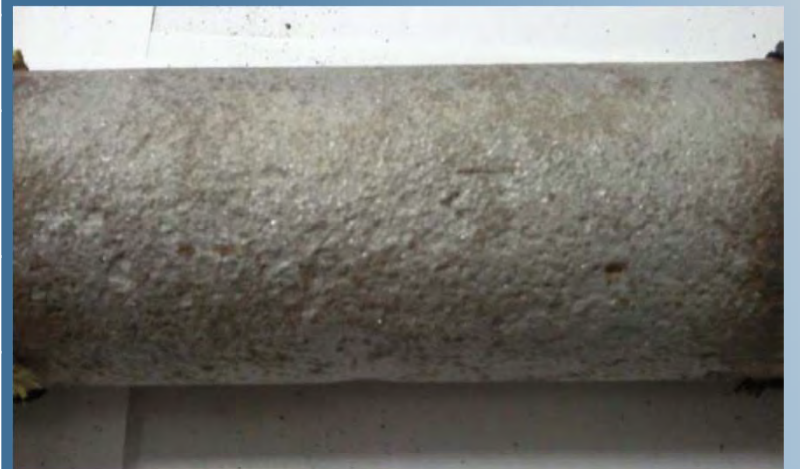
FY 2011

Address	20-34 School St
Town	Hudson
Pipe Size	2"
Install Date	1947
Wall Thickness	Unknown
Age	63
Pressure	12 in water column
Ground PH	7.5
Pipe Condition	Deep Pitting/ Fair to Poor Condition

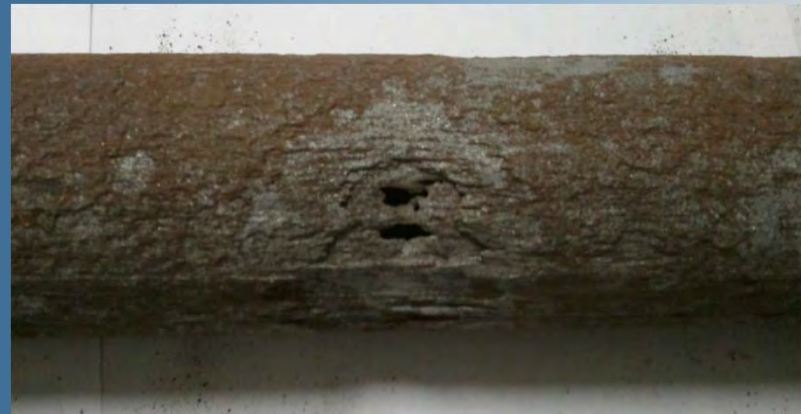
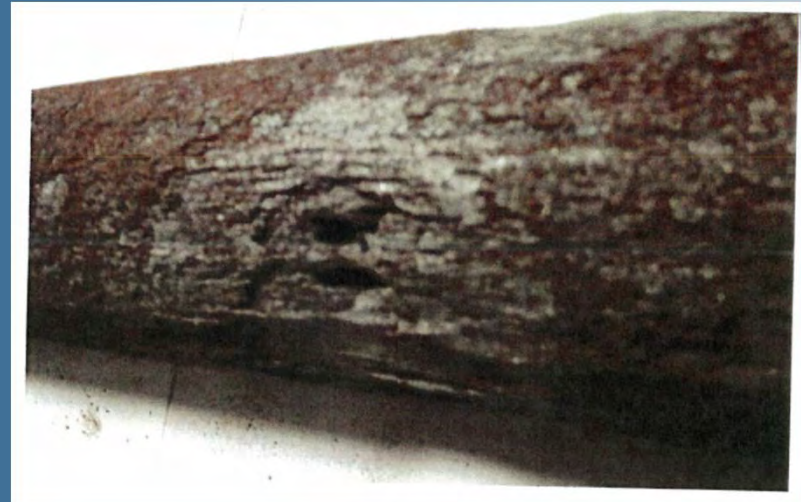
FY 2011

Address	2-18 Faxon St & 1-7 Faxon Ave
Town	Nashua
Pipe Size	2"
Install Date	1912
Wall Thickness	Unknown
Age	98
Pressure	12 in water column
Ground PH	7.5
Pipe Condition	Multiple Large Holes/ Very Poor Condition
