LIBERTY UTILITIES BARE STEEL REPLACEMENT PROGRAM

2009-2020

Prepared by the New Hampshire Public Utilities Commission
Safety Division

2020 Bare Steel Replacement Reports

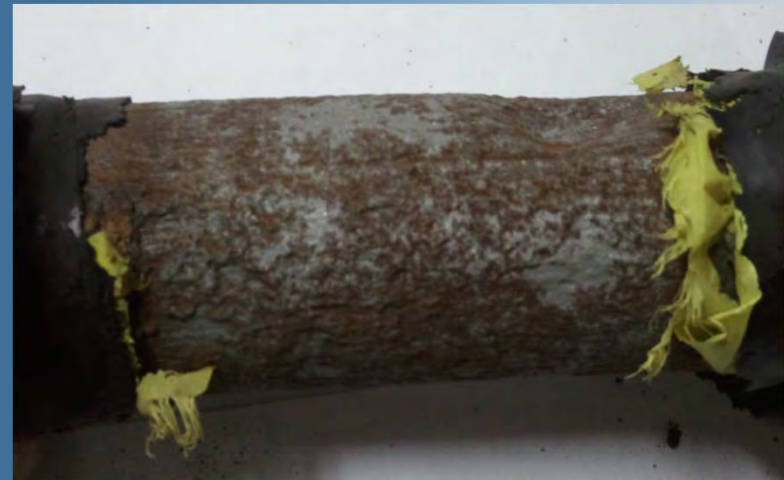
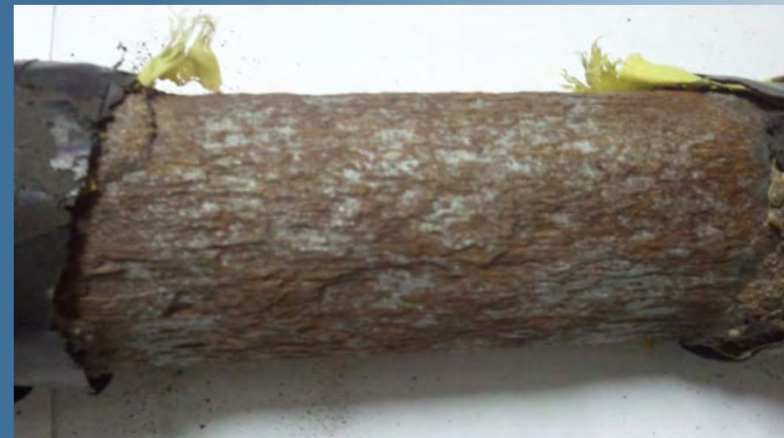
FY 2011

Address	116-130 Bowers St
Town	Nashua
Pipe Size	2"
Install Date	1913
Wall Thickness	Unknown
Age	97
Pressure	12 in water column
Ground PH	7
Pipe Condition	Heavy Wall Loss/ Poor Condition

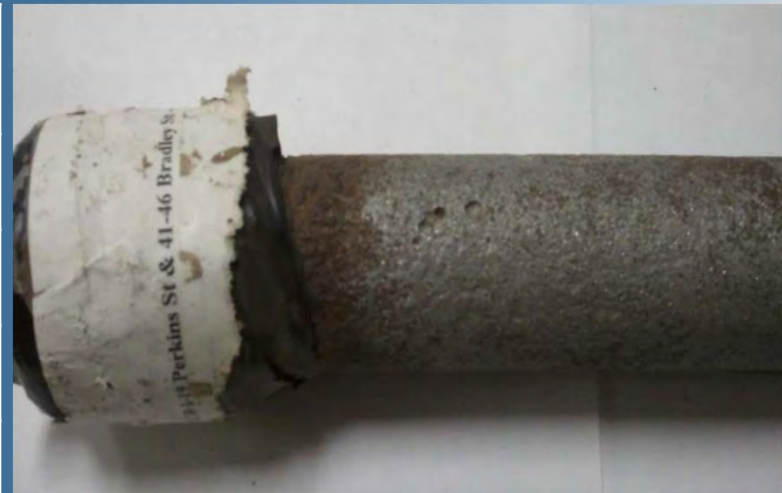
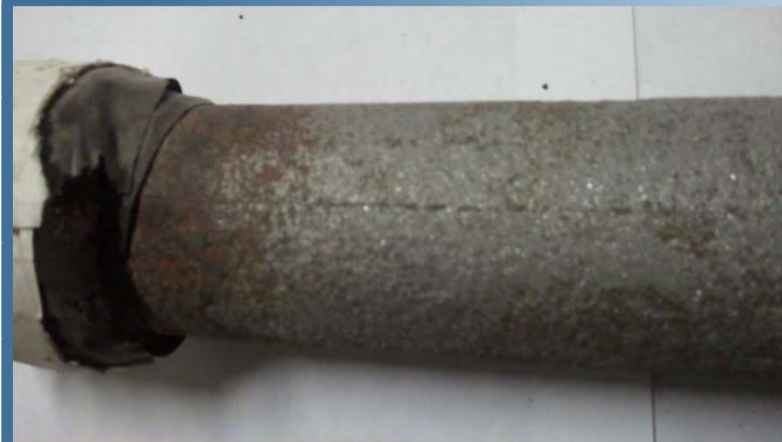
FY 2011

Address	1-19 Perkins St & 41-46 Bradley St
Town	Concord
Pipe Size	1.5"
Install Date	1955
Wall Thickness	Unknown
Age	55
Pressure	12 in water column
Ground PH	7
Pipe Condition	Deep Pitting/ Fair to Poor Condition

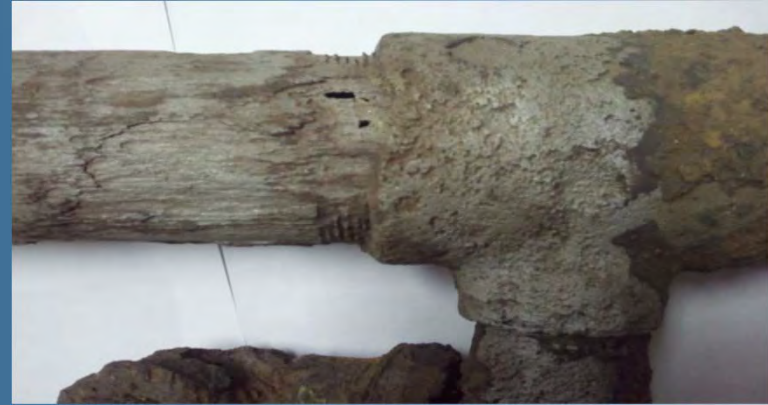
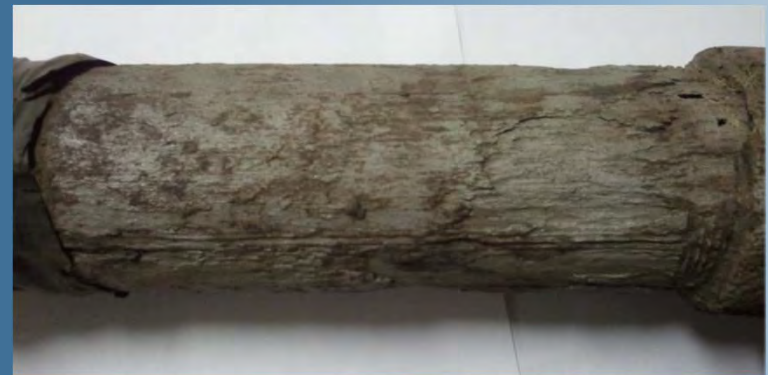
FY 2011

Address	Chester St-59 Berkeley St
Town	Nashua
Pipe Size	2"
Install Date	1947
Wall Thickness	Unknown
Age	63
Pressure	12 in water column
Ground PH	7
Pipe Condition	Visible Holes/ Very Poor Condition

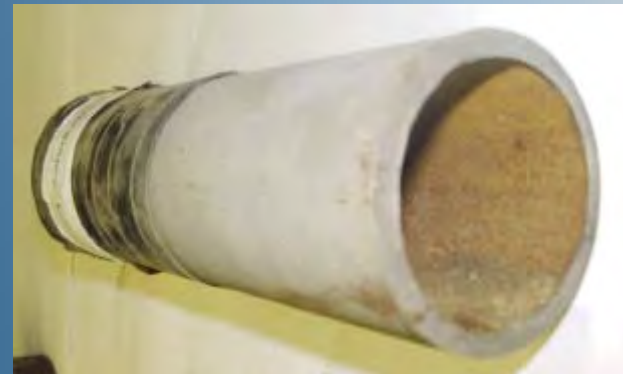
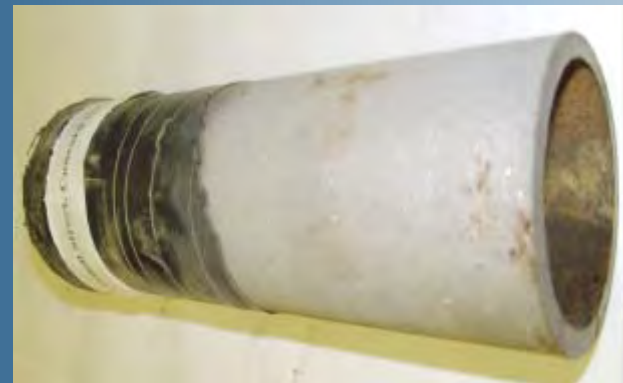
FY 2010

Address	2-7 Cornell St
Town	Concord
Pipe Size	2"
Install Date	1955
Wall Thickness	Unknown
Age	54
Pressure	60 psig
Ground PH	7 to 8
Pipe Condition	Good Condition
	Coated Steel

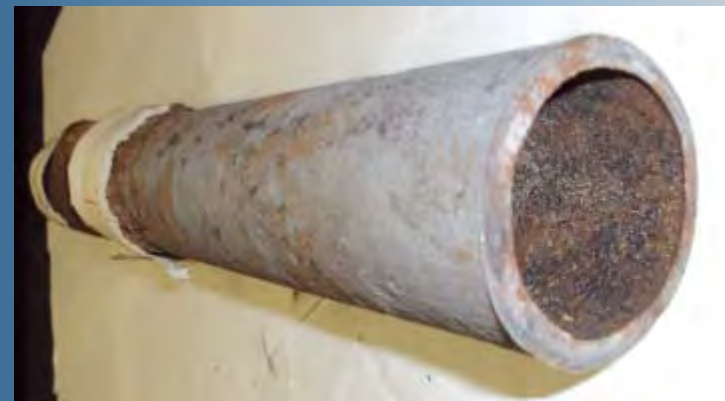
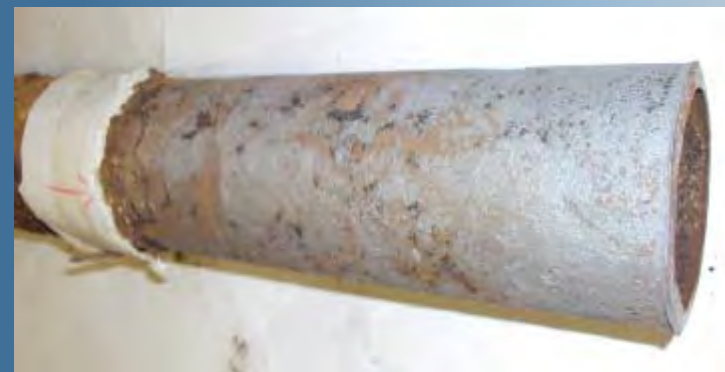
FY 2010

Address	83 Pleasant St
Town	Concord
Pipe Size	2"
Install Date	1900
Wall Thickness	Unknown
Age	109
Pressure	12 in water column
Ground PH	6
Pipe Condition	Some Areas of Pitting and Wall Loss

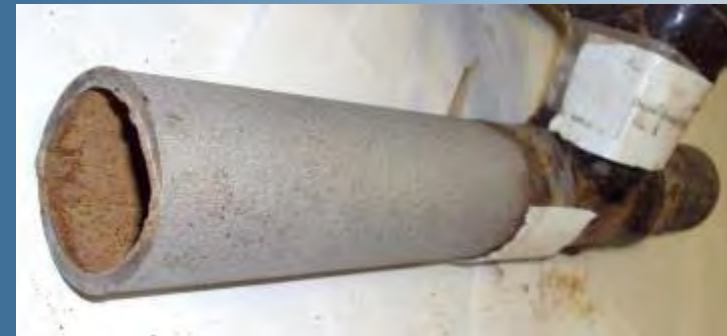
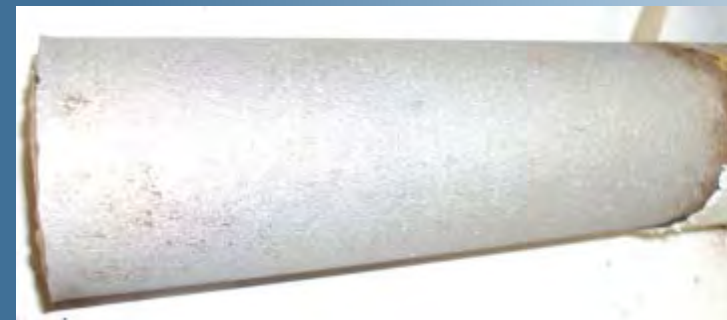
FY 2010

Address	25-28 Depot St
Town	Franklin
Pipe Size	2"
Install Date	1931
Wall Thickness	Unknown
Age	78
Pressure	60 psig
Ground PH	6
Pipe Condition	Good Condition
	Coated Steel

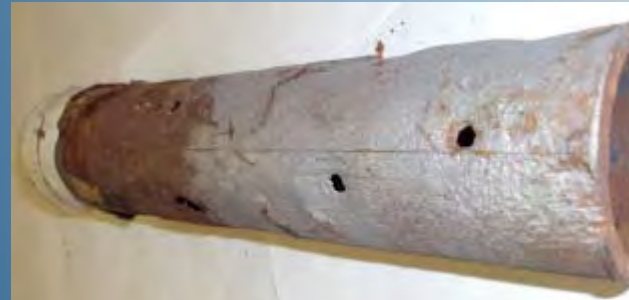
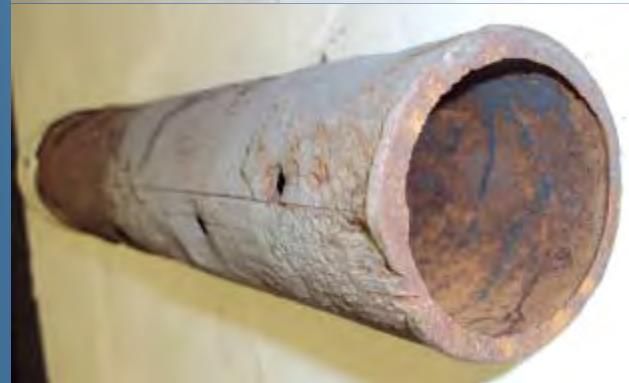
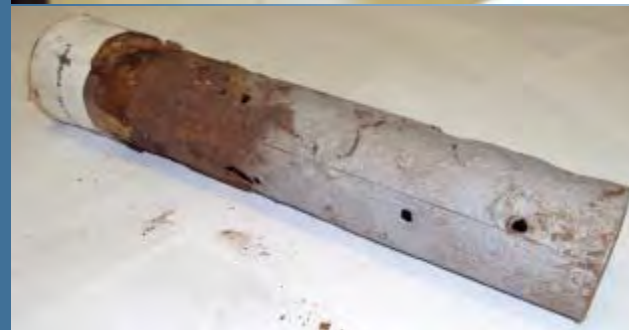
FY 2010

Address	80-113 Blossom St
Town	Nashua
Pipe Size	2"
Install Date	1908 & 1913
Wall Thickness	Unknown
Age	101
Pressure	12 in water column
Ground PH	5
Pipe Condition	Extremely Poor Condition

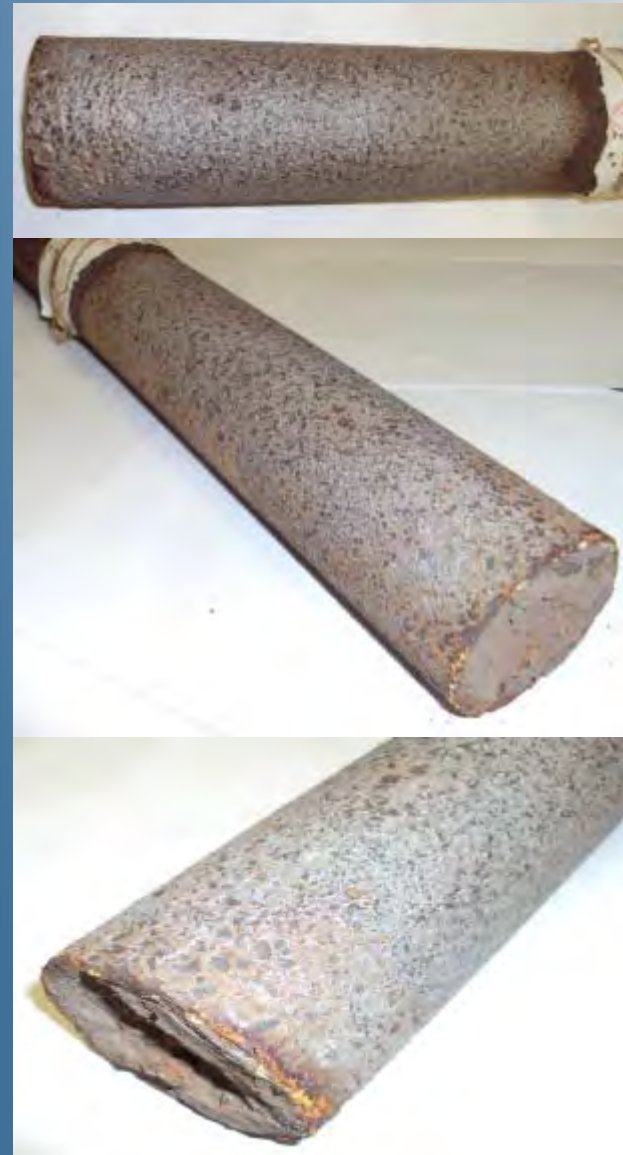
FY 2010

Address	5-11 Bristol St
Town	Nashua
Pipe Size	4"
Install Date	1947, 1951, 1954, 195?
Wall Thickness	Unknown
Age	62
Pressure	12 in water column
Ground PH	7
Pipe Condition	Moderate Uniform Pitting/ Fair Condition

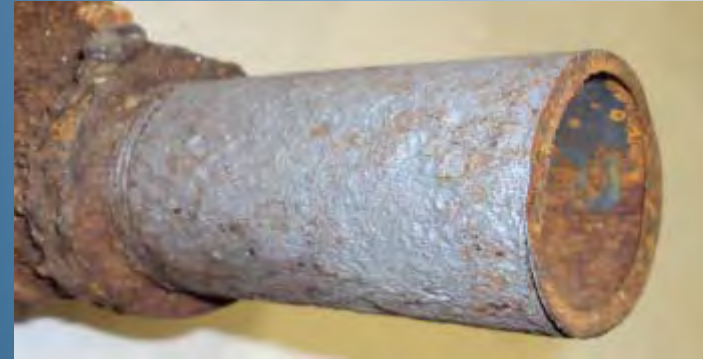
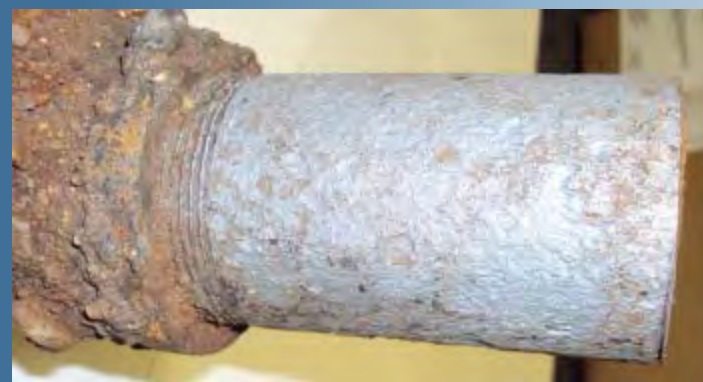
FY 2010

Address	12-25 Buck St
Town	Nashua
Pipe Size	2"
Install Date	1901, 1903 & 1911
Wall Thickness	Unknown
Age	108
Pressure	12 in water column
Ground PH	6 to 7
Pipe Condition	Heavy Pitting/ Poor Condition

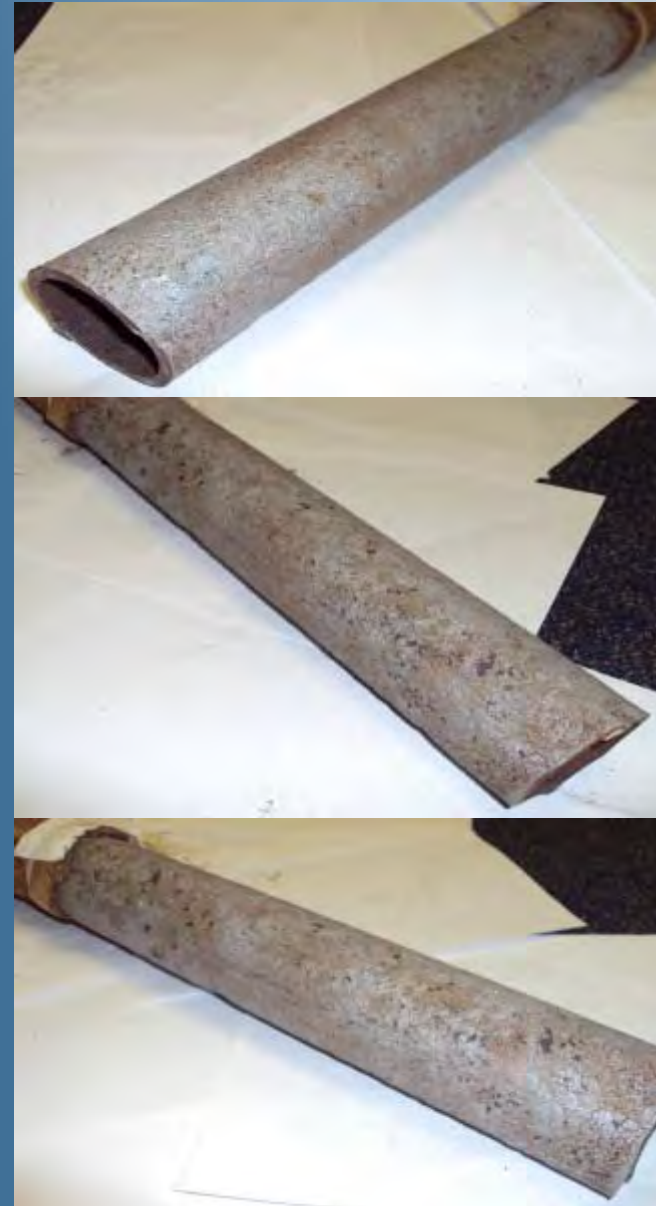
FY 2010

Address	2-4 Fourth St
Town	Nashua
Pipe Size	2"
Install Date	1926
Wall Thickness	Unknown
Age	83
Pressure	12 in water column
Ground PH	6
Pipe Condition	Significant Deep Pitting/ Poor Condition

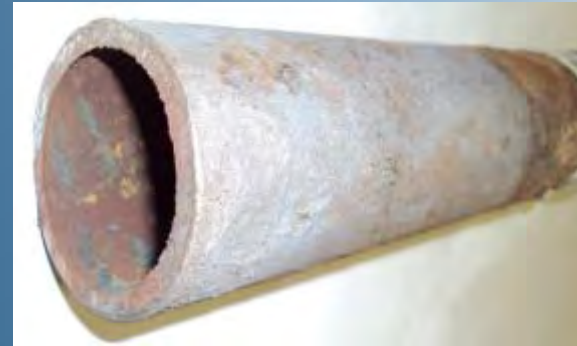
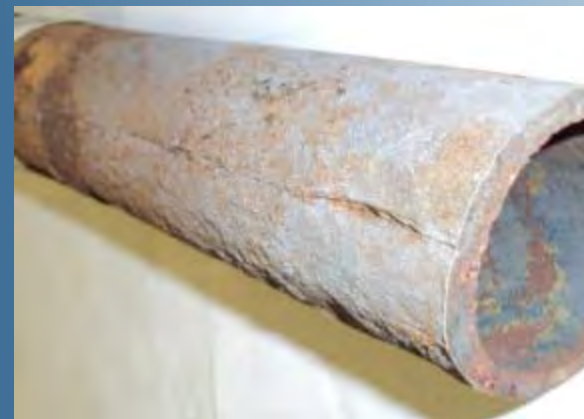
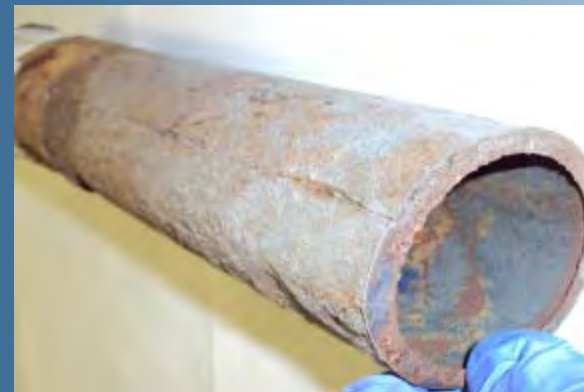
FY 2010

Address	31-39 Newbury St
Town	Nashua
Pipe Size	2"
Install Date	1898, 1910, 1928
Wall Thickness	Unknown
Age	111
Pressure	12 in water column
Ground PH	3 to 4
Pipe Condition	Significant Wall Loss/ Poor Condition

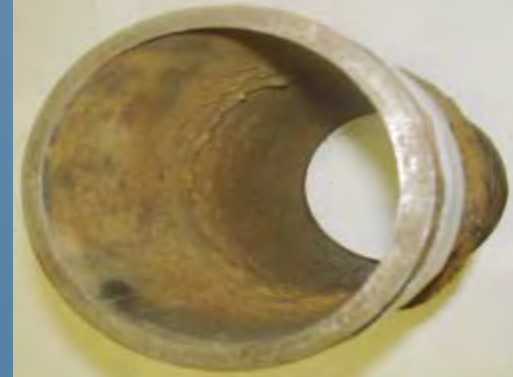
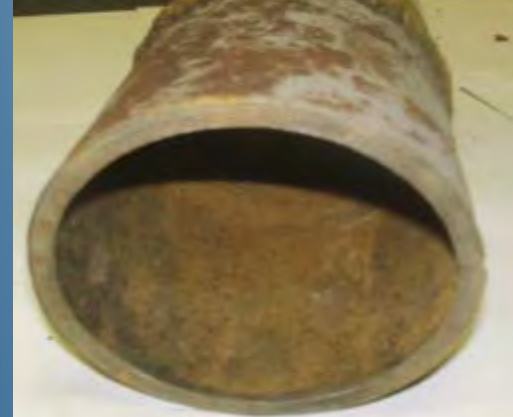
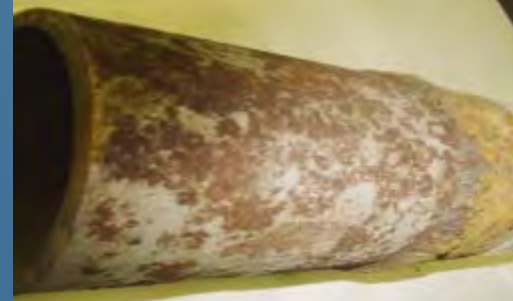
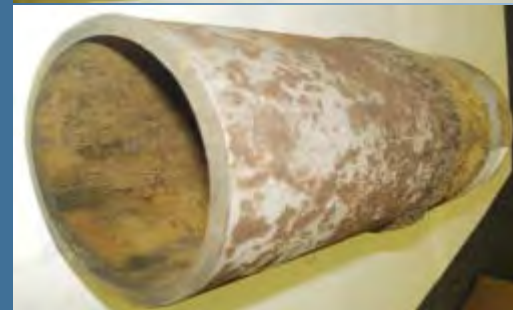
FY 2010

Address	5-21 Winter St
Town	Tilton
Pipe Size	4"
Install Date	1931
Wall Thickness	Unknown
Age	78
Pressure	60 psig
Ground PH	7
Pipe Condition	Fair Condition

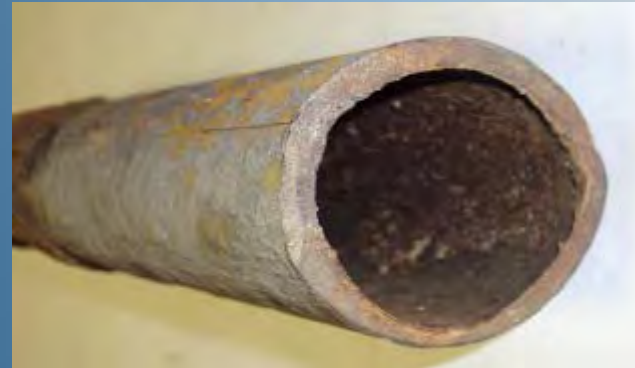
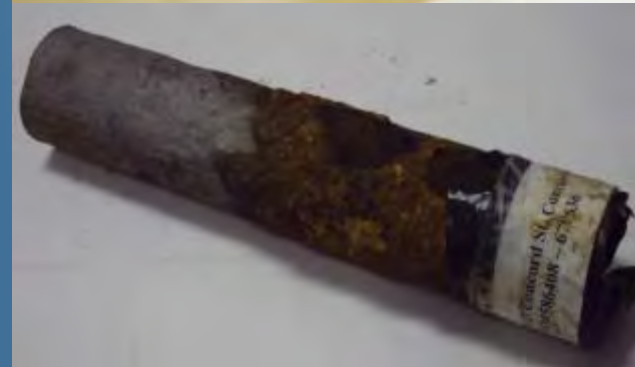
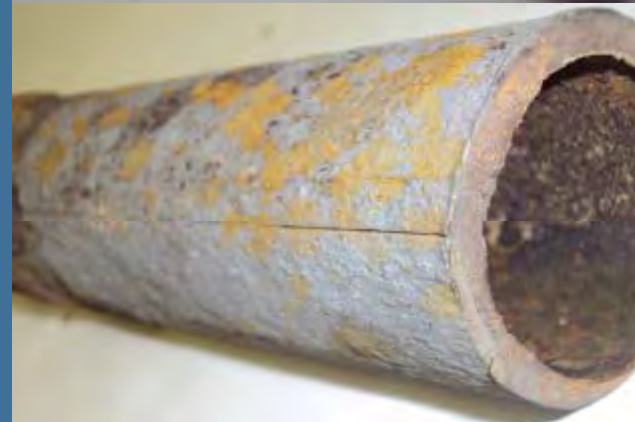
FY 2009

Address	Concord St
Town	Concord
Pipe Size	2"
Install Date	1953
Wall Thickness	0.166 in
Age	55
Pressure	12 in water column
Ground PH	7 to 8
Pipe Condition	Deep pitting/Significant wall loss

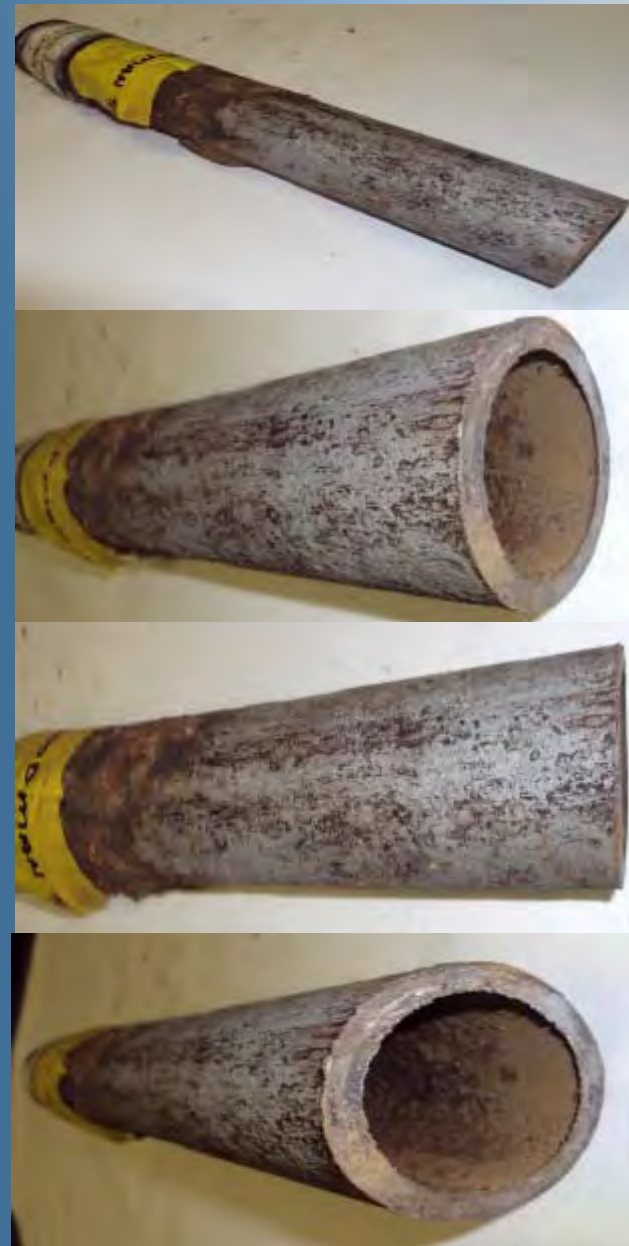
FY 2009

Address	2 Woodman St
Town	Concord
Pipe Size	1.5"
Install Date	1929
Wall Thickness	0.130 in
Age	79
Pressure	12 in water column
Ground PH	7 to 8
Pipe Condition	Deep pitting/Significant wall loss

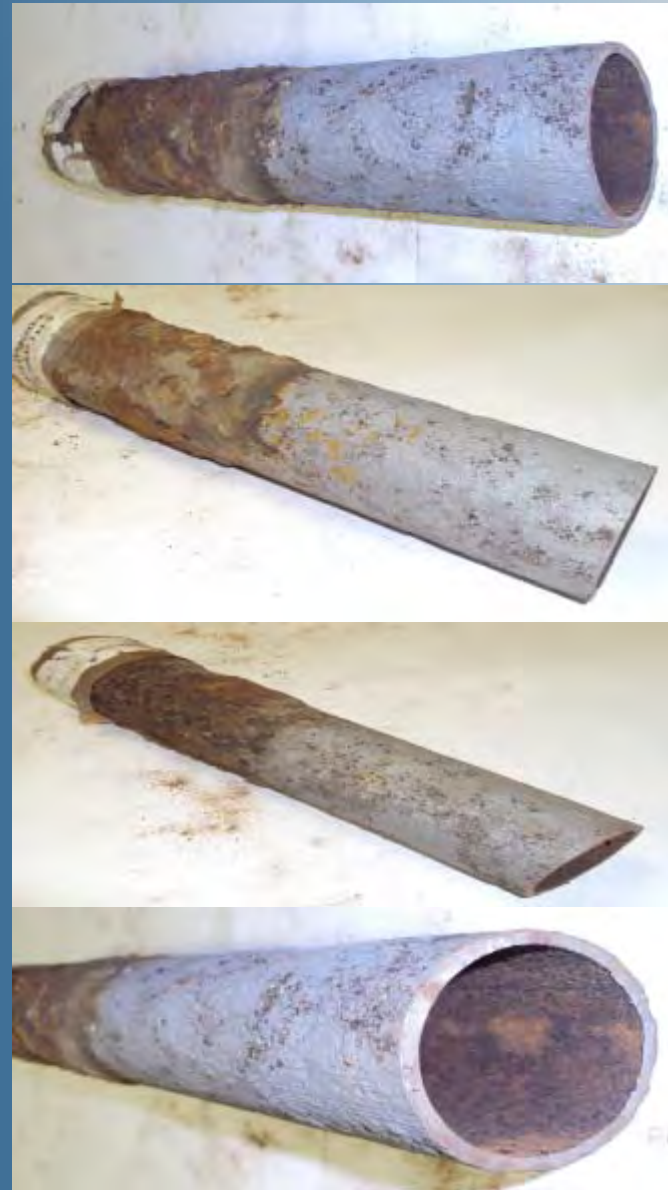
FY 2009

Address	Connell St
Town	Hudson
Pipe Size	2"
Install Date	1928
Wall Thickness	0.139 in
Age	80
Pressure	12 in water column
Ground PH	6 to 7
Pipe Condition	Deep pitting/Significant wall loss

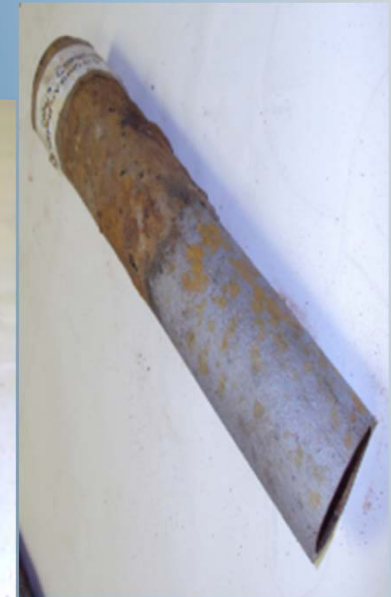
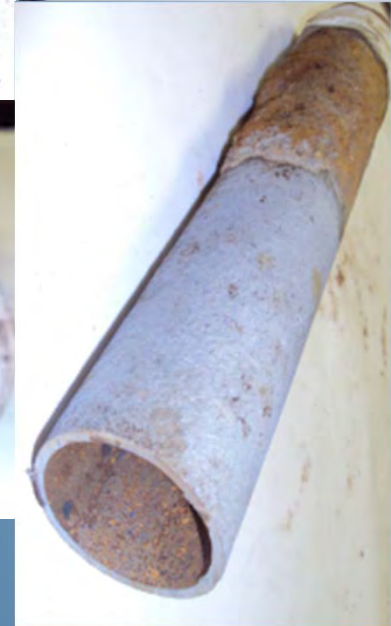
FY 2009

Address	Gloria Avenue
Town	Hudson
Pipe Size	2"
Install Date	1954
Wall Thickness	0.148 in
Age	54
Pressure	60 psig
Ground PH	7 to 8
Pipe Condition	Fair Condition

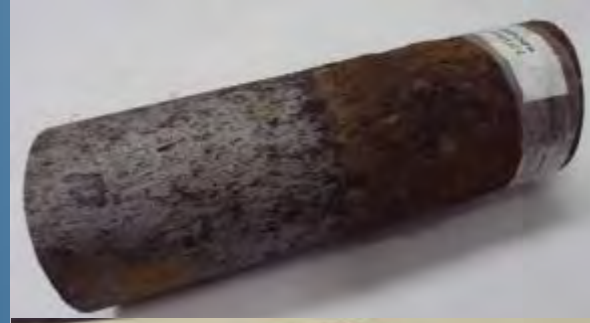
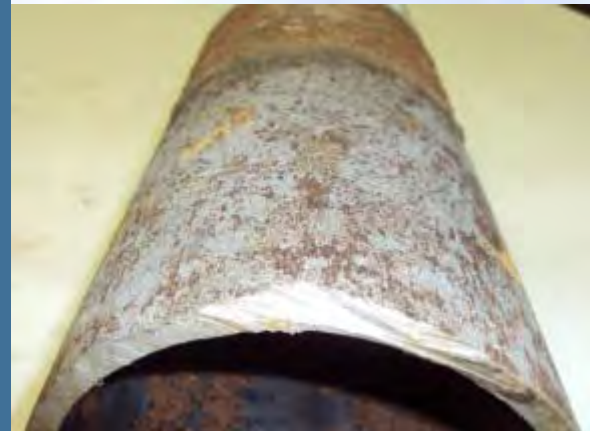
FY 2009

Address	Library St
Town	Hudson
Pipe Size	4"
Install Date	1908
Wall Thickness	0.234 in
Age	100
Pressure	12 in water column
Ground PH	6
Pipe Condition	Fair Condition

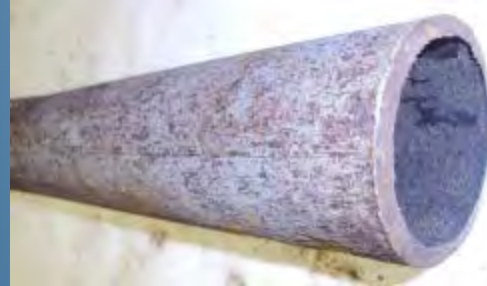
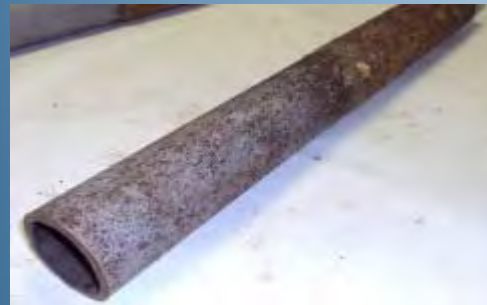
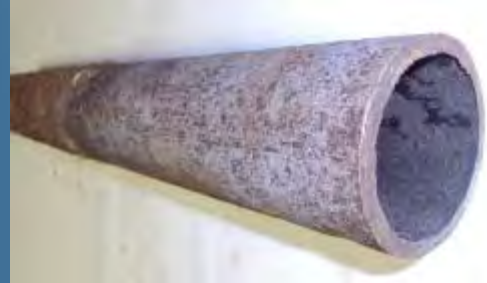
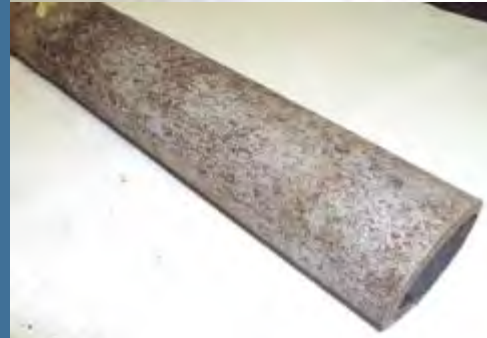
FY 2009

Address	Mulberry St
Town	Nashua
Pipe Size	2"
Install Date	1912
Wall Thickness	0.124 in
Age	96
Pressure	12 in water column
Ground PH	7 to 8
Pipe Condition	Concentrated Deep Pitting

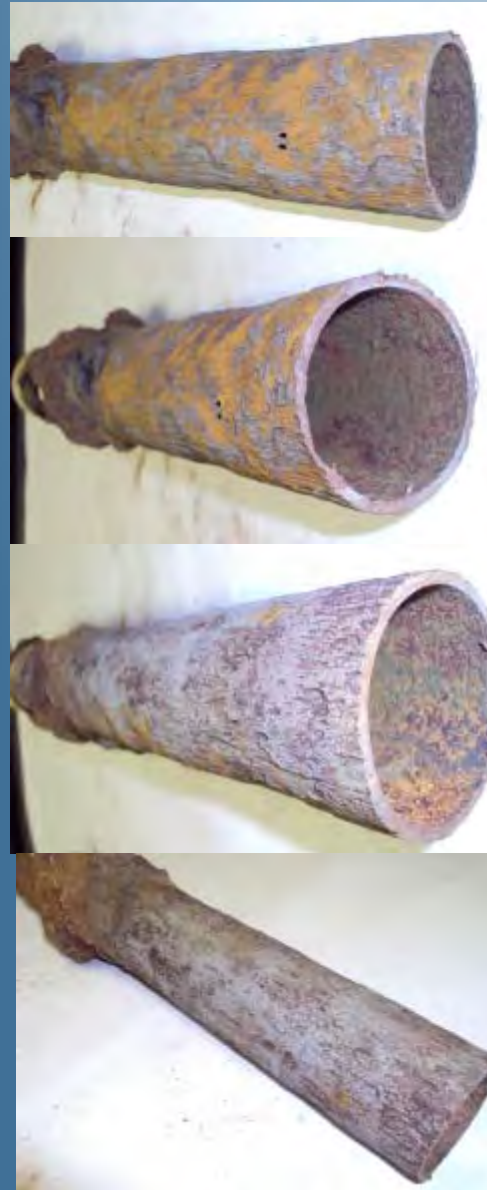
FY 2009

Address	Prescott St & Putnam St
Town	Nashua
Pipe Size	2"
Install Date	1924
Wall Thickness	Not Taken Due to Poor Condition
Age	84
Pressure	12 in water column
Ground PH	6 to 7
Pipe Condition	Pipe Breakage and Pit Holes

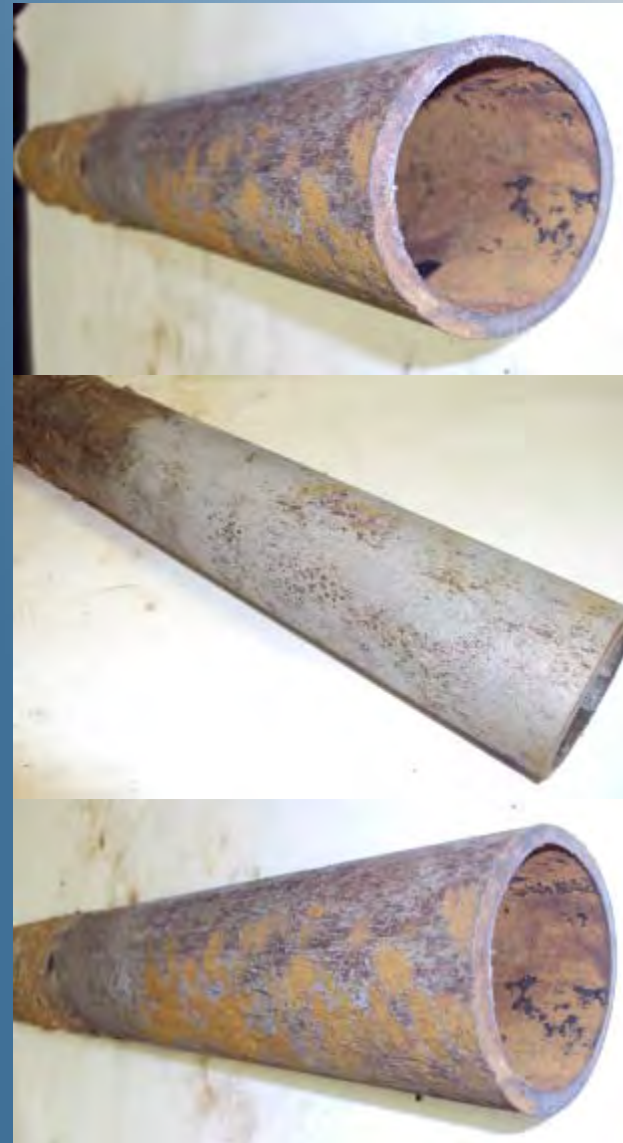
FY 2009

Address	Reed Ct
Town	Nashua
Pipe Size	2"
Install Date	1908
Wall Thickness	0.121 in
Age	100
Pressure	12 in water column
Ground PH	6
Pipe Condition	Significant Wall Loss
